## Profile/Photo Observation Report

Date:	<b>03/20/2018</b>	Weather:		Coding:	<b>PACP 6.0</b>
Pipe Length (ft):	<b>87.2</b>	Owner:	<b>NA</b>	Pre Clean:	<b>Not Known</b>
P.O.#:		Surveyor:	<b>John Kuglmaier</b>	PSR:	<b>P-809-041-040</b>
Customer:		Clean Date:	<b>01/01/1900</b>	Shape:	<b>C</b>

Street:	<b>KESTREL ST</b>	Flow Control:	<b>Not Controlled</b>
City:	<b>Hobart, IN</b>	Year Renewed:	
Location:	<b>Sidewalk</b>	Tape/Media #:	
Purpose:	<b>Maintenance Related</b>	Dia/Height:	<b>8"</b>
Use:	<b>Sanitary</b>	Material:	<b>PVC</b>
Drain Area:	<b>NA</b>	Lining:	
Category:	<b>NA</b>		
Comment:	<b>Reverse setup. mh, flow direction is wrong.</b>		
Location Details:		Direction of Survey:	<b>Upstream</b>
US MH:	<b>M-809-040</b>	DS MH:	<b>M-809-041</b>
		Total Length Surveyed (ft):	<b>84.9</b>

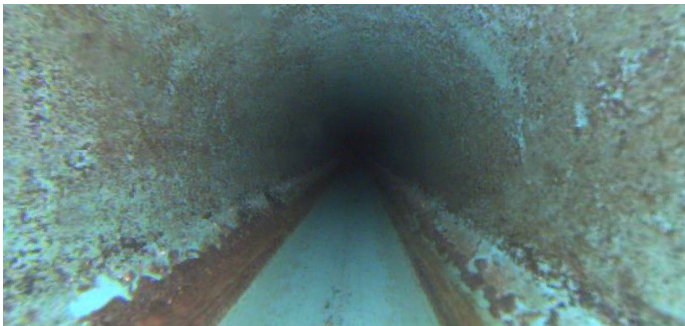
Code: **AMH**  
Description: **Manhole**

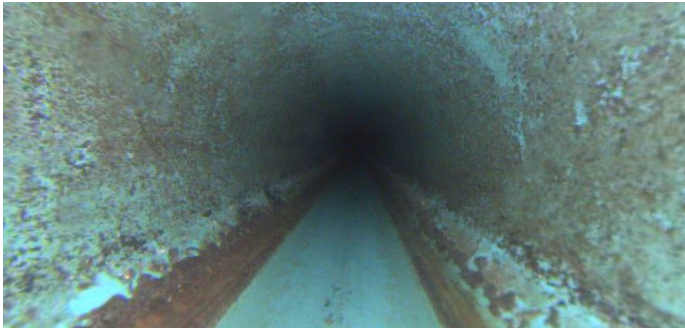
Code:	<b>MWL</b>
Description:	<b>Water Level</b>

Distance (ft):	<b>.0</b>
Structural Grade:	<b>0</b>
O&M Grade:	<b>0</b>
Clock Start/From:	
Clock To:	
1st Value:	
2nd Value:	
Value Percent:	<b>10.000</b>
Continuous Index:	
Within 8" of Joint:	<b>NO</b>
Remarks:

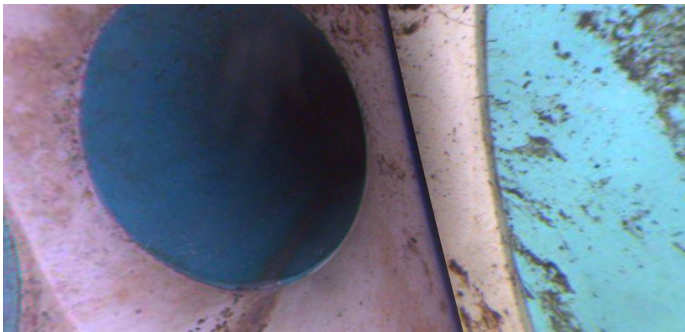
Code:	<b>TF</b>
Description:	<b>Tap Factory</b>

Distance (ft):	<b>13.0</b>
Structural Grade:	<b>0</b>
O&M Grade:	<b>0</b>
Clock Start/From:	<b>10</b>
Clock To:	
1st Value:	<b>4.000</b>
2nd Value:	
Value Percent:	
Continuous Index:	
Within 8" of Joint:	
Remarks:

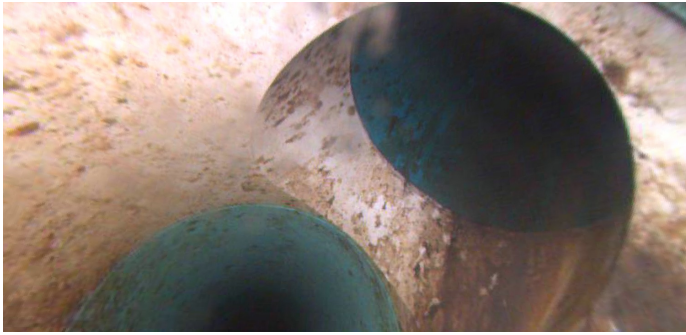
Code: **TF**  
Description: **Tap Factory**

Distance (ft): **13.9**  
Structural Grade: **0**  
O&M Grade: **0**  
Clock Start/From: **1**  
Clock To:  
1st Value: **4.000**  
2nd Value:  
Value Percent:  
Continuous Index:  
Within 8" of Joint:  
Remarks:

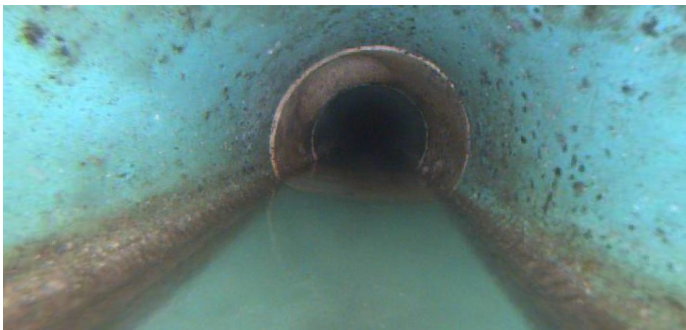
Code: **MWL**  
Description: **Water Level**

Distance (ft): **68.6**  
Structural Grade: **0**  
O&M Grade: **0**  
Clock Start/From:  
Clock To:  
1st Value:  
2nd Value:  
Value Percent: **20.000**  
Continuous Index:  
Within 8" of Joint: **NO**  
Remarks:

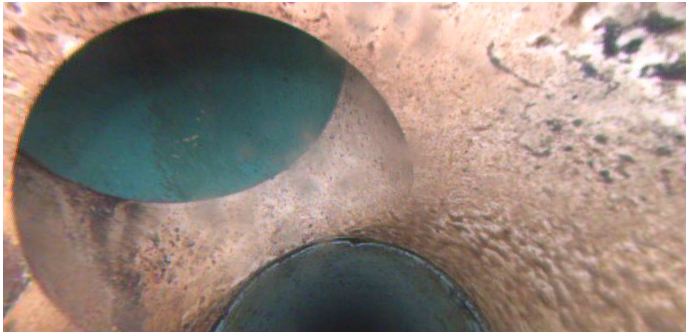
Code: **TF**  
Description: **Tap Factory**

Distance (ft): **69.5**  
Structural Grade: **0**  
O&M Grade: **0**  
Clock Start/From: **11**  
Clock To:  
1st Value: **4.000**  
2nd Value:  
Value Percent:  
Continuous Index:  
Within 8" of Joint:  
Remarks:

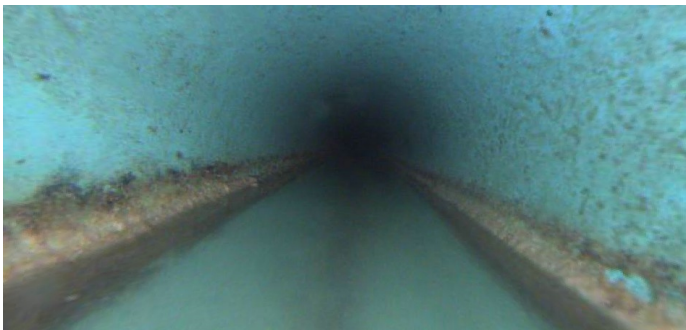
Code: **MWL**  
Description: **Water Level**

Distance (ft): **71.3**  
Structural Grade: **0**  
O&M Grade: **0**  
Clock Start/From:  
Clock To:  
1st Value:  
2nd Value:  
Value Percent: **35.000**  
Continuous Index:  
Within 8" of Joint: **NO**  
Remarks:

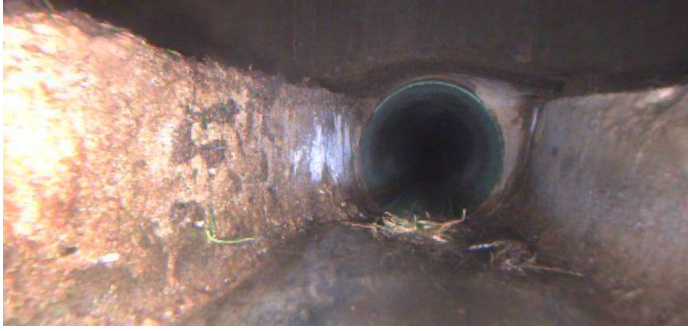
Code:	<b>AMH</b>
Description:	<b>Manhole</b>
Distance (ft):	<b>84.9</b>
Structural Grade:	<b>0</b>
O&M Grade:	<b>0</b>
Clock Start/From:	
Clock To:	
1st Value:	
2nd Value:	
Value Percent:	
Continuous Index:	
Within 8" of Joint:	<b>NO</b>
Remarks:	<b>M-809-040</b>
