Profile/Photo Observation Report

Date:	03/20/2018	Weather:		Coding:	PACP 6.0
Pipe Length (ft):	235.9	Owner:	NA	Pre Clean:	Not Known
P.O.#:		Surveyor:	John Kuglmaier	PSR:	P-809-044-043
Customer:		Clean Date:	01/01/1900	Shape:	C

Street:	Oak	Flow Control:	Not Controlled
City:	Hobart, IN	Year Renewed:	
Location:	Sidewalk	Tape/Media #:	
Purpose:	Maintenance Related	Dia/Height:	8"
Use:	Sanitary	Material:	PVC
Drain Area:	NA	Lining:	
Category:	NA		
Comment:	flow direction incorrect.

Location Details:		Direction of Survey:	Upstream
US MH:	M-809-043	DS MH:	M-809-044
		Total Length Surveyed (ft):	233.0

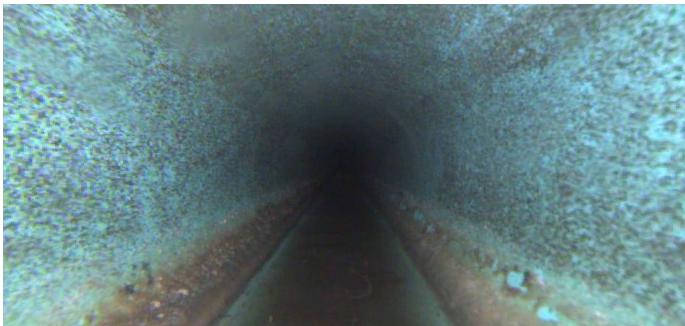
Code: **AMH**
Description: **Manhole**

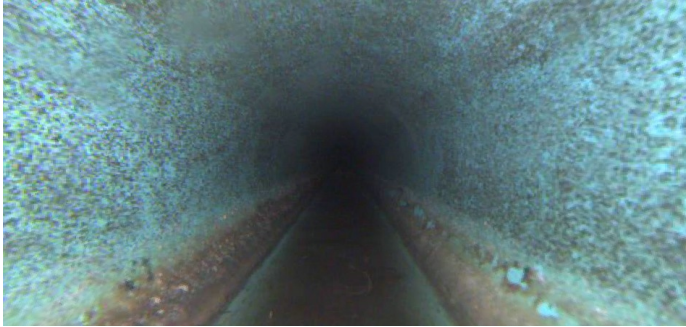
Code:	MWL
Description:	Water Level

Distance (ft):	.0
Structural Grade:	0
O&M Grade:	0
Clock Start/From:	
Clock To:	
1st Value:	
2nd Value:	
Value Percent:	10.000
Continuous Index:	
Within 8" of Joint:	NO
Remarks:

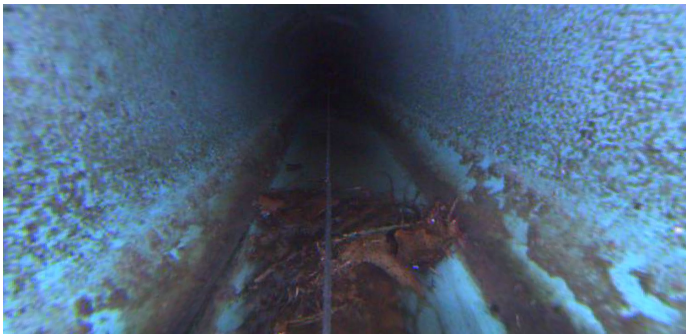
Code:	DSZ
Description:	Deposits Settled Other

Distance (ft):	10.4
Structural Grade:	0
O&M Grade:	2
Clock Start/From:	6
Clock To:	
1st Value:	
2nd Value:	
Value Percent:	5.000
Continuous Index:	
Within 8" of Joint:	NO
Remarks:	leaves

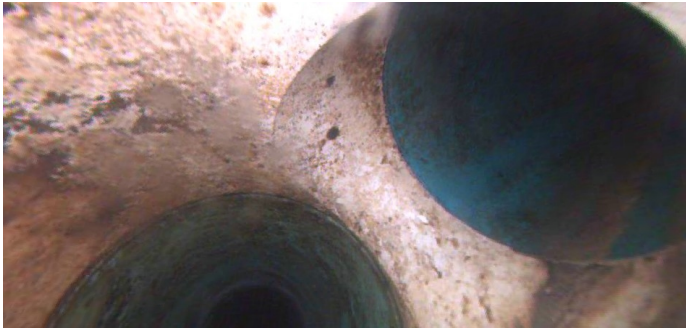
Code: **TF**
Description: **Tap Factory**

Distance (ft): **23.2**
Structural Grade: **0**
O&M Grade: **0**
Clock Start/From: **2**
Clock To:
1st Value: **4.000**
2nd Value:
Value Percent:
Continuous Index:
Within 8" of Joint:
Remarks:

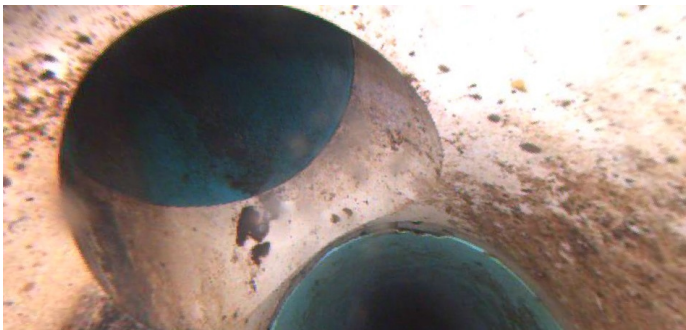
Code: **TF**
Description: **Tap Factory**

Distance (ft): **49.5**
Structural Grade: **0**
O&M Grade: **0**
Clock Start/From: **10**
Clock To:
1st Value: **4.000**
2nd Value:
Value Percent:
Continuous Index:
Within 8" of Joint:
Remarks:

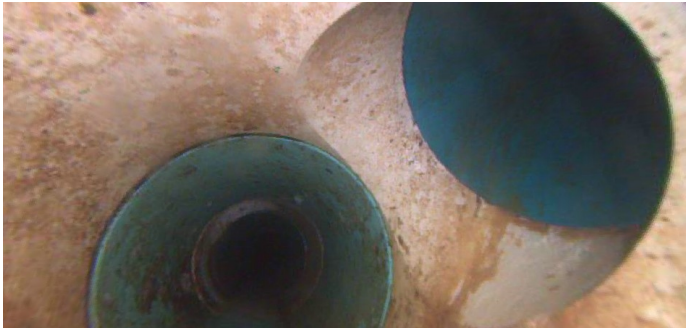
Code: **TF**
Description: **Tap Factory**

Distance (ft): **116.8**
Structural Grade: **0**
O&M Grade: **0**
Clock Start/From: **2**
Clock To:
1st Value: **4.000**
2nd Value:
Value Percent:
Continuous Index:
Within 8" of Joint:
Remarks:

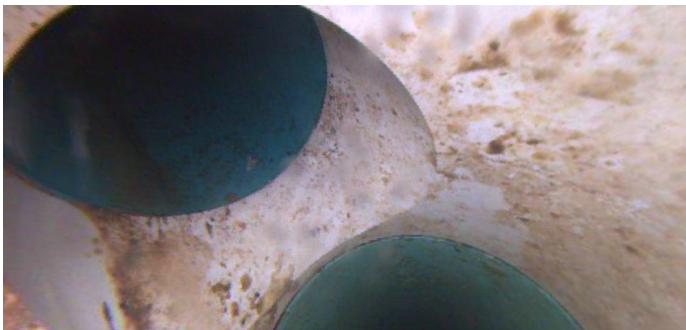
Code: **TF**
Description: **Tap Factory**

Distance (ft): **118.4**
Structural Grade: **0**
O&M Grade: **0**
Clock Start/From: **10**
Clock To:
1st Value: **4.000**
2nd Value:
Value Percent:
Continuous Index:
Within 8" of Joint:
Remarks:

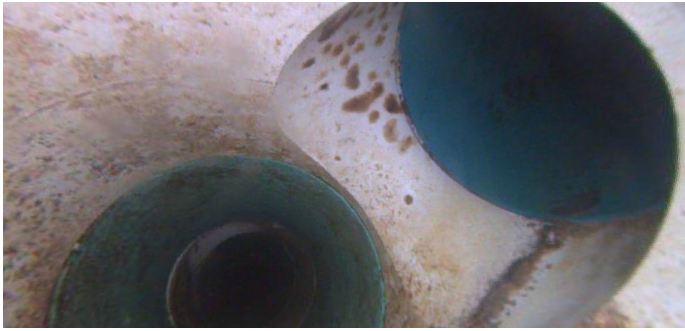
Code: **TF**
Description: **Tap Factory**

Distance (ft): **190.5**
Structural Grade: **0**
O&M Grade: **0**
Clock Start/From: **2**
Clock To:
1st Value: **4.000**
2nd Value:
Value Percent:
Continuous Index:
Within 8" of Joint:
Remarks:

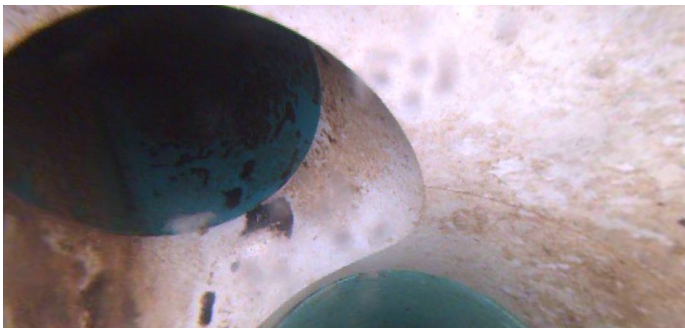
Code: **TF**
Description: **Tap Factory**

Distance (ft): **192.1**
Structural Grade: **0**
O&M Grade: **0**
Clock Start/From: **10**
Clock To:
1st Value: **4.000**
2nd Value:
Value Percent:
Continuous Index:
Within 8" of Joint:
Remarks:

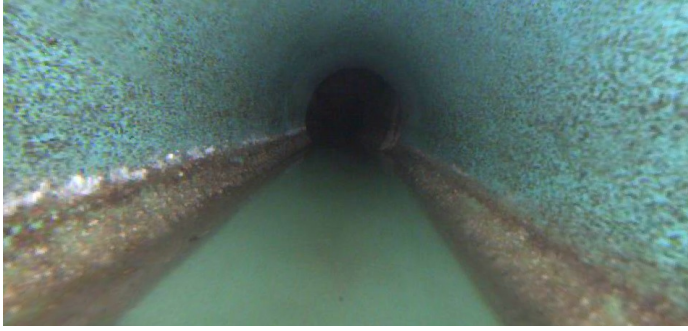
Code: **MWL**
Description: **Water Level**

Distance (ft): **229.3**
Structural Grade: **0**
O&M Grade: **0**
Clock Start/From:
Clock To:
1st Value:
2nd Value:
Value Percent: **20.000**
Continuous Index:
Within 8" of Joint: **NO**
Remarks:

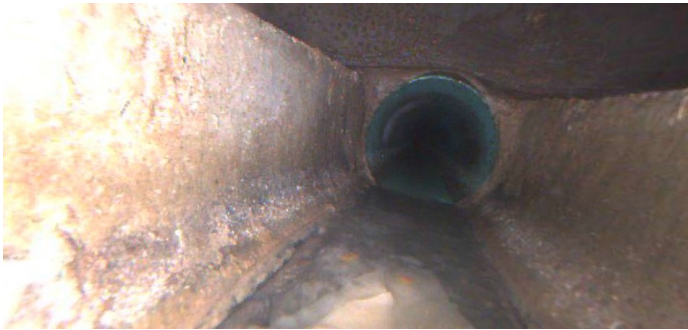
Code: **AMH**
Description: **Manhole**

Distance (ft): **233.0**
Structural Grade: **0**
O&M Grade: **0**
Clock Start/From:
Clock To:
1st Value:
2nd Value:
Value Percent:
Continuous Index:
Within 8" of Joint: **NO**
Remarks: **M-809-043**
