## Profile/Photo Observation Report

Street:	<b>TANAGER ST</b>	Flow Control:	<b>Not Controlled</b>
City:	<b>Hobart, IN</b>	Year Renewed:	
Location:	<b>Ditch</b>	Tape/Media #:	
Purpose:	<b>Maintenance Related</b>	Dia/Height:	<b>8"</b>
Use:	<b>Sanitary</b>	Material:	<b>PVC</b>
Drain Area:	<b>NA</b>	Lining:	
Category:	<b>NA</b>		
Comment:

Location Details:		Direction of Survey:	<b>Upstream</b>
US MH:	<b>M-809-047</b>	DS MH:	<b>M-809-048</b>
		Total Length Surveyed (ft):	<b>227.8</b>

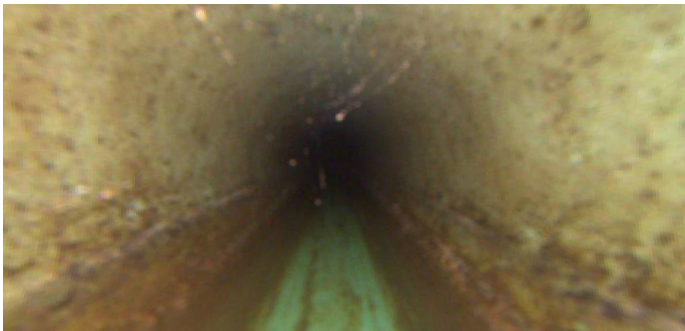
Code: **AMH**  
Description: **Manhole**

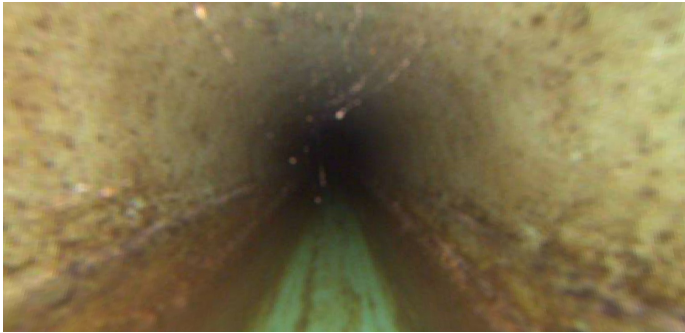
Code:	<b>MWL</b>
Description:	<b>Water Level</b>

Distance (ft):	<b>.0</b>
Structural Grade:	<b>0</b>
O&M Grade:	<b>0</b>
Clock Start/From:	
Clock To:	
1st Value:	
2nd Value:	
Value Percent:	<b>5.000</b>
Continuous Index:	
Within 8" of Joint:	<b>NO</b>
Remarks:

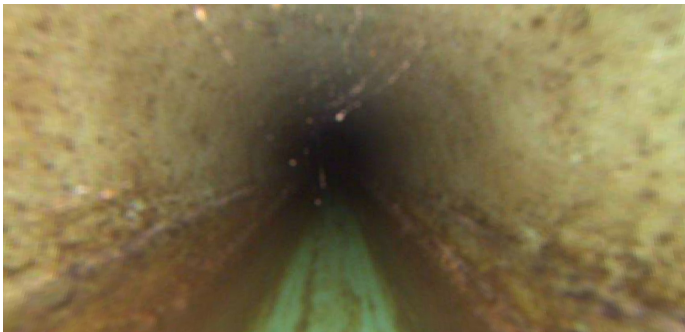
Code:	<b>DAZ</b>
Description:	<b>Deposits Attached Other</b>

Distance (ft):	<b>.0</b>
Structural Grade:	<b>0</b>
O&M Grade:	<b>2</b>
Clock Start/From:	<b>7</b>
Clock To:	<b>5</b>
1st Value:	
2nd Value:	
Value Percent:	<b>5.000</b>
Continuous Index:	<b>S01</b>
Within 8" of Joint:	<b>YES</b>
Remarks:	<b>WANDER</b>

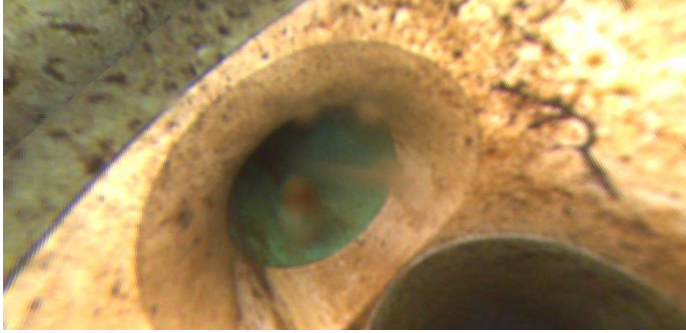
Code: **TF**  
Description: **Tap Factory**

Distance (ft): **5.7**  
Structural Grade: **0**  
O&M Grade: **0**  
Clock Start/From: **10**  
Clock To:  
1st Value: **4.000**  
2nd Value:  
Value Percent:  
Continuous Index:  
Within 8" of Joint:  
Remarks:

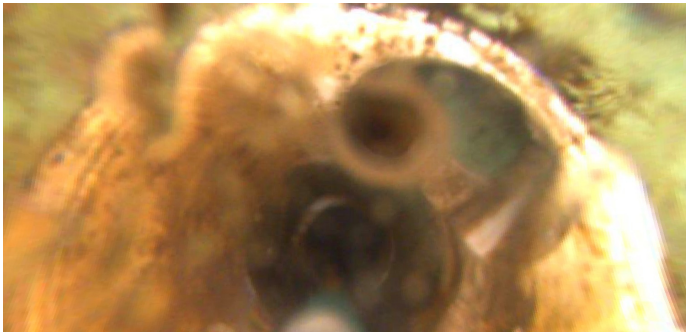
Code: **TF**  
Description: **Tap Factory**

Distance (ft): **50.7**  
Structural Grade: **0**  
O&M Grade: **0**  
Clock Start/From: **2**  
Clock To:  
1st Value: **4.000**  
2nd Value:  
Value Percent:  
Continuous Index:  
Within 8" of Joint:  
Remarks:

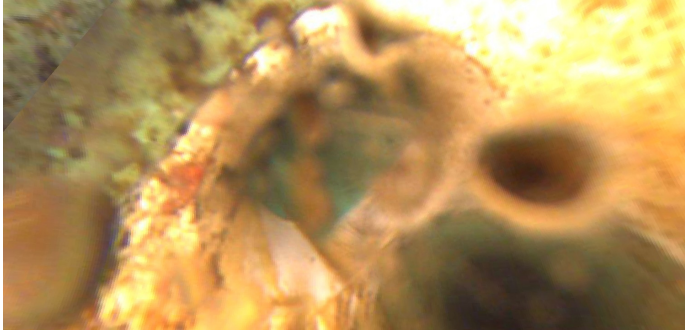
Code: **TF**  
Description: **Tap Factory**

Distance (ft): **52.4**  
Structural Grade: **0**  
O&M Grade: **0**  
Clock Start/From: **10**  
Clock To:  
1st Value: **4.000**  
2nd Value:  
Value Percent:  
Continuous Index:  
Within 8" of Joint:  
Remarks:

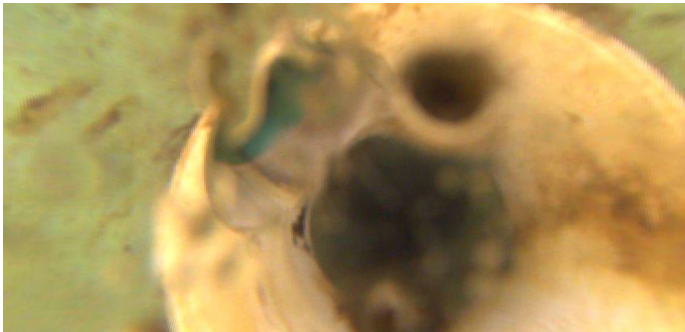
Code: **TF**  
Description: **Tap Factory**

Distance (ft): **116.6**  
Structural Grade: **0**  
O&M Grade: **0**  
Clock Start/From: **10**  
Clock To:  
1st Value: **4.000**  
2nd Value:  
Value Percent:  
Continuous Index:  
Within 8" of Joint:  
Remarks:

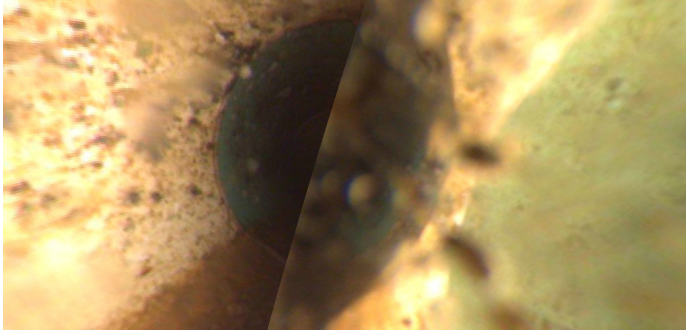
Code: **TF**  
Description: **Tap Factory**

Distance (ft): **207.3**  
Structural Grade: **0**  
O&M Grade: **0**  
Clock Start/From: **10**  
Clock To:  
1st Value: **4.000**  
2nd Value:  
Value Percent:  
Continuous Index:  
Within 8" of Joint:  
Remarks:

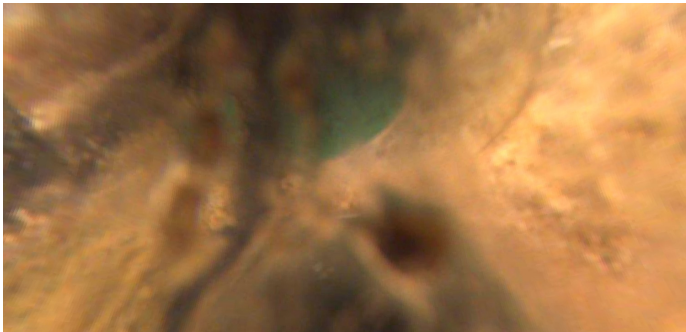
Code: **TF**  
Description: **Tap Factory**

Distance (ft): **222.4**  
Structural Grade: **0**  
O&M Grade: **0**  
Clock Start/From: **11**  
Clock To:  
1st Value: **4.000**  
2nd Value:  
Value Percent:  
Continuous Index:  
Within 8" of Joint:  
Remarks:

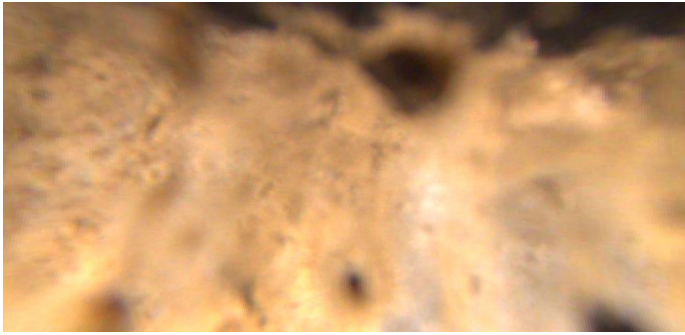
Code: **AMH**  
Description: **Manhole**

Distance (ft): **227.8**  
Structural Grade: **0**  
O&M Grade: **0**  
Clock Start/From:  
Clock To:  
1st Value:  
2nd Value:  
Value Percent:  
Continuous Index:  
Within 8" of Joint: **NO**  
Remarks: **M-809-047**

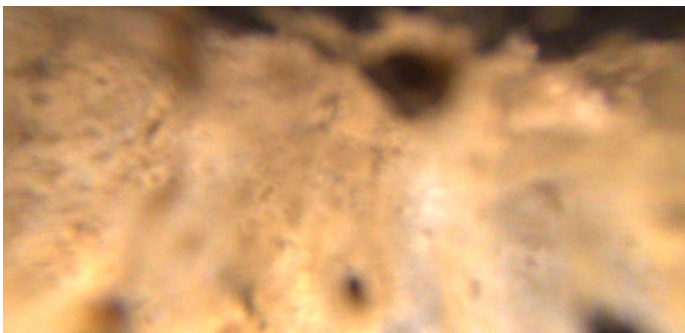
Code: **DAZ**  
Description: **Deposits Attached Other**

Distance (ft): **227.8**  
Structural Grade: **0**  
O&M Grade: **2**  
Clock Start/From: **7**  
Clock To: **5**  
1st Value:  
2nd Value:  
Value Percent: **5.000**  
Continuous Index: **F01**  
Within 8" of Joint: **YES**  
Remarks: **WANDER**
