Profile/Photo Observation Report

Date:	03/23/2018	Weather:		Coding:	PACP 6.0
Pipe Length (ft):	232.4	Owner:	NA	Pre Clean:	Not Known
P.O.#:		Surveyor:	Justin Gonzales	PSR:	P-809-047-048
Customer:		Clean Date:	01/01/1900	Shape:	C

Street:	Oak	Flow Control:	Not Controlled
City:	Hobart, IN	Year Renewed:	
Location:	Ditch	Tape/Media #:	
Purpose:	Maintenance Related	Dia/Height:	8"
Use:	Sanitary	Material:	PVC
Drain Area:	NA	Lining:	
Category:	NA		
Comment:

Location Details:		Direction of Survey:	Upstream
US MH:	M-809-047	DS MH:	M-809-048
		Total Length Surveyed (ft):	227.8

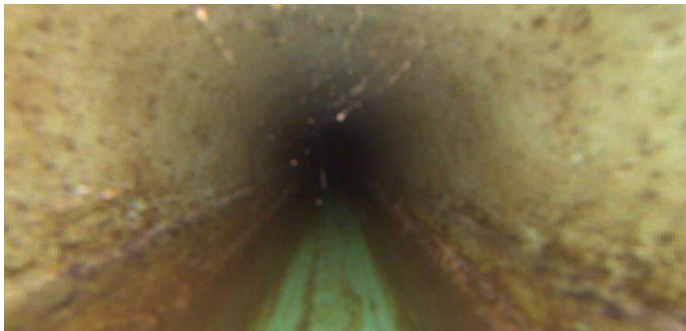
Code: **AMH**
Description: **Manhole**

Distance (ft): **.0**
Structural Grade: **0**
O&M Grade: **0**
Clock Start/From:
Clock To:
1st Value:
2nd Value:
Value Percent:
Continuous Index:
Within 8" of Joint: **NO**
Remarks: **M-809-048**

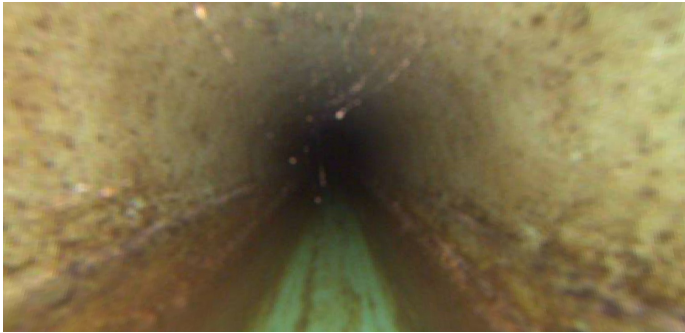
Code:	MWL
Description:	Water Level

Distance (ft):	.0
Structural Grade:	0
O&M Grade:	0
Clock Start/From:	
Clock To:	
1st Value:	
2nd Value:	
Value Percent:	5.000
Continuous Index:	
Within 8" of Joint:	NO
Remarks:

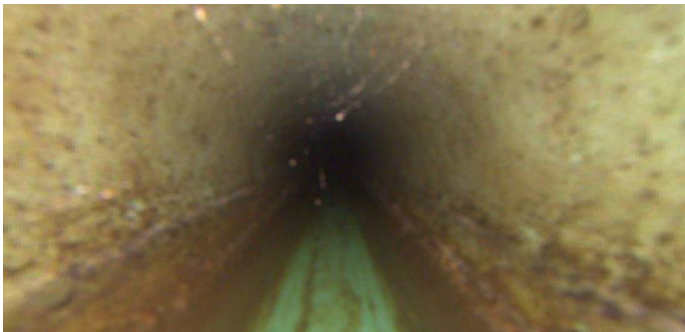
Code:	DAZ
Description:	Deposits Attached Other

Distance (ft):	.0
Structural Grade:	0
O&M Grade:	2
Clock Start/From:	7
Clock To:	5
1st Value:	
2nd Value:	
Value Percent:	5.000
Continuous Index:	S01
Within 8" of Joint:	YES
Remarks:	WANDER

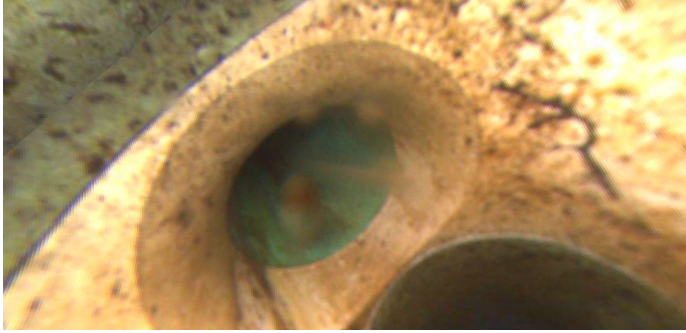
Code: **TF**
Description: **Tap Factory**

Distance (ft): **5.7**
Structural Grade: **0**
O&M Grade: **0**
Clock Start/From: **10**
Clock To:
1st Value: **4.000**
2nd Value:
Value Percent:
Continuous Index:
Within 8" of Joint:
Remarks:

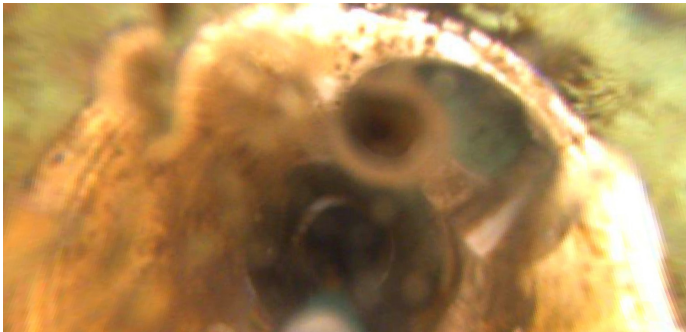
Code: **TF**
Description: **Tap Factory**

Distance (ft): **50.7**
Structural Grade: **0**
O&M Grade: **0**
Clock Start/From: **2**
Clock To:
1st Value: **4.000**
2nd Value:
Value Percent:
Continuous Index:
Within 8" of Joint:
Remarks:

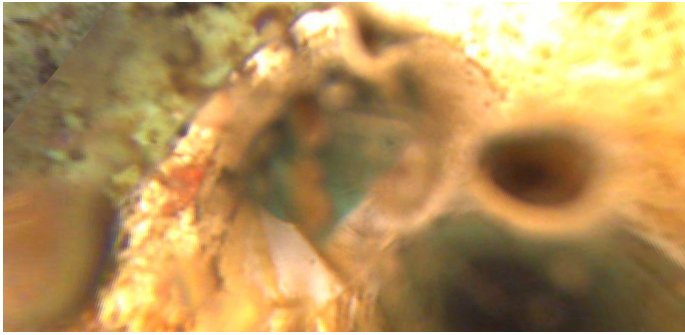
Code: **TF**
Description: **Tap Factory**

Distance (ft): **52.4**
Structural Grade: **0**
O&M Grade: **0**
Clock Start/From: **10**
Clock To:
1st Value: **4.000**
2nd Value:
Value Percent:
Continuous Index:
Within 8" of Joint:
Remarks:

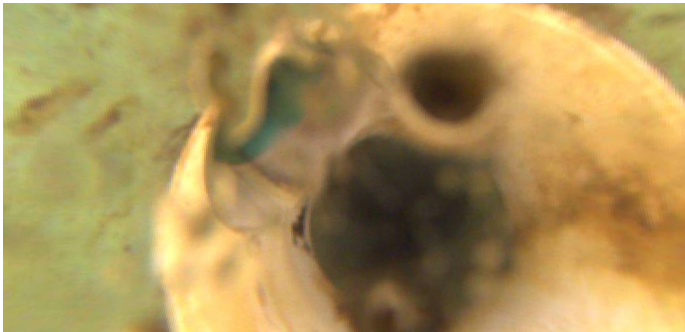
Code: **TF**
Description: **Tap Factory**

Distance (ft): **116.6**
Structural Grade: **0**
O&M Grade: **0**
Clock Start/From: **10**
Clock To:
1st Value: **4.000**
2nd Value:
Value Percent:
Continuous Index:
Within 8" of Joint:
Remarks:

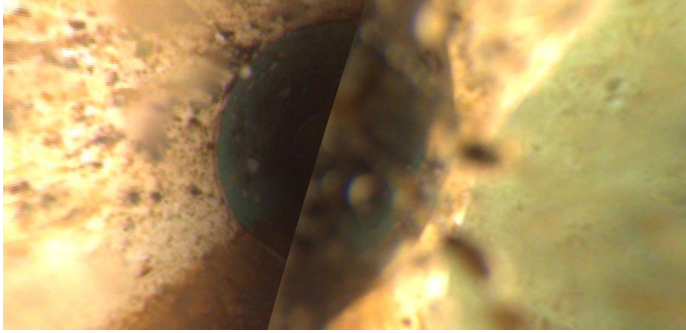
Code: **TF**
Description: **Tap Factory**

Distance (ft): **207.3**
Structural Grade: **0**
O&M Grade: **0**
Clock Start/From: **10**
Clock To:
1st Value: **4.000**
2nd Value:
Value Percent:
Continuous Index:
Within 8" of Joint:
Remarks:

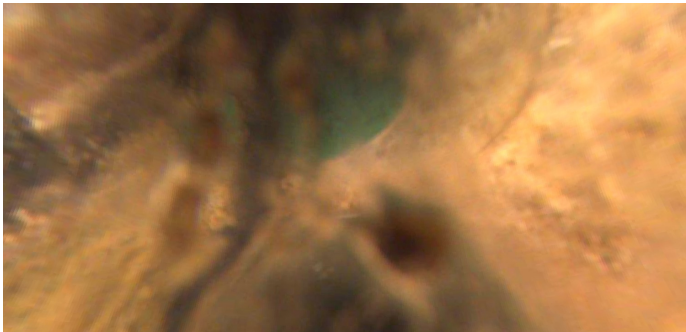
Code: **TF**
Description: **Tap Factory**

Distance (ft): **222.4**
Structural Grade: **0**
O&M Grade: **0**
Clock Start/From: **11**
Clock To:
1st Value: **4.000**
2nd Value:
Value Percent:
Continuous Index:
Within 8" of Joint:
Remarks:

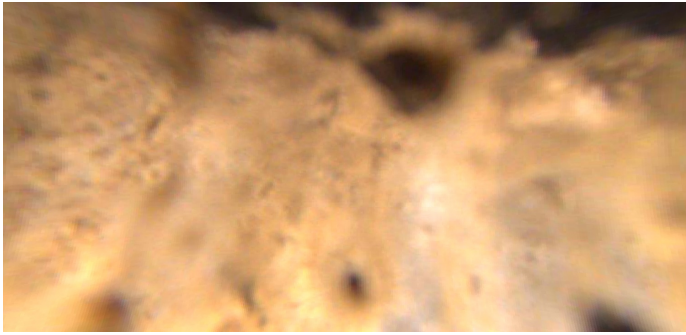
Code: **AMH**
Description: **Manhole**

Distance (ft): **227.8**
Structural Grade: **0**
O&M Grade: **0**
Clock Start/From:
Clock To:
1st Value:
2nd Value:
Value Percent:
Continuous Index:
Within 8" of Joint: **NO**
Remarks: **M-809-047**

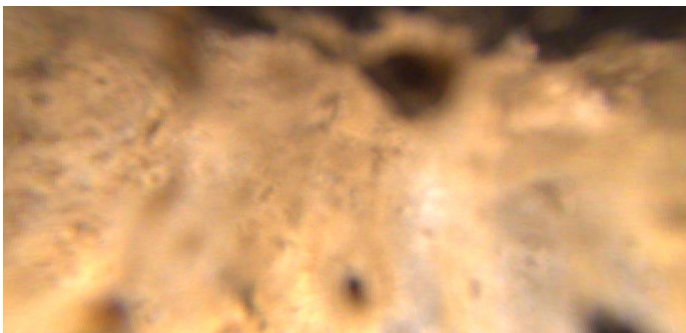
Code: **DAZ**
Description: **Deposits Attached Other**

Distance (ft): **227.8**
Structural Grade: **0**
O&M Grade: **2**
Clock Start/From: **7**
Clock To: **5**
1st Value:
2nd Value:
Value Percent: **5.000**
Continuous Index: **F01**
Within 8" of Joint: **YES**
Remarks: **WANDER**
