Profile/Photo Observation Report

Street:	TANAGER ST	Flow Control:	Not Controlled
City:	Hobart, IN	Year Renewed:	
Location:	Ditch	Tape/Media #:	
Purpose:	Maintenance Related	Dia/Height:	8"
Use:	Sanitary	Material:	PVC
Drain Area:	NA	Lining:	
Category:	NA		
Comment:

Location Details:		Direction of Survey:	Downstream
US MH:	M-809-048	DS MH:	M-809-049
		Total Length Surveyed (ft):	80.1

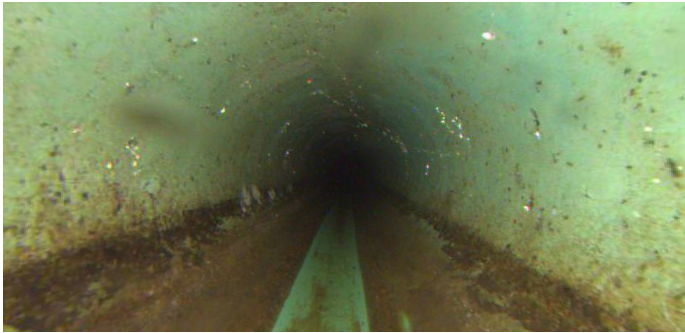
Code:	MWL
Description:	Water Level

Distance (ft):	.0
Structural Grade:	0
O&M Grade:	0
Clock Start/From:	
Clock To:	
1st Value:	
2nd Value:	
Value Percent:	5.000
Continuous Index:	
Within 8" of Joint:	NO
Remarks:

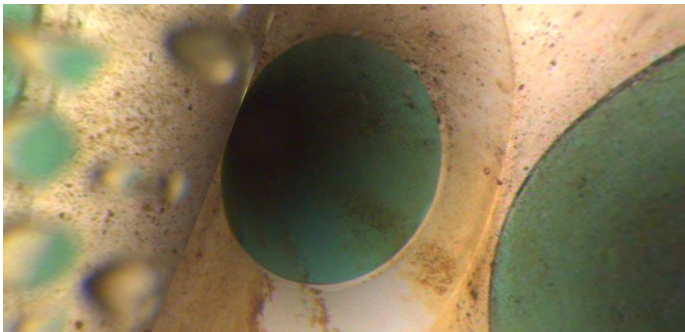
Code:	TF
Description:	Tap Factory

Distance (ft):	58.5
Structural Grade:	0
O&M Grade:	0
Clock Start/From:	2
Clock To:	
1st Value:	4.000
2nd Value:	
Value Percent:	
Continuous Index:	
Within 8" of Joint:	
Remarks:

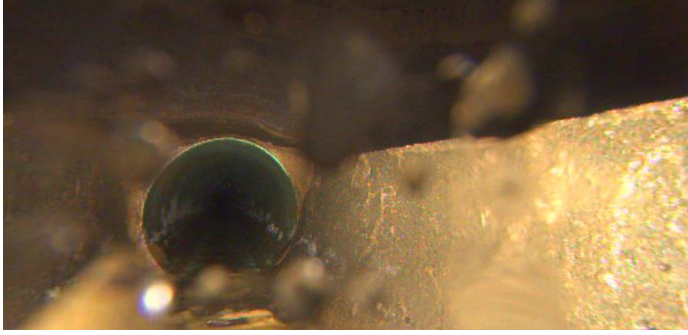
Code:	AMH
Description:	Manhole
Distance (ft):	80.1
Structural Grade:	0
O&M Grade:	0
Clock Start/From:	
Clock To:	
1st Value:	
2nd Value:	
Value Percent:	
Continuous Index:	
Within 8" of Joint:	NO
Remarks:	M-809-049
