## Profile/Photo Observation Report

Street:	<b>TANAGER ST</b>	Flow Control:	<b>Not Controlled</b>
City:	<b>Hobart, IN</b>	Year Renewed:	
Location:	<b>Sidewalk</b>	Tape/Media #:	
Purpose:	<b>Maintenance Related</b>	Dia/Height:	<b>8"</b>
Use:	<b>Sanitary</b>	Material:	<b>PVC</b>
Drain Area:	<b>NA</b>	Lining:	
Category:	<b>NA</b>		
Comment:	<b>Reverse setup.</b>

Location Details:		Direction of Survey:	<b>Upstream</b>
US MH:	<b>M-809-049</b>	DS MH:	<b>M-809-050</b>
		Total Length Surveyed (ft):	<b>122.0</b>

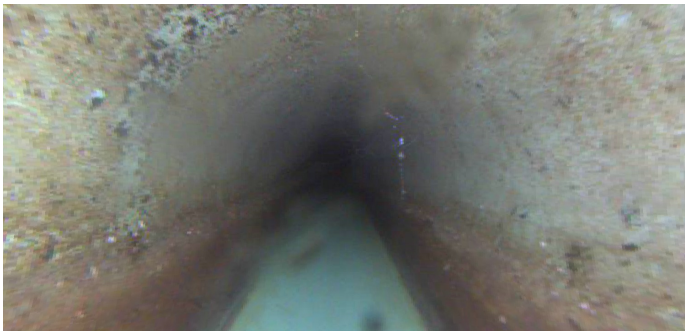
Code: **AMH**  
Description: **Manhole**

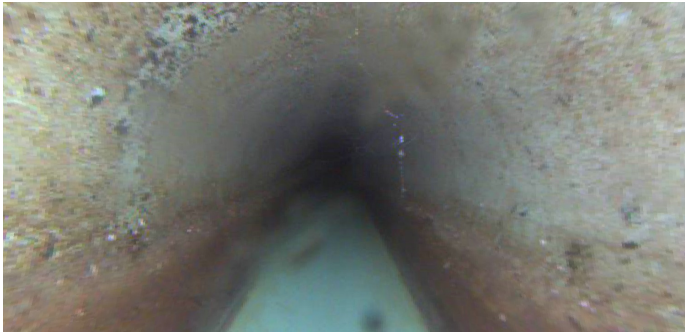
Code:	<b>MWL</b>
Description:	<b>Water Level</b>

Distance (ft):	<b>.0</b>
Structural Grade:	<b>0</b>
O&M Grade:	<b>0</b>
Clock Start/From:	
Clock To:	
1st Value:	
2nd Value:	
Value Percent:	<b>5.000</b>
Continuous Index:	
Within 8" of Joint:	<b>NO</b>
Remarks:

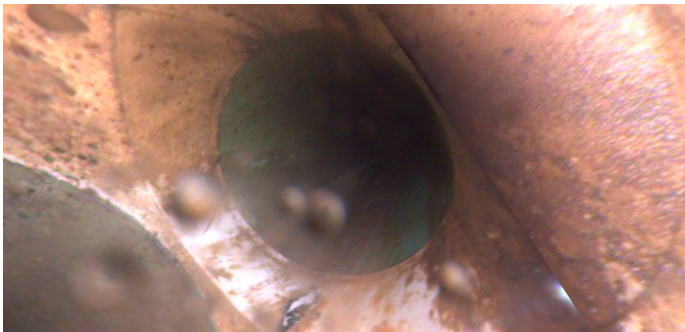
Code:	<b>TF</b>
Description:	<b>Tap Factory</b>

Distance (ft):	<b>17.5</b>
Structural Grade:	<b>0</b>
O&M Grade:	<b>0</b>
Clock Start/From:	<b>2</b>
Clock To:	
1st Value:	<b>4.000</b>
2nd Value:	
Value Percent:	
Continuous Index:	
Within 8" of Joint:	
Remarks:

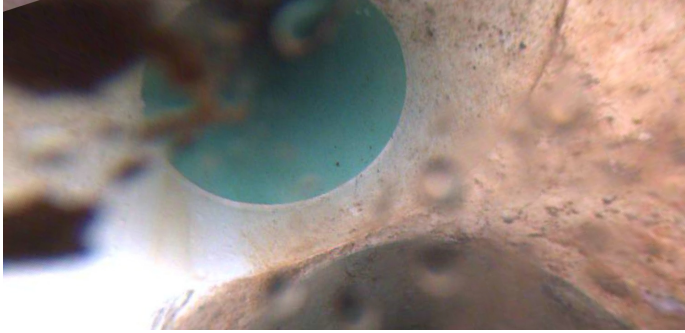
Code: **TF**  
Description: **Tap Factory**

Distance (ft): **19.1**  
Structural Grade: **0**  
O&M Grade: **0**  
Clock Start/From: **11**  
Clock To:  
1st Value: **4.000**  
2nd Value:  
Value Percent:  
Continuous Index:  
Within 8" of Joint:  
Remarks:

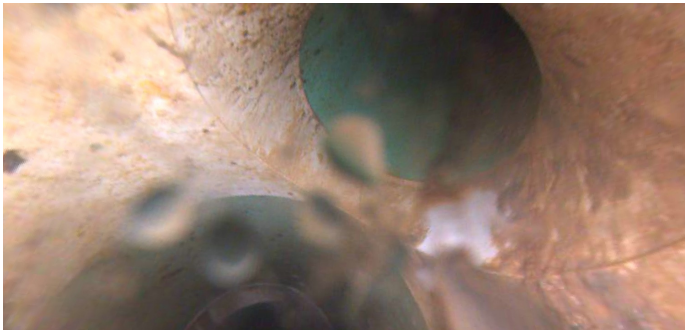
Code: **TF**  
Description: **Tap Factory**

Distance (ft): **81.5**  
Structural Grade: **0**  
O&M Grade: **0**  
Clock Start/From: **1**  
Clock To:  
1st Value: **4.000**  
2nd Value:  
Value Percent:  
Continuous Index:  
Within 8" of Joint:  
Remarks:

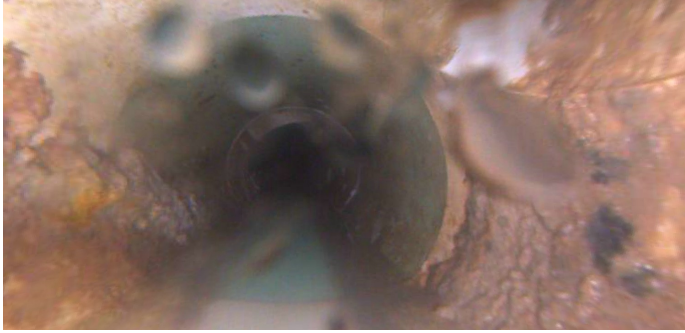
Code: **DAGS**  
Description: **Deposits Attached Grease**

Distance (ft): **81.5**  
Structural Grade: **0**  
O&M Grade: **2**  
Clock Start/From: **8**  
Clock To: **4**  
1st Value:  
2nd Value:  
Value Percent: **5.000**  
Continuous Index:  
Within 8" of Joint: **NO**  
Remarks:

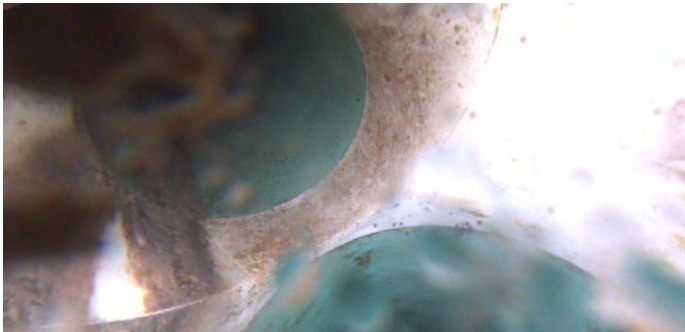
Code: **TF**  
Description: **Tap Factory**

Distance (ft): **83.2**  
Structural Grade: **0**  
O&M Grade: **0**  
Clock Start/From: **11**  
Clock To:  
1st Value: **4.000**  
2nd Value:  
Value Percent:  
Continuous Index:  
Within 8" of Joint:  
Remarks:

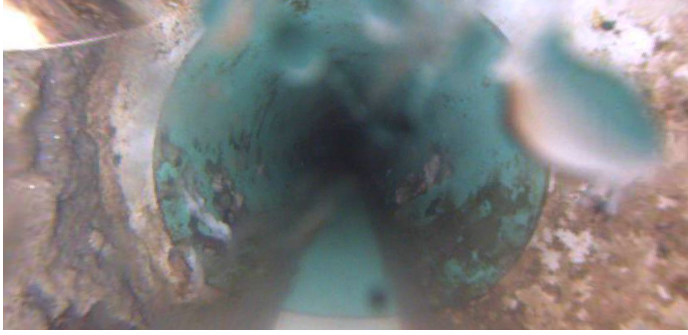
Code:	<b>DAGS</b>
Description:	<b>Deposits Attached Grease</b>
Distance (ft):	<b>83.2</b>
Structural Grade:	<b>0</b>
O&M Grade:	<b>2</b>
Clock Start/From:	<b>8</b>
Clock To:	<b>4</b>
1st Value:	
2nd Value:	
Value Percent:	<b>5.000</b>
Continuous Index:	
Within 8" of Joint:	<b>NO</b>
Remarks:

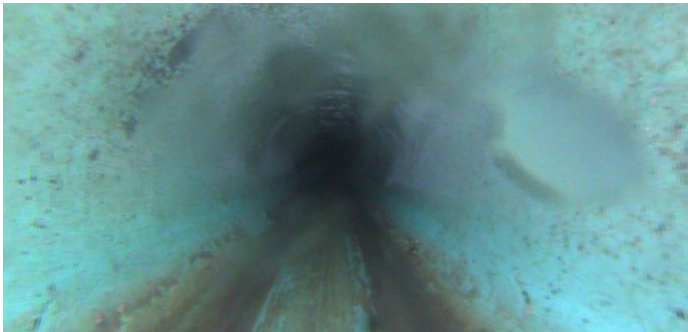
Code:	<b>MSA</b>
Description:	<b>Abandoned Survey</b>
Distance (ft):	<b>122.0</b>
Structural Grade:	<b>0</b>
O&M Grade:	<b>0</b>
Clock Start/From:	
Clock To:	
1st Value:	
2nd Value:	
Value Percent:	
Continuous Index:	
Within 8" of Joint:	<b>NO</b>
Remarks:	<b>debris</b>
