## Profile/Photo Observation Report

Date:	<b>03/28/2018</b>	Weather:		Coding:	<b>PACP 6.0</b>
Pipe Length (ft):	<b>271.5</b>	Owner:	<b>NA</b>	Pre Clean:	<b>Not Known</b>
P.O.#:		Surveyor:	<b>Selasie Honu</b>	PSR:	<b>P-809-049-050</b>
Customer:		Clean Date:	<b>01/01/1900</b>	Shape:	<b>C</b>

Street:	<b>Tanager</b>	Flow Control:	<b>Not Controlled</b>
City:	<b>Hobart, IN</b>	Year Renewed:	
Location:	<b>Sidewalk</b>	Tape/Media #:	
Purpose:	<b>Maintenance Related</b>	Dia/Height:	<b>8"</b>
Use:	<b>Sanitary</b>	Material:	<b>PVC</b>
Drain Area:	<b>NA</b>	Lining:	
Category:	<b>NA</b>		
Comment:	<b>Reverse setup.</b>

Location Details:		Direction of Survey:	<b>Upstream</b>
US MH:	<b>M-809-049</b>	DS MH:	<b>M-809-050</b>
		Total Length Surveyed (ft):	<b>122.0</b>

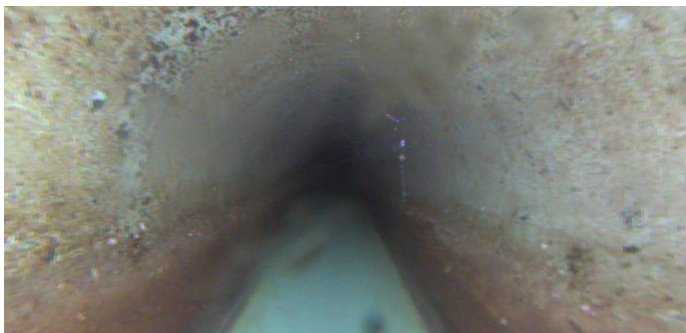
Code: **AMH**  
Description: **Manhole**

Distance (ft): **.0**  
Structural Grade: **0**  
O&M Grade: **0**  
Clock Start/From:  
Clock To:  
1st Value:  
2nd Value:  
Value Percent:  
Continuous Index:  
Within 8" of Joint: **NO**  
Remarks: **M-809-050**

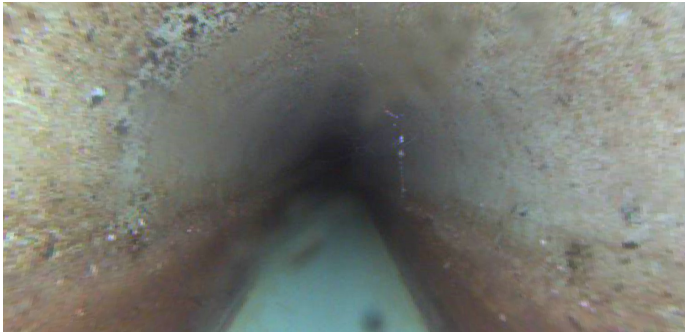
Code:	<b>MWL</b>
Description:	<b>Water Level</b>

Distance (ft):	<b>.0</b>
Structural Grade:	<b>0</b>
O&M Grade:	<b>0</b>
Clock Start/From:	
Clock To:	
1st Value:	
2nd Value:	
Value Percent:	<b>5.000</b>
Continuous Index:	
Within 8" of Joint:	<b>NO</b>
Remarks:

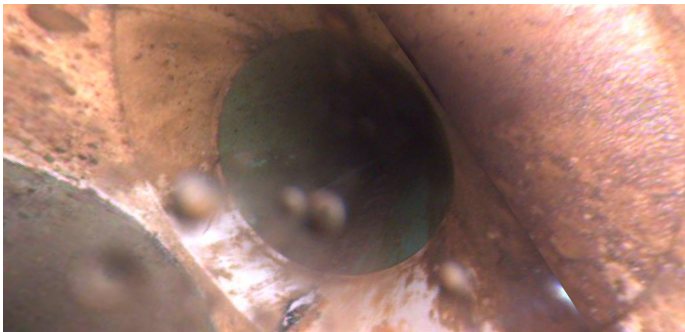
Code:	<b>TF</b>
Description:	<b>Tap Factory</b>

Distance (ft):	<b>17.5</b>
Structural Grade:	<b>0</b>
O&M Grade:	<b>0</b>
Clock Start/From:	<b>2</b>
Clock To:	
1st Value:	<b>4.000</b>
2nd Value:	
Value Percent:	
Continuous Index:	
Within 8" of Joint:	
Remarks:

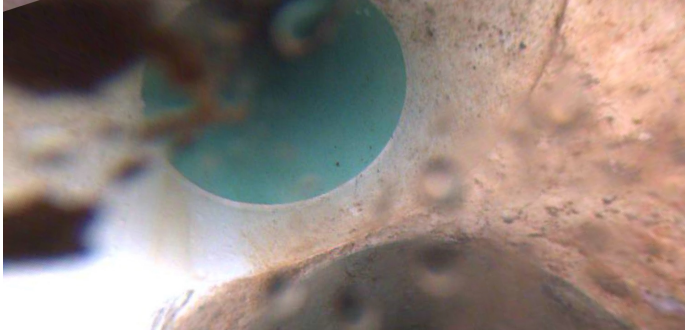
Code: **TF**  
Description: **Tap Factory**

Distance (ft): **19.1**  
Structural Grade: **0**  
O&M Grade: **0**  
Clock Start/From: **11**  
Clock To:  
1st Value: **4.000**  
2nd Value:  
Value Percent:  
Continuous Index:  
Within 8" of Joint:  
Remarks:

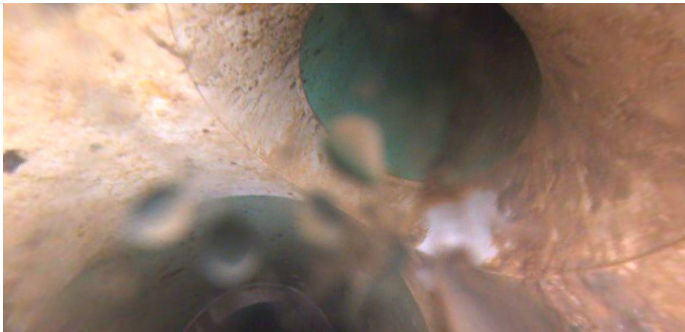
Code: **TF**  
Description: **Tap Factory**

Distance (ft): **81.5**  
Structural Grade: **0**  
O&M Grade: **0**  
Clock Start/From: **1**  
Clock To:  
1st Value: **4.000**  
2nd Value:  
Value Percent:  
Continuous Index:  
Within 8" of Joint:  
Remarks:

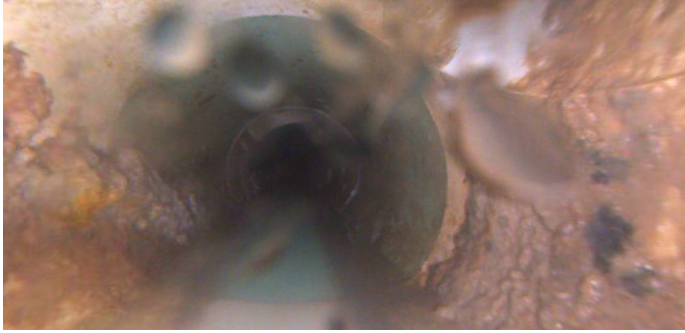
Code: **DAGS**  
Description: **Deposits Attached Grease**

Distance (ft): **81.5**  
Structural Grade: **0**  
O&M Grade: **2**  
Clock Start/From: **8**  
Clock To: **4**  
1st Value:  
2nd Value:  
Value Percent: **5.000**  
Continuous Index:  
Within 8" of Joint: **NO**  
Remarks:

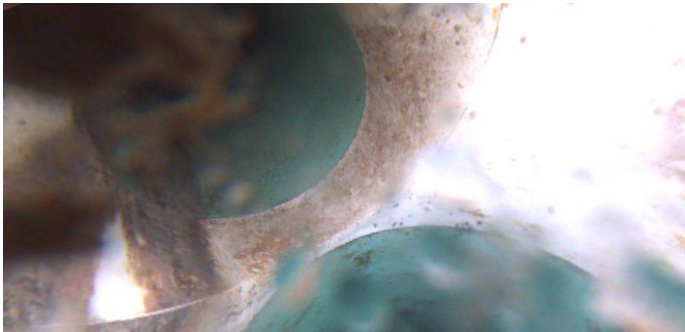
Code: **TF**  
Description: **Tap Factory**

Distance (ft): **83.2**  
Structural Grade: **0**  
O&M Grade: **0**  
Clock Start/From: **11**  
Clock To:  
1st Value: **4.000**  
2nd Value:  
Value Percent:  
Continuous Index:  
Within 8" of Joint:  
Remarks:

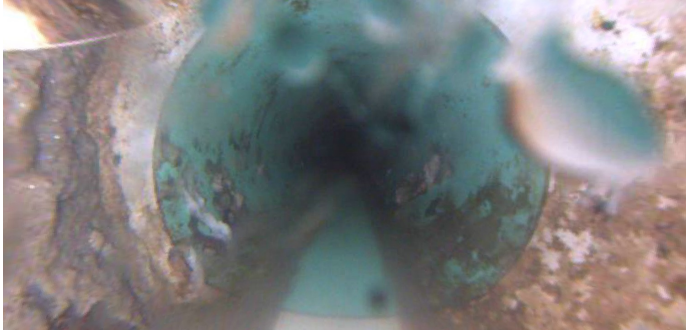
Code:	<b>DAGS</b>
Description:	<b>Deposits Attached Grease</b>
Distance (ft):	<b>83.2</b>
Structural Grade:	<b>0</b>
O&M Grade:	<b>2</b>
Clock Start/From:	<b>8</b>
Clock To:	<b>4</b>
1st Value:	
2nd Value:	
Value Percent:	<b>5.000</b>
Continuous Index:	
Within 8" of Joint:	<b>NO</b>
Remarks:

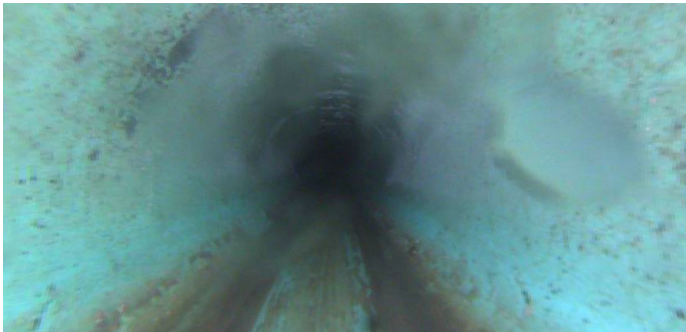
Code:	<b>MSA</b>
Description:	<b>Abandoned Survey</b>
Distance (ft):	<b>122.0</b>
Structural Grade:	<b>0</b>
O&M Grade:	<b>0</b>
Clock Start/From:	
Clock To:	
1st Value:	
2nd Value:	
Value Percent:	
Continuous Index:	
Within 8" of Joint:	<b>NO</b>
Remarks:	<b>debris</b>
