Profile/Photo Observation Report

Date:	03/24/2018	Weather:		Coding:	PACP 6.0
Pipe Length (ft):	136.2	Owner:	NA	Pre Clean:	Not Known
P.O.#:		Surveyor:	Justin Gonzales	PSR:	P-809-051-052
Customer:		Clean Date:	01/01/1900	Shape:	C

Street:	BRACKEN PKWY	Flow Control:	Not Controlled
City:	Hobart, IN	Year Renewed:	
Location:	Sidewalk	Tape/Media #:	
Purpose:	Maintenance Related	Dia/Height:	8"
Use:	Sanitary	Material:	PVC
Drain Area:	NA	Lining:	
Category:	NA		
Comment:	rollover on sediment at 118'.		
Location Details:		Direction of Survey:	Upstream
US MH:	M-809-051	DS MH:	M-809-052
		Total Length Surveyed (ft):	119.2

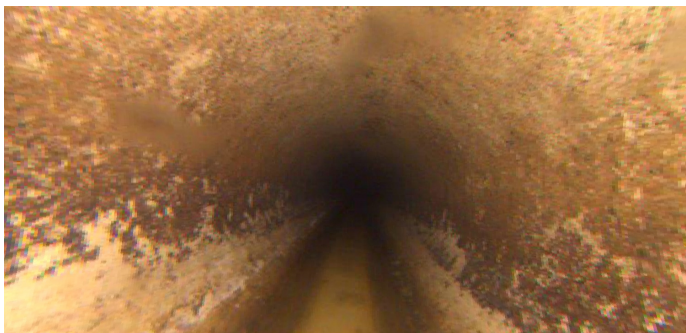
Code: **AMH**
Description: **Manhole**

Distance (ft): **.0**
Structural Grade: **0**
O&M Grade: **0**
Clock Start/From:
Clock To:
1st Value:
2nd Value:
Value Percent:
Continuous Index:
Within 8" of Joint: **NO**
Remarks: **M-809-052**

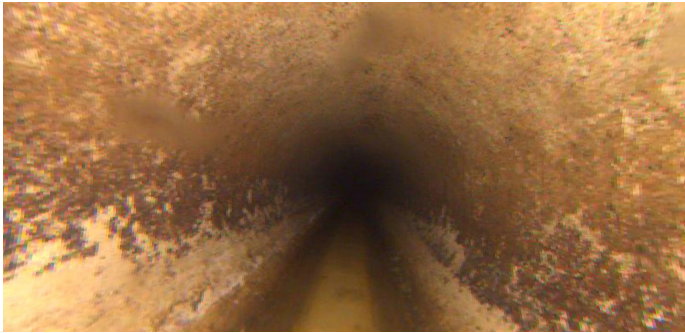
Code:	MWL
Description:	Water Level

Distance (ft):	.0
Structural Grade:	0
O&M Grade:	0
Clock Start/From:	
Clock To:	
1st Value:	
2nd Value:	
Value Percent:	5.000
Continuous Index:	
Within 8" of Joint:	NO
Remarks:

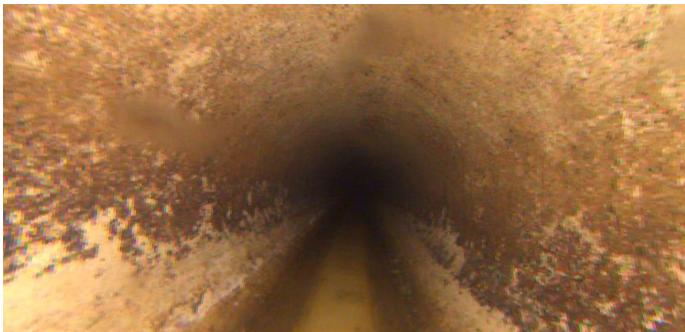
Code:	DAZ
Description:	Deposits Attached Other

Distance (ft):	.0
Structural Grade:	0
O&M Grade:	2
Clock Start/From:	7
Clock To:	5
1st Value:	
2nd Value:	
Value Percent:	5.000
Continuous Index:	S01
Within 8" of Joint:	YES
Remarks:	WANDER

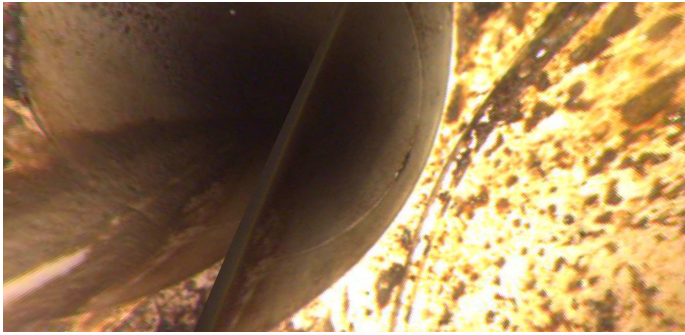
Code: **TF**
Description: **Tap Factory**

Distance (ft): **67.9**
Structural Grade: **0**
O&M Grade: **0**
Clock Start/From: **11**
Clock To:
1st Value: **4.000**
2nd Value:
Value Percent:
Continuous Index:
Within 8" of Joint:
Remarks:

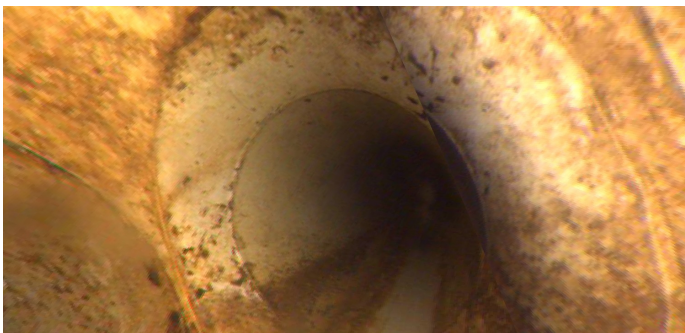
Code: **TF**
Description: **Tap Factory**

Distance (ft): **70.3**
Structural Grade: **0**
O&M Grade: **0**
Clock Start/From: **2**
Clock To:
1st Value: **4.000**
2nd Value:
Value Percent:
Continuous Index:
Within 8" of Joint:
Remarks:

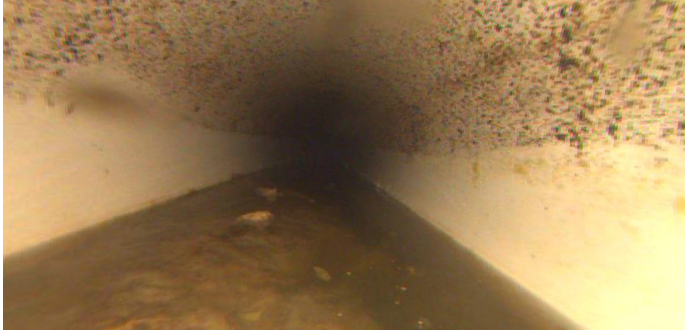
Code: **MSA**
Description: **Abandoned Survey**

Distance (ft): **119.2**
Structural Grade: **0**
O&M Grade: **0**
Clock Start/From:
Clock To:
1st Value:
2nd Value:
Value Percent:
Continuous Index:
Within 8" of Joint: **NO**
Remarks: **ROBOT HAS STOPPED**

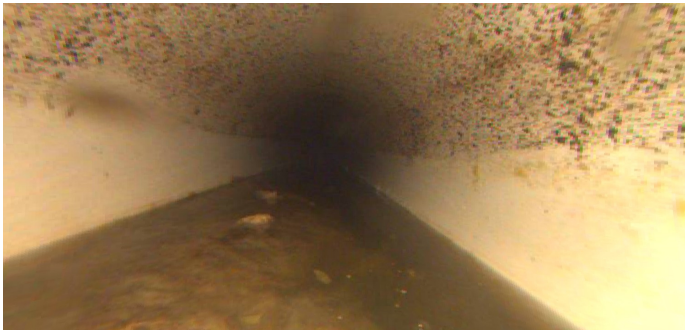
Code: **DAZ**
Description: **Deposits Attached Other**

Distance (ft): **119.2**
Structural Grade: **0**
O&M Grade: **2**
Clock Start/From: **7**
Clock To: **5**
1st Value:
2nd Value:
Value Percent: **5.000**
Continuous Index: **F01**
Within 8" of Joint: **YES**
Remarks: **WANDER**
