Profile/Photo Observation Report

| Street: | Oak | Flow Control: | Not Controlled |
| City: | Hobart, IN | Year Renewed: | |

| US MH: | M-809-051 | DS MH: | M-809-052 |

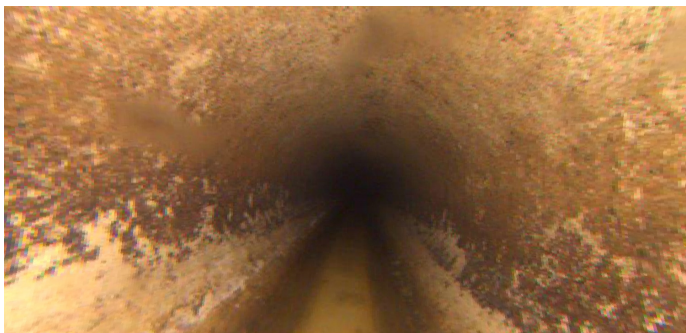
Code: **AMH**
Description: **Manhole**

Distance (ft): **.0**
Structural Grade: **0**
O&M Grade: **0**
Clock Start/From:
Clock To:
1st Value:
2nd Value:
Value Percent:
Continuous Index:
Within 8" of Joint: **NO**
Remarks: **M-809-052**

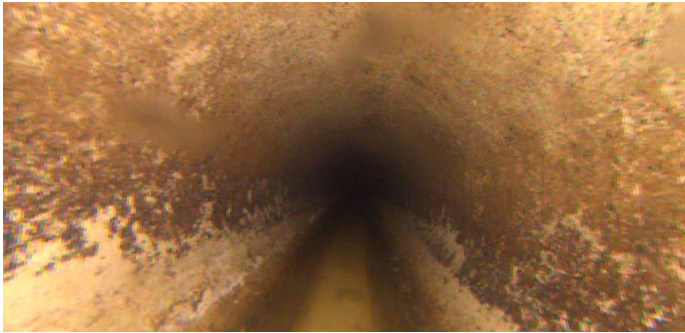
| Code: | MWL |
| Description: | Water Level |

| Distance (ft): | .0 |
| Value Percent: | 5.000 |

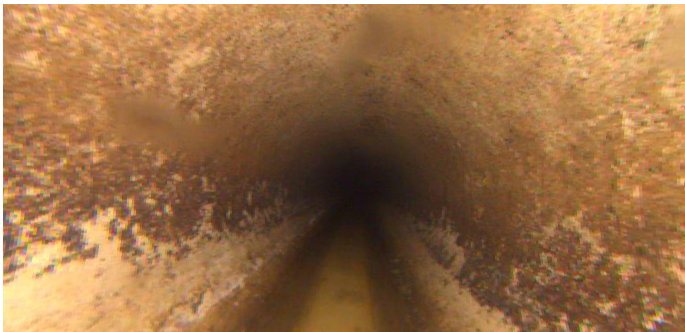
| Code: | DAZ |
| Description: | Deposits Attached Other |

| Distance (ft): | .0 |
| O&M Grade: | 2 |
| Clock Start/From: | 7 |
| Clock To: | 5 |
| Value Percent: | 5.000 |
| Continuous Index: | S01 |
| Within 8" of Joint: | YES |
| Remarks: | WANDER |

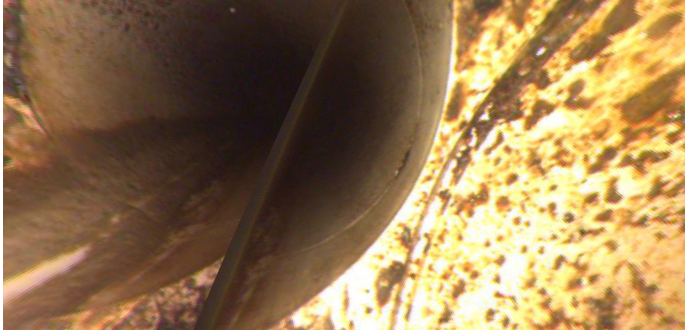
Code: **TF**
Description: **Tap Factory**

Distance (ft): **67.9**
Structural Grade: **0**
O&M Grade: **0**
Clock Start/From: **11**
Clock To:
1st Value: **4.000**
2nd Value:
Value Percent:
Continuous Index:
Within 8" of Joint:
Remarks:

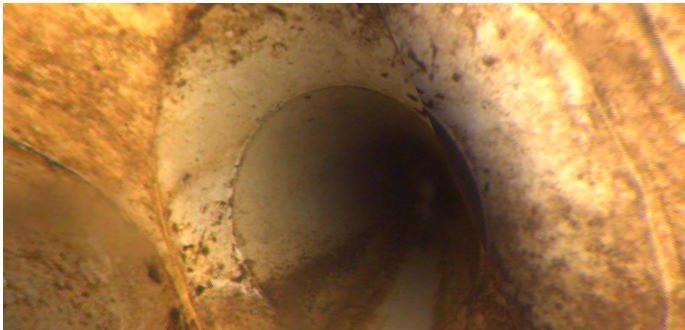
Code: **TF**
Description: **Tap Factory**

Distance (ft): **70.3**
Structural Grade: **0**
O&M Grade: **0**
Clock Start/From: **2**
Clock To:
1st Value: **4.000**
2nd Value:
Value Percent:
Continuous Index:
Within 8" of Joint:
Remarks:

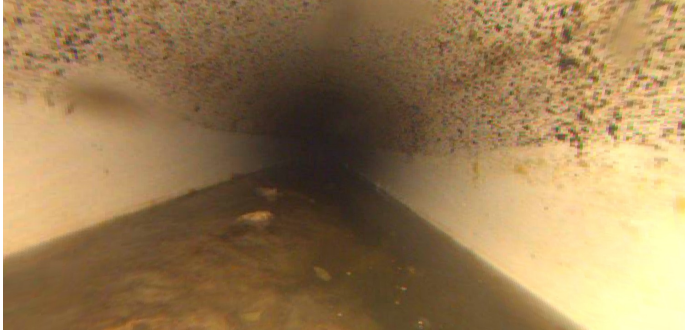
| Comment: | rollover on sediment at 118'. | | |

Code: **MSA**
Description: **Abandoned Survey**

Distance (ft): **119.2**
Structural Grade: **0**
O&M Grade: **0**
Clock Start/From:
Clock To:
1st Value:
2nd Value:
Value Percent:
Continuous Index:
Within 8" of Joint: **NO**
Remarks: **ROBOT HAS STOPPED**

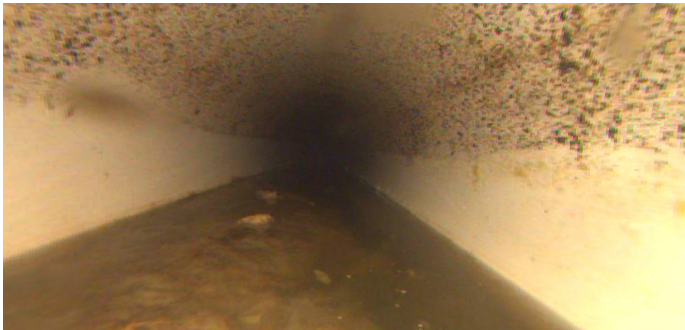
Code: **DAZ**
Description: **Deposits Attached Other**

Distance (ft): **119.2**
Structural Grade: **0**
O&M Grade: **2**
Clock Start/From: **7**
Clock To: **5**
1st Value:
2nd Value:
Value Percent: **5.000**
Continuous Index: **F01**
Within 8" of Joint: **YES**
Remarks: **WANDER**
