Profile/Photo Observation Report

Street:	BRACKEN PKWY	Flow Control:	Not Controlled
City:	Hobart, IN	Year Renewed:	
Location:	Sidewalk	Tape/Media #:	
Purpose:	Maintenance Related	Dia/Height:	8"
Use:	Sanitary	Material:	PVC
Drain Area:	NA	Lining:	
Category:	NA		
Comment:	sludge at 22'.

Location Details:		Direction of Survey:	Upstream
US MH:	M-809-054	DS MH:	M-709-001
		Total Length Surveyed (ft):	23.3

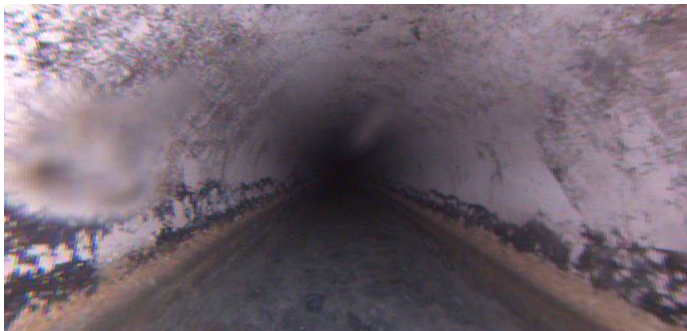
Code: **AMH**
Description: **Manhole**

Distance (ft): **.0**
Structural Grade: **0**
O&M Grade: **0**
Clock Start/From:
Clock To:
1st Value:
2nd Value:
Value Percent:
Continuous Index:
Within 8" of Joint: **NO**
Remarks: **M-709-001**

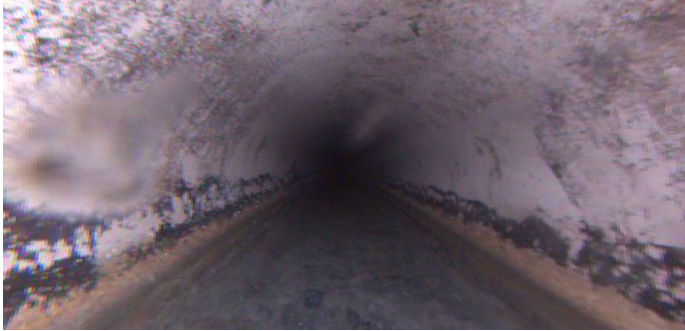
Code:	MWL
Description:	Water Level

Distance (ft):	.0
Structural Grade:	0
O&M Grade:	0
Clock Start/From:	
Clock To:	
1st Value:	
2nd Value:	
Value Percent:	5.000
Continuous Index:	
Within 8" of Joint:	NO
Remarks:

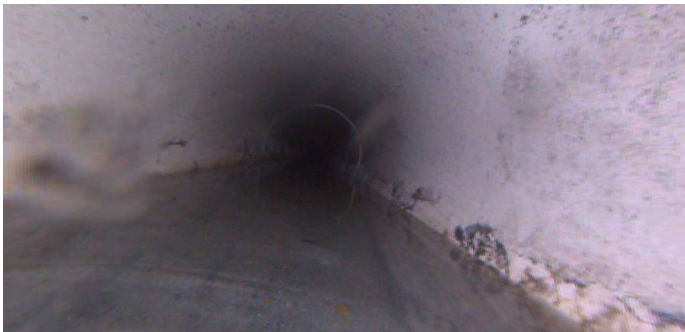
Code:	MSA
Description:	Abandoned Survey

Distance (ft):	23.3
Structural Grade:	0
O&M Grade:	0
Clock Start/From:	
Clock To:	
1st Value:	
2nd Value:	
Value Percent:	
Continuous Index:	
Within 8" of Joint:	NO
Remarks:	camera stopped
