Profile/Photo Observation Report

Street:	Oak	Flow Control:	Not Controlled
City:	Hobart, IN	Year Renewed:	
Location:	Sidewalk	Tape/Media #:	
Purpose:	Maintenance Related	Dia/Height:	8"
Use:	Sanitary	Material:	PVC
Drain Area:	NA	Lining:	
Category:	NA		
Comment:	sludge at 22'.

Location Details:		Direction of Survey:	Upstream
US MH:	M-809-054	DS MH:	M-709-001
		Total Length Surveyed (ft):	23.3

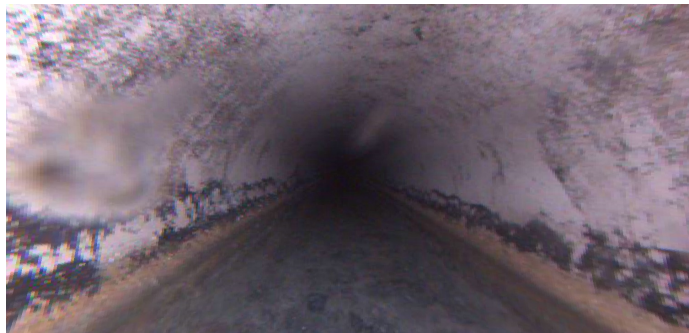
Code: **AMH**
Description: **Manhole**

Distance (ft): **.0**
Structural Grade: **0**
O&M Grade: **0**
Clock Start/From:
Clock To:
1st Value:
2nd Value:
Value Percent:
Continuous Index:
Within 8" of Joint: **NO**
Remarks: **M-709-001**

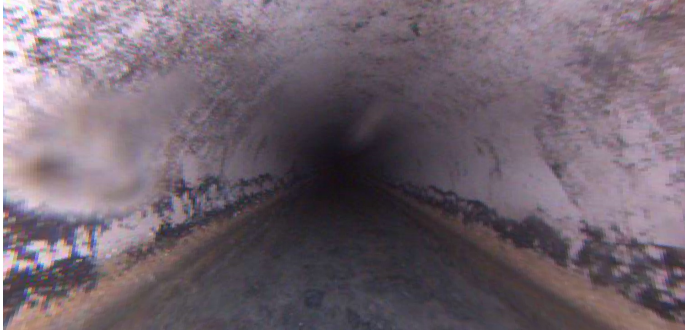
Code:	MWL
Description:	Water Level

Distance (ft):	.0
Structural Grade:	0
O&M Grade:	0
Clock Start/From:	
Clock To:	
1st Value:	
2nd Value:	
Value Percent:	5.000
Continuous Index:	
Within 8" of Joint:	NO
Remarks:

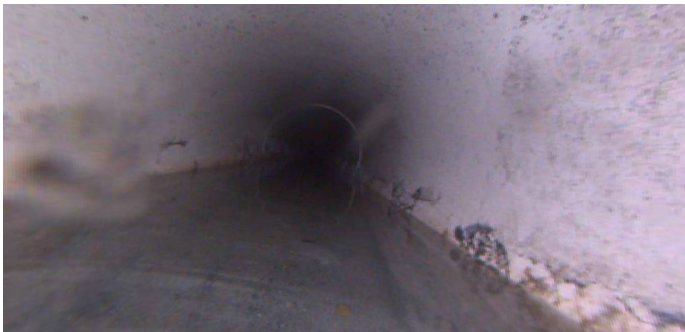
Code:	MSA
Description:	Abandoned Survey

Distance (ft):	23.3
Structural Grade:	0
O&M Grade:	0
Clock Start/From:	
Clock To:	
1st Value:	
2nd Value:	
Value Percent:	
Continuous Index:	
Within 8" of Joint:	NO
Remarks:	camera stopped
