Profile/Photo Observation Report

Street:	SORA ST & WILLET AVE	Flow Control:	Not Controlled
City:	Hobart, IN	Year Renewed:	
Location:	Sidewalk	Tape/Media #:	
Purpose:	Maintenance Related	Dia/Height:	8"
Use:	Sanitary	Material:	PVC
Drain Area:	NA	Lining:	
Category:	NA		
Comment:

Location Details:		Direction of Survey:	Upstream
US MH:	M-809-055	DS MH:	M-809-056
		Total Length Surveyed (ft):	136.8

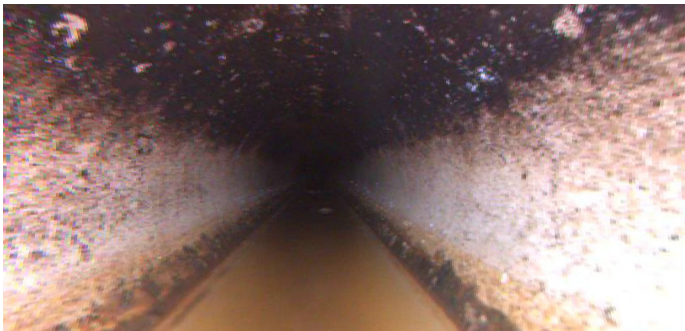
Code: **AMH**
Description: **Manhole**

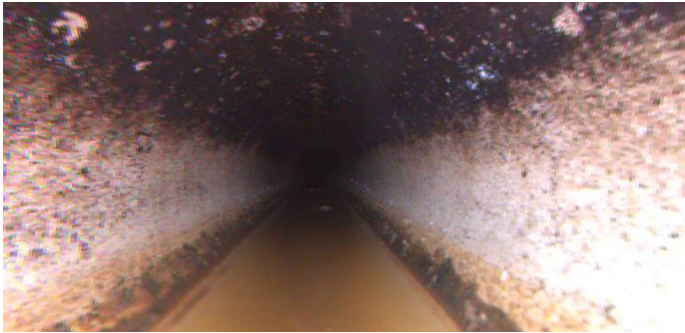
Code:	MWL
Description:	Water Level

Distance (ft):	.0
Structural Grade:	0
O&M Grade:	0
Clock Start/From:	
Clock To:	
1st Value:	
2nd Value:	
Value Percent:	10.000
Continuous Index:	
Within 8" of Joint:	NO
Remarks:

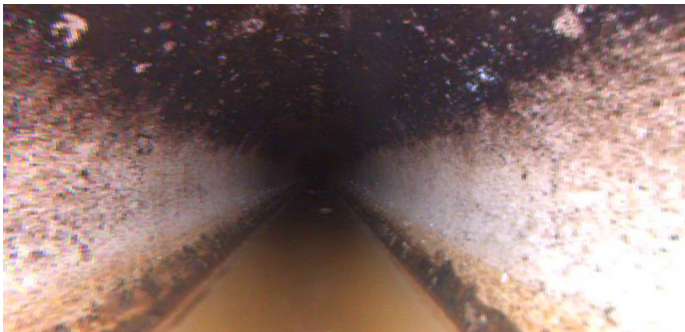
Code:	DAZ
Description:	Deposits Attached Other

Distance (ft):	.0
Structural Grade:	0
O&M Grade:	2
Clock Start/From:	7
Clock To:	5
1st Value:	
2nd Value:	
Value Percent:	5.000
Continuous Index:	S01
Within 8" of Joint:	YES
Remarks:	WANDER

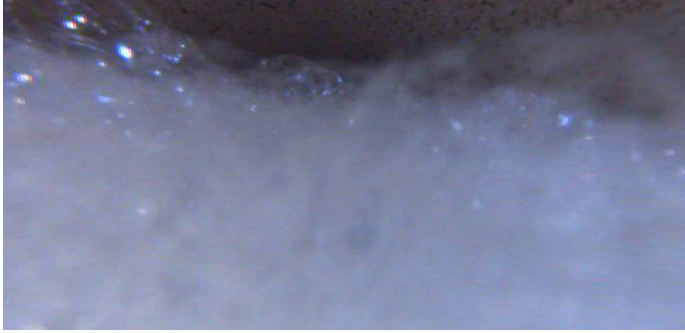
Code: **MGO**
Description: **General Observation**

Distance (ft): **24.8**
Structural Grade: **0**
O&M Grade: **0**
Clock Start/From:
Clock To:
1st Value:
2nd Value:
Value Percent:
Continuous Index:
Within 8" of Joint: **NO**
Remarks: **SOAP SUDS**

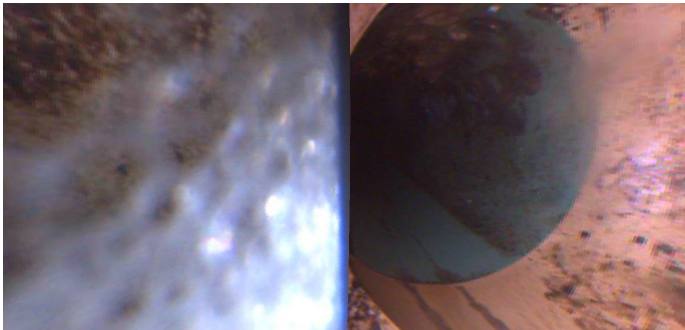
Code: **TF**
Description: **Tap Factory**

Distance (ft): **39.3**
Structural Grade: **0**
O&M Grade: **0**
Clock Start/From: **3**
Clock To:
1st Value: **4.000**
2nd Value:
Value Percent:
Continuous Index:
Within 8" of Joint:
Remarks:

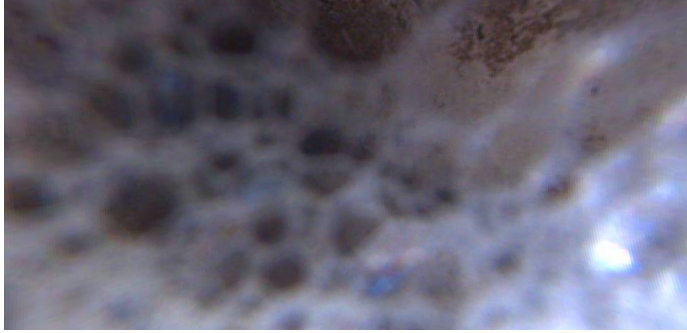
Code:	MGO
Description:	General Observation
Distance (ft):	40.4
Structural Grade:	0
O&M Grade:	0
Clock Start/From:	
Clock To:	
1st Value:	
2nd Value:	
Value Percent:	
Continuous Index:	
Within 8" of Joint:	NO
Remarks:	SOAP SUDS PREVENTING VISIBILITY

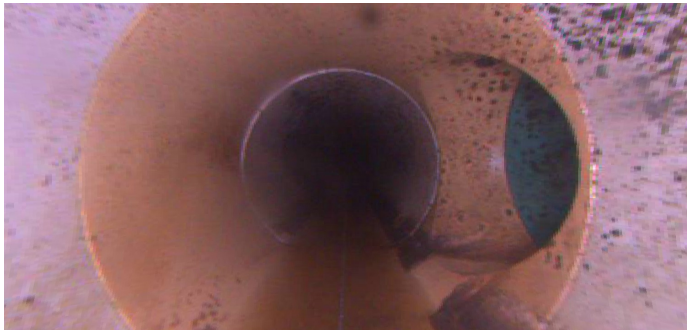
Code:	TF
Description:	Tap Factory
Distance (ft):	66.3
Structural Grade:	0
O&M Grade:	0
Clock Start/From:	3
Clock To:	
1st Value:	4.000
2nd Value:	
Value Percent:	
Continuous Index:	
Within 8" of Joint:	
Remarks:

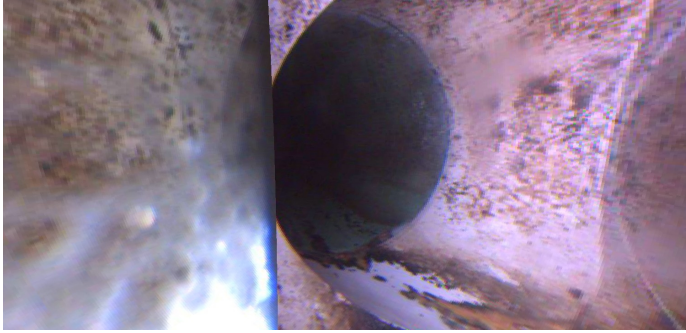
Code: **TF**
Description: **Tap Factory**

Distance (ft): **105.6**
Structural Grade: **0**
O&M Grade: **0**
Clock Start/From: **3**
Clock To:
1st Value: **4.000**
2nd Value:
Value Percent:
Continuous Index:
Within 8" of Joint:
Remarks:

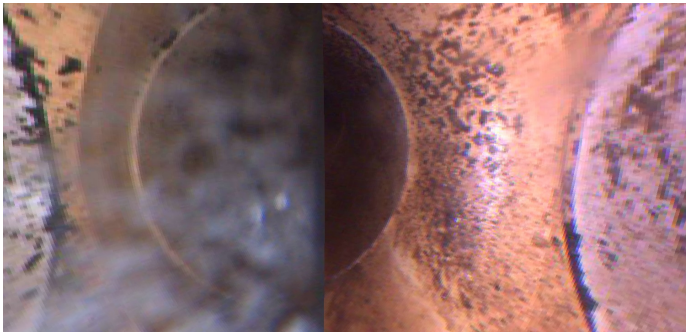
Code: **TF**
Description: **Tap Factory**

Distance (ft): **130.5**
Structural Grade: **0**
O&M Grade: **0**
Clock Start/From: **3**
Clock To:
1st Value: **4.000**
2nd Value:
Value Percent:
Continuous Index:
Within 8" of Joint:
Remarks:

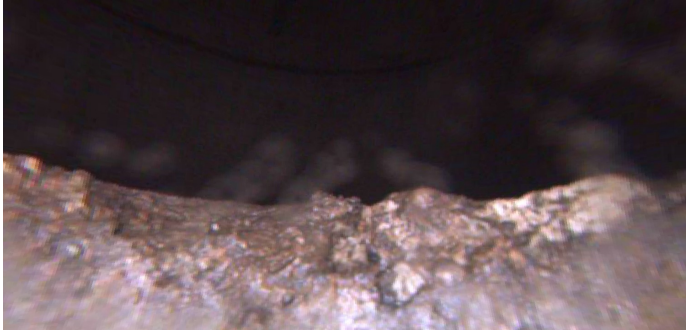
Code: **AMH**
Description: **Manhole**

Distance (ft): **136.8**
Structural Grade: **0**
O&M Grade: **0**
Clock Start/From:
Clock To:
1st Value:
2nd Value:
Value Percent:
Continuous Index:
Within 8" of Joint: **NO**
Remarks: **M-809-055**

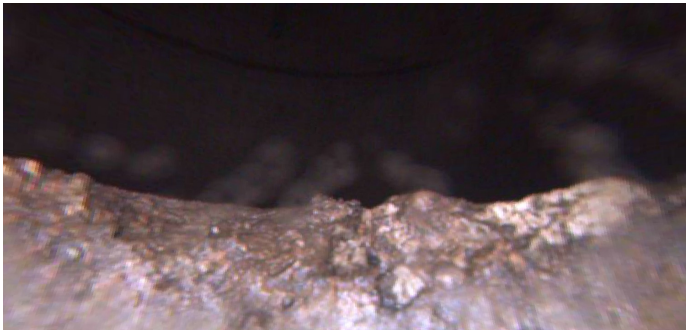
Code: **DAZ**
Description: **Deposits Attached Other**

Distance (ft): **136.8**
Structural Grade: **0**
O&M Grade: **2**
Clock Start/From: **7**
Clock To: **5**
1st Value:
2nd Value:
Value Percent: **5.000**
Continuous Index: **F01**
Within 8" of Joint: **YES**
Remarks: **WANDER**
