Profile/Ph	noto Observatio	n Report			RedZor
Date:	03/23/2018	Weather:		Coding:	PACP 6.0
Pipe Length (ft	t): <b>161.6</b>	Owner:	NA	Pre Clean:	Not Known
P.O.#:		Surveyor:	Justin Gonzal	es PSR:	P-809-057-056
Customer:		Clean Date	: <b>01/01/1900</b>	Shape:	С
Street:	Oak		Flow Control:	Not Controlle	ed
City:	Hobart, IN		Year Renewed		
Location:	Sidewalk		Tape/Media #:		
Purpose:	Maintenance Rela	ated	Dia/Height:	8"	
Use:	Sanitary		Material:	PVC	
Drain Area:	NA		Lining:		
Category:	NA				
Comment:	flow is incorrect.				
Location Detai	ils:		Direction of Su	rvey: Downstream	I
US MH:	M-809-056	DS MH:	M-809-057	Total Length Surveyed (	ft): <b>159.0</b>
D&M Index:	0.00	O&M Quick		00 O&M Rating:	0.00
Structural Index	. 0.00	Structural C	Luick: OC	00 Structural Ratin	g: <b>0.00</b>
Overall Index:	0.00	Overall Qui		00 Overall Rating:	0.00

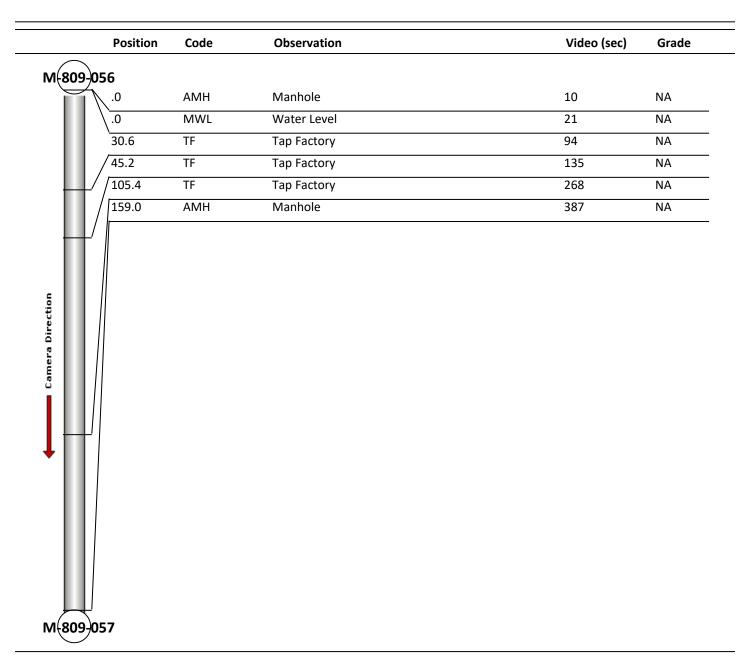
Code: Description:	AMH Manhole	
Distance (ft):	.0	
Structural Grade:	0	
O&M Grade:	0	
Clock Start/From:		
Clock To:		
1st Value:		
2nd Value:		
Value Percent:		
Continuous Index:		
Within 8" of Joint:	NO	
Remarks:	M-809-056
