## Profile/Photo Observation Report

Street:	<b>Oak</b>	Flow Control:	<b>Not Controlled</b>
City:	<b>Hobart, IN</b>	Year Renewed:	
Location:	<b>Sidewalk</b>	Tape/Media #:	
Purpose:	<b>Maintenance Related</b>	Dia/Height:	<b>8"</b>
Use:	<b>Sanitary</b>	Material:	<b>PVC</b>
Drain Area:	<b>NA</b>	Lining:	
Category:	<b>NA</b>		
Comment:	<b>new mh found at 42'.</b>

Location Details:		Direction of Survey:	<b>Downstream</b>
US MH:	<b>M-809-059</b>	DS MH:	<b>M-809-059A</b>
		Total Length Surveyed (ft):	<b>43.7</b>

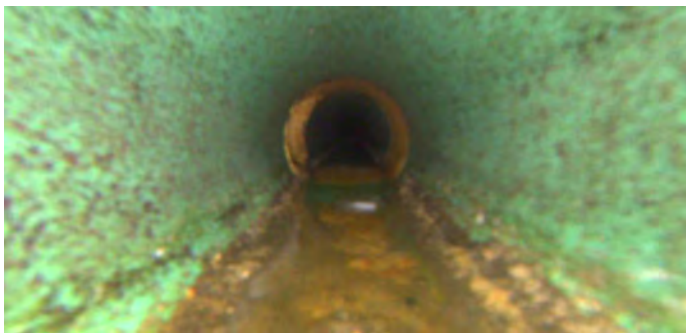
Code: **AMH**  
Description: **Manhole**

Distance (ft): **.0**  
Structural Grade: **0**  
O&M Grade: **0**  
Clock Start/From:  
Clock To:  
1st Value:  
2nd Value:  
Value Percent:  
Continuous Index:  
Within 8" of Joint: **NO**  
Remarks: **M-809-059**

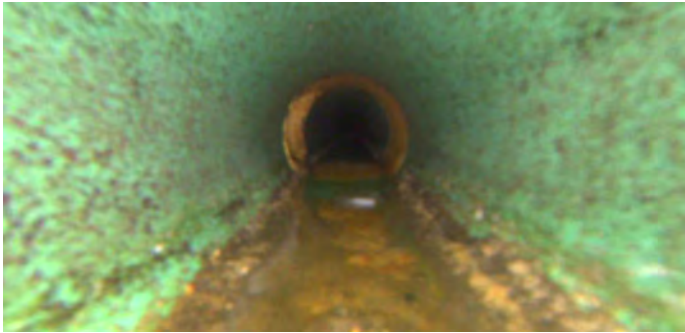
Code:	<b>MWL</b>
Description:	<b>Water Level</b>

Distance (ft):	<b>.0</b>
Structural Grade:	<b>0</b>
O&M Grade:	<b>0</b>
Clock Start/From:	
Clock To:	
1st Value:	
2nd Value:	
Value Percent:	<b>5.000</b>
Continuous Index:	
Within 8" of Joint:	<b>NO</b>
Remarks:

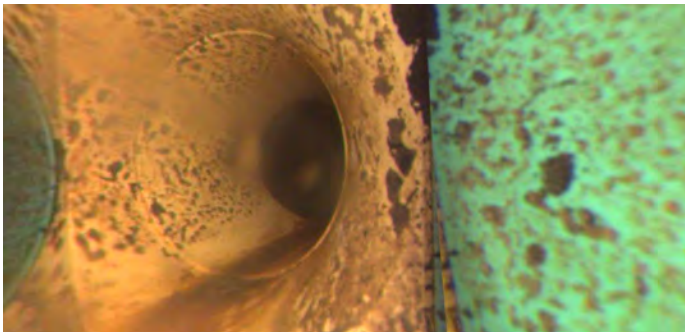
Code:	<b>TF</b>
Description:	<b>Tap Factory</b>

Distance (ft):	<b>2.9</b>
Structural Grade:	<b>0</b>
O&M Grade:	<b>0</b>
Clock Start/From:	<b>9</b>
Clock To:	
1st Value:	<b>4.000</b>
2nd Value:	
Value Percent:	
Continuous Index:	
Within 8" of Joint:	
Remarks:

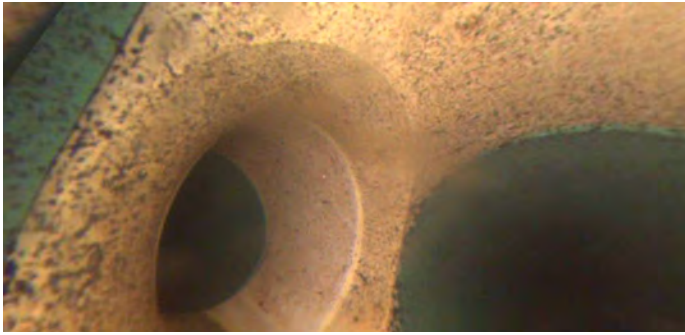
Code: **TF**  
Description: **Tap Factory**

Distance (ft): **24.1**  
Structural Grade: **0**  
O&M Grade: **0**  
Clock Start/From: **3**  
Clock To:  
1st Value: **4.000**  
2nd Value:  
Value Percent:  
Continuous Index:  
Within 8" of Joint:  
Remarks:

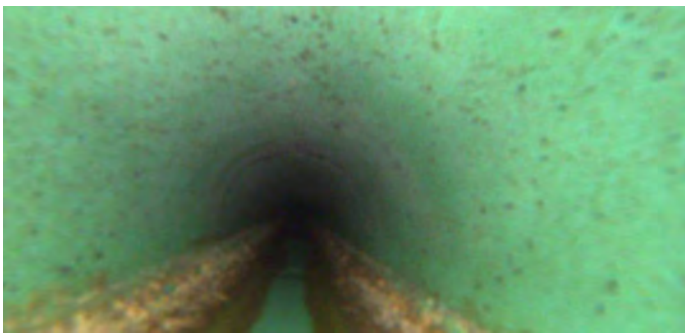
Code: **DAGS**  
Description: **Deposits Attached Grease**

Distance (ft): **27.1**  
Structural Grade: **0**  
O&M Grade: **2**  
Clock Start/From: **8**  
Clock To: **4**  
1st Value:  
2nd Value:  
Value Percent: **5.000**  
Continuous Index: **S01**  
Within 8" of Joint: **NO**  
Remarks:

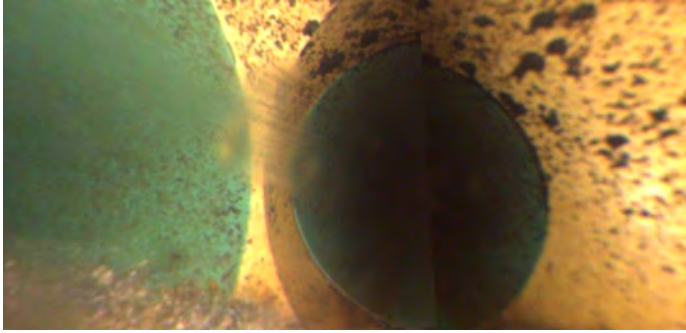
Code: **TF**  
Description: **Tap Factory**

Distance (ft): **36.8**  
Structural Grade: **0**  
O&M Grade: **0**  
Clock Start/From: **9**  
Clock To:  
1st Value: **4.000**  
2nd Value:  
Value Percent:  
Continuous Index:  
Within 8" of Joint:  
Remarks:

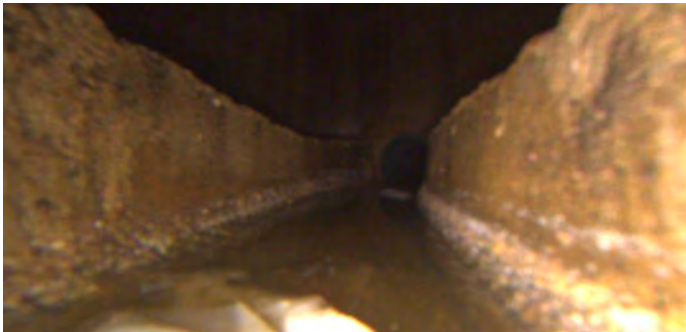
Code: **DAGS**  
Description: **Deposits Attached Grease**

Distance (ft): **41.8**  
Structural Grade: **0**  
O&M Grade: **2**  
Clock Start/From: **8**  
Clock To: **4**  
1st Value:  
2nd Value:  
Value Percent: **5.000**  
Continuous Index: **F01**  
Within 8" of Joint: **NO**  
Remarks:

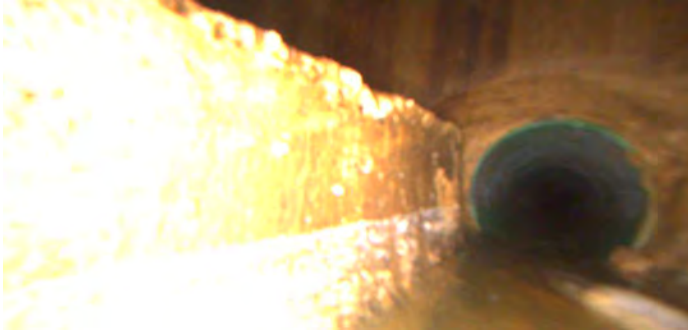
Code: **AMH**  
Description: **Manhole**

Distance (ft): **43.7**  
Structural Grade: **0**  
O&M Grade: **0**  
Clock Start/From:  
Clock To:  
1st Value:  
2nd Value:  
Value Percent:  
Continuous Index:  
Within 8" of Joint: **NO**  
Remarks: **M-809-059A**
