Profile/Photo Observation Report

| Street: | Oak | Flow Control: | Not Controlled |
| City: | Hobart, IN | Year Renewed: | |

| US MH: | M-809-060 | DS MH: | M-809-056 |

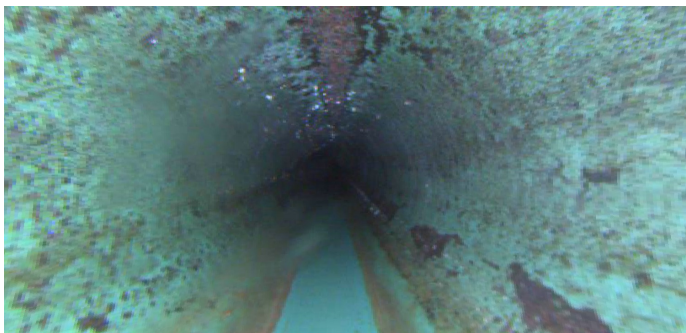
Code: **AMH**
Description: **Manhole**

Distance (ft): **.0**
Structural Grade: **0**
O&M Grade: **0**
Clock Start/From:
Clock To:
1st Value:
2nd Value:
Value Percent:
Continuous Index:
Within 8" of Joint: **NO**
Remarks: **M-809-056**

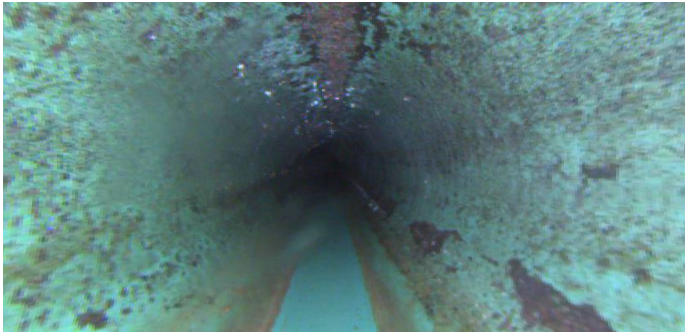
| Code: | MWL |
| Description: | Water Level |

| Value Percent: | 5.000 |

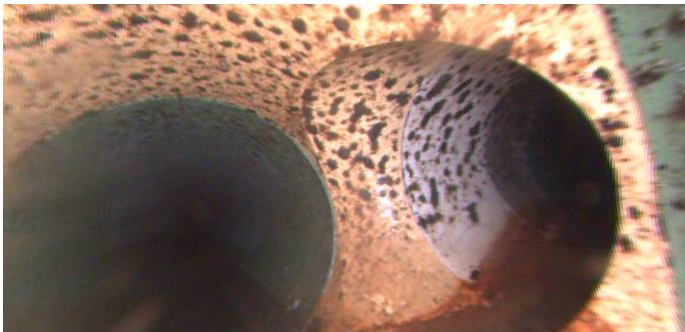
| Code: | TF |
| Description: | Tap Factory |

| Distance (ft): | 140.9 |

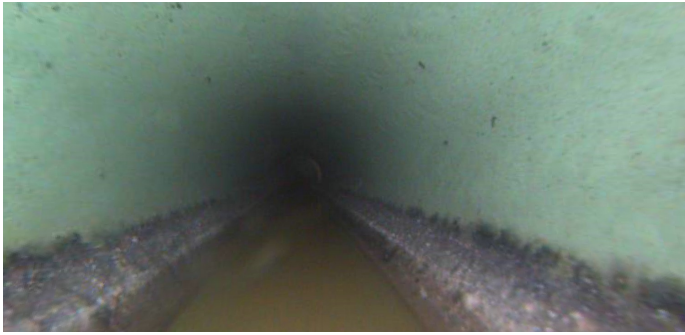
| | Position | Code | Observation | Video (sec) | Grade |
|--|---|---|---|---|---|
| | 222.1 | DAGS(S01) | Deposits Attached Grease | 489 | M 2 |

Code: **DAGS**
Description: **Deposits Attached Grease**

Distance (ft): **222.1**
Structural Grade: **0**
O&M Grade: **2**
Clock Start/From: **7**
Clock To: **5**
1st Value:
2nd Value:
Value Percent: **5.000**
Continuous Index: **S01**
Within 8" of Joint: **NO**
Remarks:

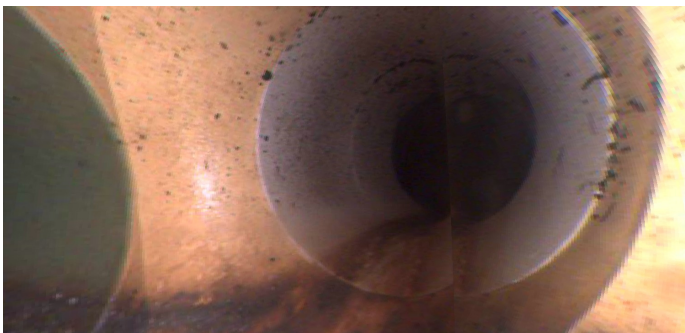
Code: **TF**
Description: **Tap Factory**

Distance (ft): **226.5**
Structural Grade: **0**
O&M Grade: **0**
Clock Start/From: **3**
Clock To:
1st Value: **4.000**
2nd Value:
Value Percent:
Continuous Index:
Within 8" of Joint:
Remarks:

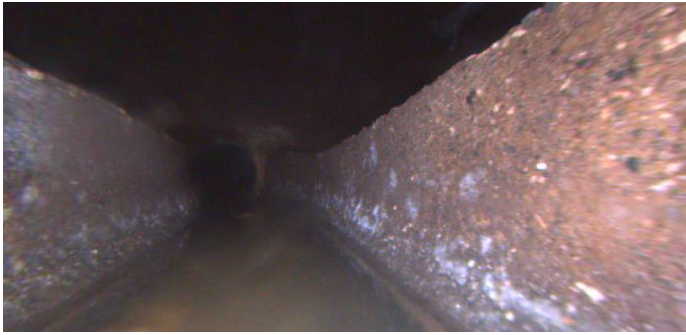
| | Position | Code | Observation | Video (sec) | Grade |
|--|---|---|---|---|---|
| | 264.3 | DAGS(F01) | Deposits Attached Grease | 597 | M 2 |

Code: **DAGS**
Description: **Deposits Attached Grease**

Distance (ft): **264.3**
Structural Grade: **0**
O&M Grade: **2**
Clock Start/From: **7**
Clock To: **5**
1st Value:
2nd Value:
Value Percent: **5.000**
Continuous Index: **F01**
Within 8" of Joint: **NO**
Remarks:

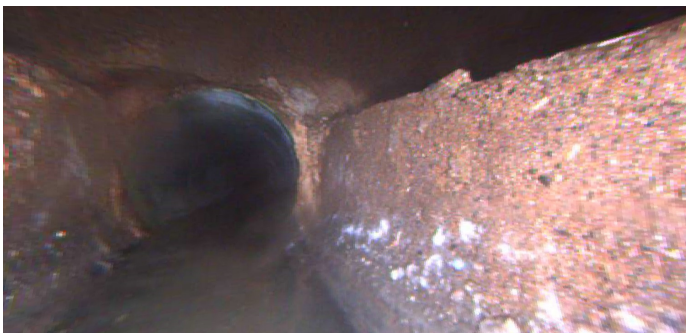
Code: **AMH**
Description: **Manhole**

Distance (ft): **266.2**
Structural Grade: **0**
O&M Grade: **0**
Clock Start/From:
Clock To:
1st Value:
2nd Value:
Value Percent:
Continuous Index:
Within 8" of Joint: **NO**
Remarks: **M-809-060**
