Profile/Photo Observation Report

Date:	03/22/2018	Weather:		Coding:	PACP 6.0
Pipe Length (ft):	61.6	Owner:	NA	Pre Clean:	Not Known
P.O.#:		Surveyor:	Selasie Honu	PSR:	P-809-061-062
Customer:		Clean Date:	01/01/1900	Shape:	C

Street:	EIDER ST & SORA ST	Flow Control:	Not Controlled
City:	Hobart, IN	Year Renewed:	
Location:	Ditch	Tape/Media #:	
Purpose:	Maintenance Related	Dia/Height:	8"
Use:	Sanitary	Material:	PVC
Drain Area:	NA	Lining:	
Category:	NA		
Comment:			
Location Details:		Direction of Survey:	Downstream
US MH:	M-809-061	DS MH:	M-809-062
		Total Length Surveyed (ft):	57.8

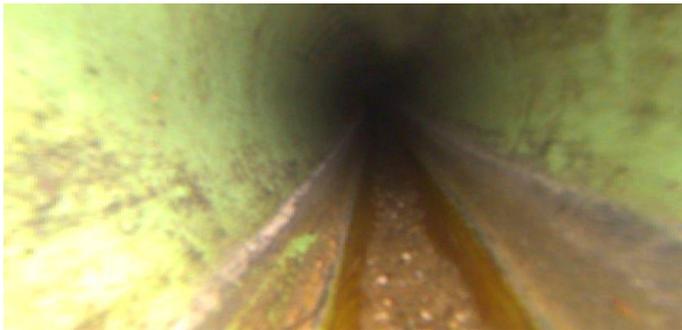
Code: **AMH**
Description: **Manhole**

Distance (ft): **.0**
Structural Grade: **0**
O&M Grade: **0**
Clock Start/From:
Clock To:
1st Value:
2nd Value:
Value Percent:
Continuous Index:
Within 8" of Joint: **NO**
Remarks: **M-809-061**

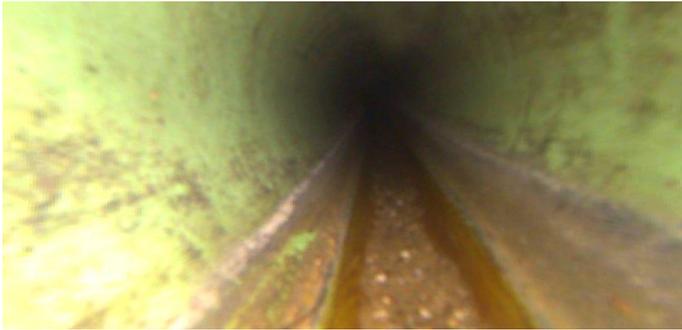
Code: **MWL**
Description: **Water Level**

Distance (ft): **.0**
Structural Grade: **0**
O&M Grade: **0**
Clock Start/From:
Clock To:
1st Value:
2nd Value:
Value Percent: **5.000**
Continuous Index:
Within 8" of Joint: **NO**
Remarks:

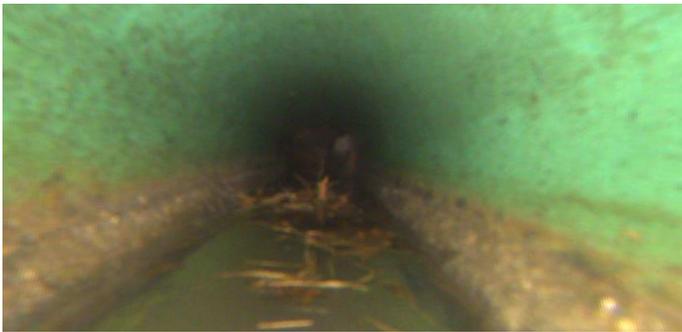
Code: **DSZ**
Description: **Deposits Settled Other**

Distance (ft): **53.3**
Structural Grade: **0**
O&M Grade: **2**
Clock Start/From: **6**
Clock To:
1st Value:
2nd Value:
Value Percent: **5.000**
Continuous Index:
Within 8" of Joint: **NO**
Remarks: **fine grass**
