Profile/Photo Observation Report

Location Details:		Direction of Survey:	Downstream
US MH:	M-809-061	DS MH:	M-809-062
		Total Length Surveyed (ft):	57.8

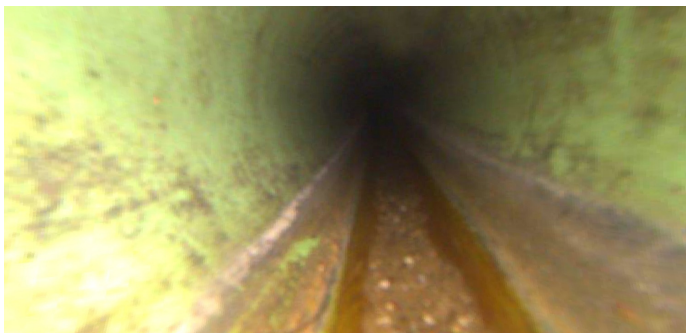
Code: **AMH**
Description: **Manhole**

Distance (ft): **.0**
Structural Grade: **0**
O&M Grade: **0**
Clock Start/From:
Clock To:
1st Value:
2nd Value:
Value Percent:
Continuous Index:
Within 8" of Joint: **NO**
Remarks: **M-809-061**

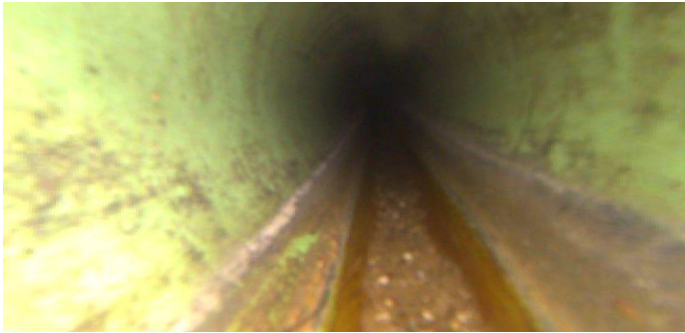
Code:	MWL
Description:	Water Level

Distance (ft):	.0
Structural Grade:	0
O&M Grade:	0
Clock Start/From:	
Clock To:	
1st Value:	
2nd Value:	
Value Percent:	5.000
Continuous Index:	
Within 8" of Joint:	NO
Remarks:

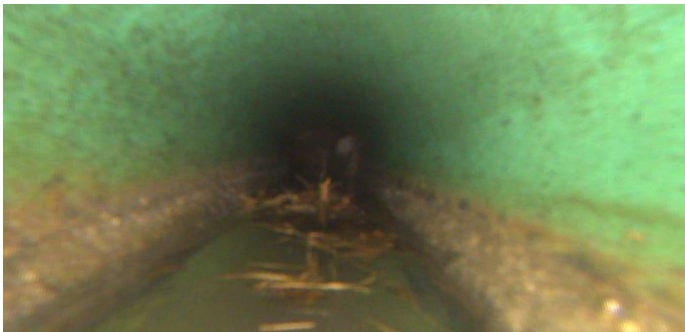
Code:	DSZ
Description:	Deposits Settled Other

Distance (ft):	53.3
Structural Grade:	0
O&M Grade:	2
Clock Start/From:	6
Clock To:	
1st Value:	
2nd Value:	
Value Percent:	5.000
Continuous Index:	
Within 8" of Joint:	NO
Remarks:	fine grass
