Profile/Photo Observation Report

Street:	BRACKEN PKWY & EIDER ST	Flow Control:	Not Controlled
City:	Hobart, IN	Year Renewed:	
Location:	Sidewalk	Tape/Media #:	
Purpose:	Maintenance Related	Dia/Height:	8"
Use:	Sanitary	Material:	PVC
Drain Area:	NA	Lining:	
Category:	NA		
Comment:	debris rollover at 43'.		
Location Details:		Direction of Survey:	Downstream
US MH:	M-809-062	DS MH:	M-809-019
		Total Length Surveyed (ft):	44.4

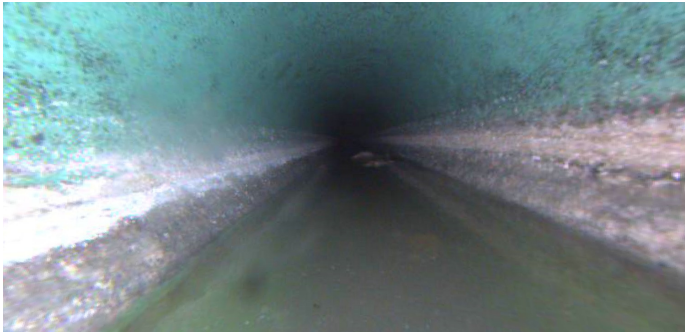
Code:	MWL
Description:	Water Level

Distance (ft):	.0
Structural Grade:	0
O&M Grade:	0
Clock Start/From:	
Clock To:	
1st Value:	
2nd Value:	
Value Percent:	10.000
Continuous Index:	
Within 8" of Joint:	NO
Remarks:

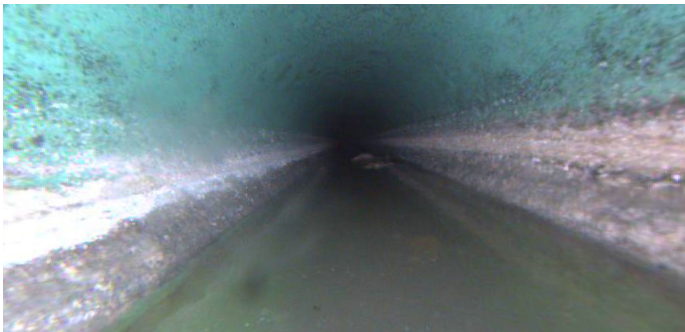
Code:	DAGS
Description:	Deposits Attached Grease

Distance (ft):	.0
Structural Grade:	0
O&M Grade:	2
Clock Start/From:	8
Clock To:	4
1st Value:	
2nd Value:	
Value Percent:	5.000
Continuous Index:	S01
Within 8" of Joint:	NO
Remarks:

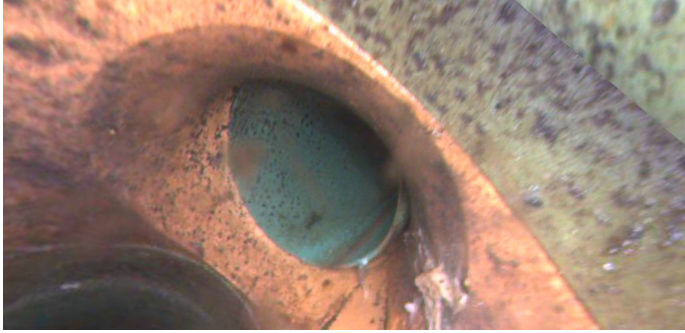
Code: **TF**
Description: **Tap Factory**

Distance (ft): **41.0**
Structural Grade: **0**
O&M Grade: **0**
Clock Start/From: **10**
Clock To:
1st Value: **4.000**
2nd Value:
Value Percent:
Continuous Index:
Within 8" of Joint:
Remarks:

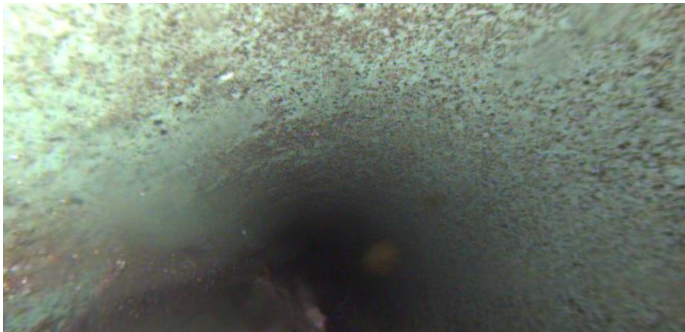
Code: **MSA**
Description: **Abandoned Survey**

Distance (ft): **44.4**
Structural Grade: **0**
O&M Grade: **0**
Clock Start/From:
Clock To:
1st Value:
2nd Value:
Value Percent:
Continuous Index:
Within 8" of Joint: **NO**
Remarks: **OVERTURNED**

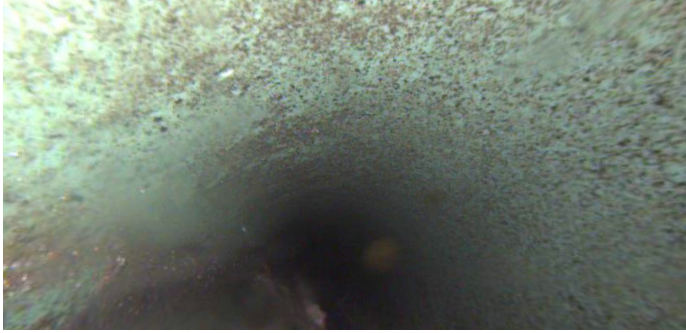
Code:	DAGS
Description:	Deposits Attached Grease
Distance (ft):	44.4
Structural Grade:	0
O&M Grade:	2
Clock Start/From:	8
Clock To:	4
1st Value:	
2nd Value:	
Value Percent:	5.000
Continuous Index:	F01
Within 8" of Joint:	NO
Remarks:
