## Profile/Photo Observation Report

Street:	<b>Oak</b>	Flow Control:	<b>Not Controlled</b>
City:	<b>Hobart, IN</b>	Year Renewed:	
Location:	<b>Sidewalk</b>	Tape/Media #:	
Purpose:	<b>Maintenance Related</b>	Dia/Height:	<b>8"</b>
Use:	<b>Sanitary</b>	Material:	<b>PVC</b>
Drain Area:	<b>NA</b>	Lining:	
Category:	<b>NA</b>		
Comment:	<b>debris rollover at 43'.</b>

Location Details:		Direction of Survey:	<b>Downstream</b>
US MH:	<b>M-809-062</b>	DS MH:	<b>M-809-019</b>
		Total Length Surveyed (ft):	<b>44.4</b>

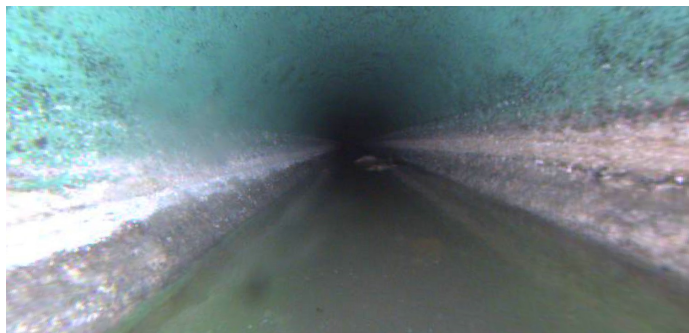
Code: **AMH**  
 Description: **Manhole**  
 Distance (ft): **.0**  
 Structural Grade: **0**  
 O&M Grade: **0**  
 Clock Start/From:  
 Clock To:  
 1st Value:  
 2nd Value:  
 Value Percent:  
 Continuous Index:  
 Within 8" of Joint: **NO**  
 Remarks: **M-809-062**

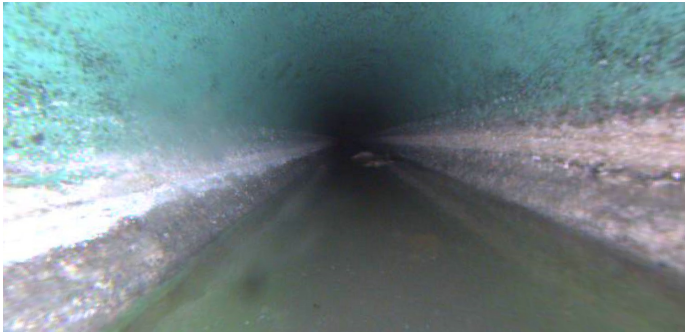
Code:	<b>MWL</b>
Description:	<b>Water Level</b>

Distance (ft):	<b>.0</b>
Structural Grade:	<b>0</b>
O&M Grade:	<b>0</b>
Clock Start/From:	
Clock To:	
1st Value:	
2nd Value:	
Value Percent:	<b>10.000</b>
Continuous Index:	
Within 8" of Joint:	<b>NO</b>
Remarks:

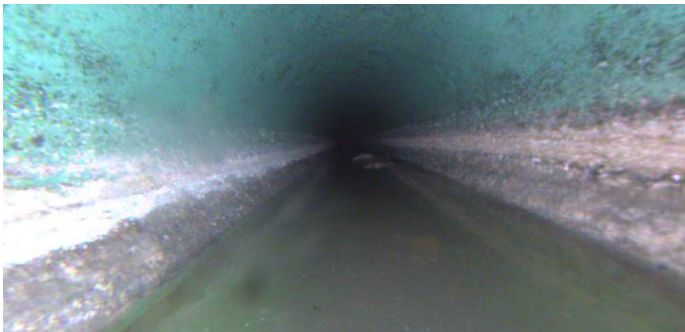
Code:	<b>DAGS</b>
Description:	<b>Deposits Attached Grease</b>

Distance (ft):	<b>.0</b>
Structural Grade:	<b>0</b>
O&M Grade:	<b>2</b>
Clock Start/From:	<b>8</b>
Clock To:	<b>4</b>
1st Value:	
2nd Value:	
Value Percent:	<b>5.000</b>
Continuous Index:	<b>S01</b>
Within 8" of Joint:	<b>NO</b>
Remarks:

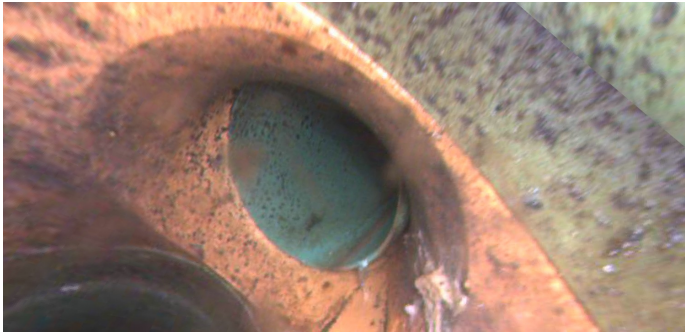
Code: **TF**  
Description: **Tap Factory**

Distance (ft): **41.0**  
Structural Grade: **0**  
O&M Grade: **0**  
Clock Start/From: **10**  
Clock To:  
1st Value: **4.000**  
2nd Value:  
Value Percent:  
Continuous Index:  
Within 8" of Joint:  
Remarks:

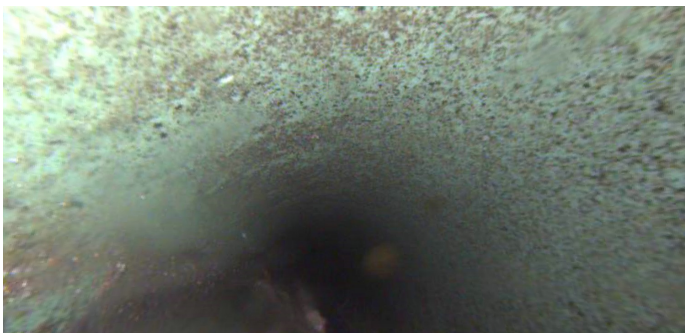
Code: **MSA**  
Description: **Abandoned Survey**

Distance (ft): **44.4**  
Structural Grade: **0**  
O&M Grade: **0**  
Clock Start/From:  
Clock To:  
1st Value:  
2nd Value:  
Value Percent:  
Continuous Index:  
Within 8" of Joint: **NO**  
Remarks: **OVERTURNED**

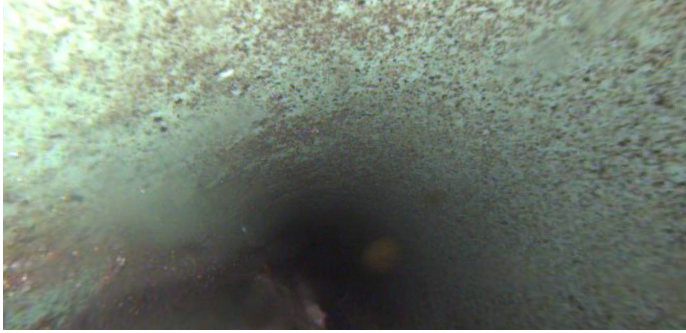
Code:	<b>DAGS</b>
Description:	<b>Deposits Attached Grease</b>
Distance (ft):	<b>44.4</b>
Structural Grade:	<b>0</b>
O&M Grade:	<b>2</b>
Clock Start/From:	<b>8</b>
Clock To:	<b>4</b>
1st Value:	
2nd Value:	
Value Percent:	<b>5.000</b>
Continuous Index:	<b>F01</b>
Within 8" of Joint:	<b>NO</b>
Remarks:
