Profile/Photo Observation Report

Date:	03/23/2018	Weather:		Coding:	PACP 6.0
Pipe Length (ft):	400.6	Owner:	NA	Pre Clean:	Not Known
P.O.#:		Surveyor:	Justin Gonzales	PSR:	P-809-062-019
Customer:		Clean Date:	01/01/1900	Shape:	C

Street:	Oak	Flow Control:	Not Controlled
City:	Hobart, IN	Year Renewed:	
Location:	Sidewalk	Tape/Media #:	
Purpose:	Maintenance Related	Dia/Height:	10"
Use:	Sanitary	Material:	PVC
Drain Area:	NA	Lining:	
Category:	NA		
Comment:	Reverse setup. debris rollover at 389'.		
Location Details:		Direction of Survey:	Upstream
US MH:	M-809-062	DS MH:	M-809-019
		Total Length Surveyed (ft):	391.0

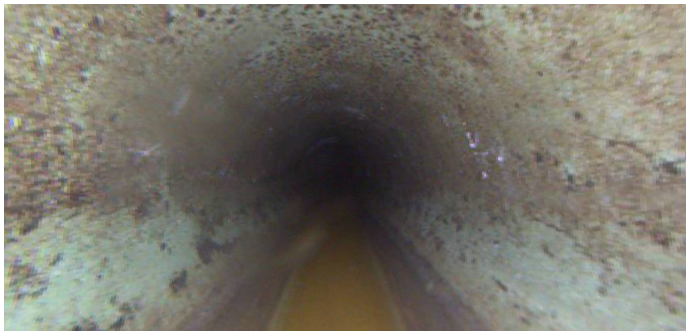
Code: **AMH**
Description: **Manhole**

Distance (ft): **.0**
Structural Grade: **0**
O&M Grade: **0**
Clock Start/From:
Clock To:
1st Value:
2nd Value:
Value Percent:
Continuous Index:
Within 8" of Joint: **NO**
Remarks: **M-809-019**

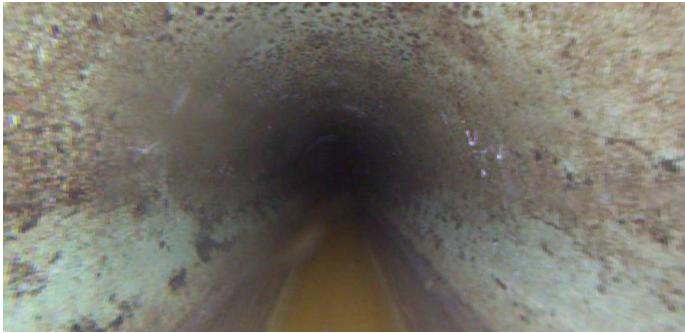
Code:	MWL
Description:	Water Level

Distance (ft):	.0
Structural Grade:	0
O&M Grade:	0
Clock Start/From:	
Clock To:	
1st Value:	
2nd Value:	
Value Percent:	5.000
Continuous Index:	
Within 8" of Joint:	NO
Remarks:

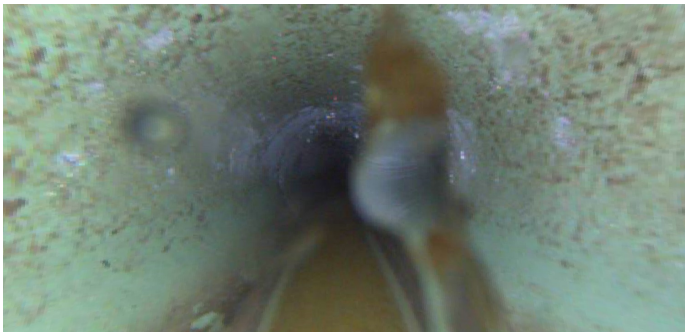
Code:	MGO
Description:	General Observation

Distance (ft):	15.5
Structural Grade:	0
O&M Grade:	0
Clock Start/From:	
Clock To:	
1st Value:	
2nd Value:	
Value Percent:	
Continuous Index:	
Within 8" of Joint:	NO
Remarks:	LARVAE

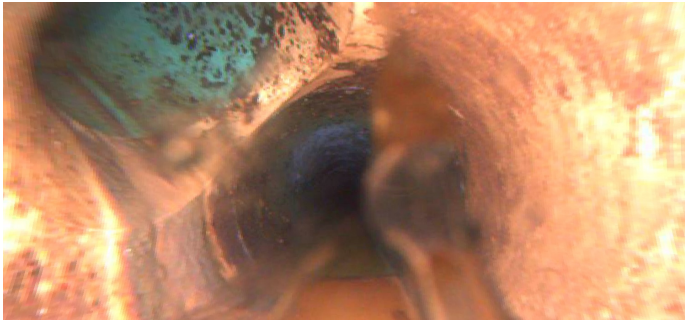
Code: **TF**
Description: **Tap Factory**

Distance (ft): **43.6**
Structural Grade: **0**
O&M Grade: **0**
Clock Start/From: **10**
Clock To:
1st Value: **4.000**
2nd Value:
Value Percent:
Continuous Index:
Within 8" of Joint:
Remarks:

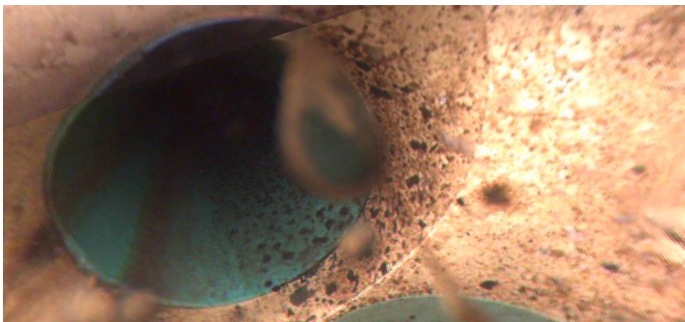
Code: **TF**
Description: **Tap Factory**

Distance (ft): **125.9**
Structural Grade: **0**
O&M Grade: **0**
Clock Start/From: **11**
Clock To:
1st Value: **4.000**
2nd Value:
Value Percent:
Continuous Index:
Within 8" of Joint:
Remarks:

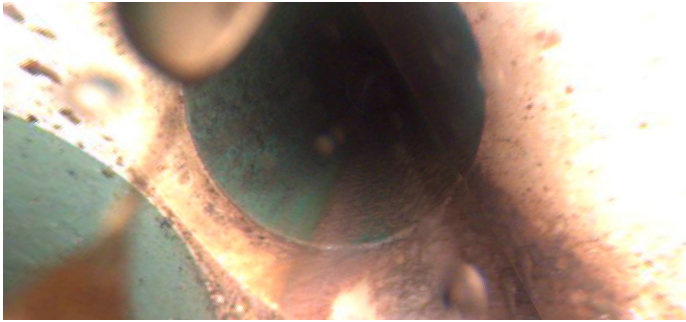
Code: **TF**
Description: **Tap Factory**

Distance (ft): **132.6**
Structural Grade: **0**
O&M Grade: **0**
Clock Start/From: **1**
Clock To:
1st Value: **4.000**
2nd Value:
Value Percent:
Continuous Index:
Within 8" of Joint:
Remarks:

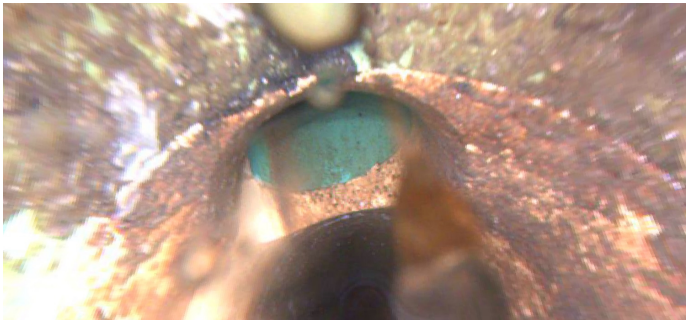
Code: **TF**
Description: **Tap Factory**

Distance (ft): **200.6**
Structural Grade: **0**
O&M Grade: **0**
Clock Start/From: **11**
Clock To:
1st Value: **4.000**
2nd Value:
Value Percent:
Continuous Index:
Within 8" of Joint:
Remarks:

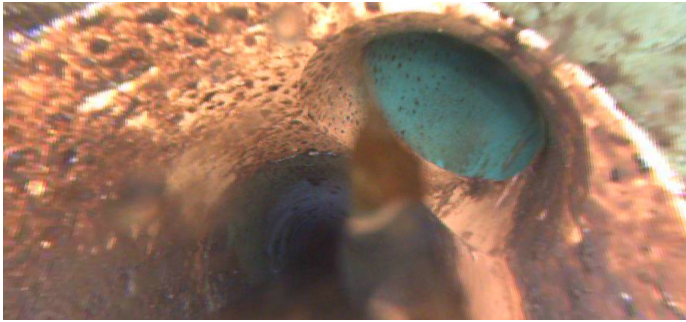
Code: **TF**
Description: **Tap Factory**

Distance (ft): **205.8**
Structural Grade: **0**
O&M Grade: **0**
Clock Start/From: **2**
Clock To:
1st Value: **4.000**
2nd Value:
Value Percent:
Continuous Index:
Within 8" of Joint:
Remarks:

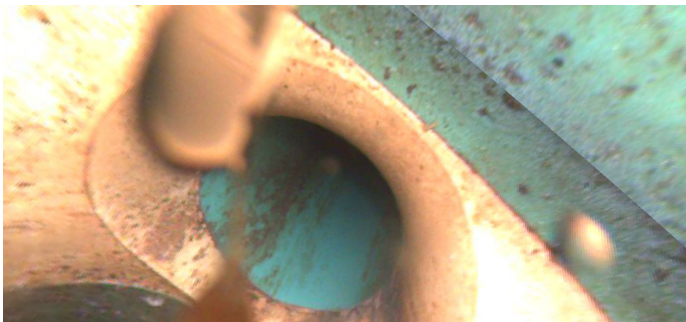
Code: **TF**
Description: **Tap Factory**

Distance (ft): **284.8**
Structural Grade: **0**
O&M Grade: **0**
Clock Start/From: **2**
Clock To:
1st Value: **4.000**
2nd Value:
Value Percent:
Continuous Index:
Within 8" of Joint:
Remarks:

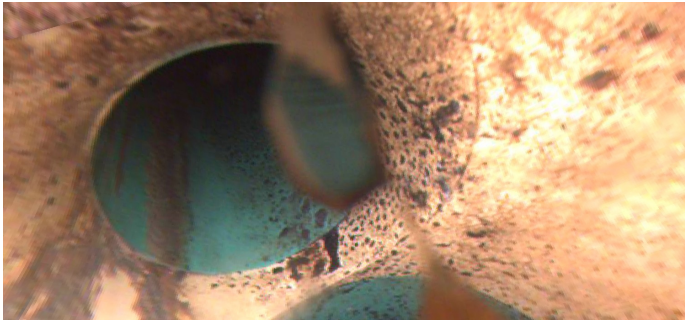
Code: **TF**
Description: **Tap Factory**

Distance (ft): **290.3**
Structural Grade: **0**
O&M Grade: **0**
Clock Start/From: **11**
Clock To:
1st Value: **4.000**
2nd Value:
Value Percent:
Continuous Index:
Within 8" of Joint:
Remarks:

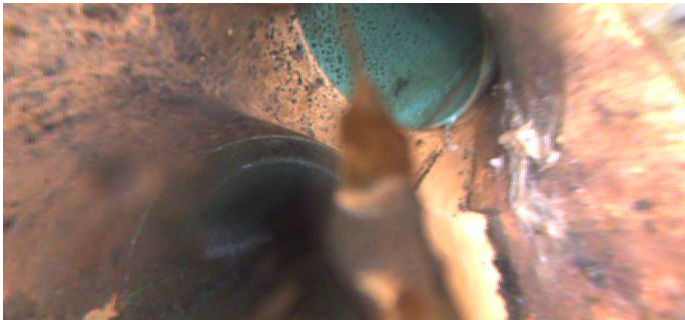
Code: **TF**
Description: **Tap Factory**

Distance (ft): **351.2**
Structural Grade: **0**
O&M Grade: **0**
Clock Start/From: **1**
Clock To:
1st Value: **4.000**
2nd Value:
Value Percent:
Continuous Index:
Within 8" of Joint:
Remarks:

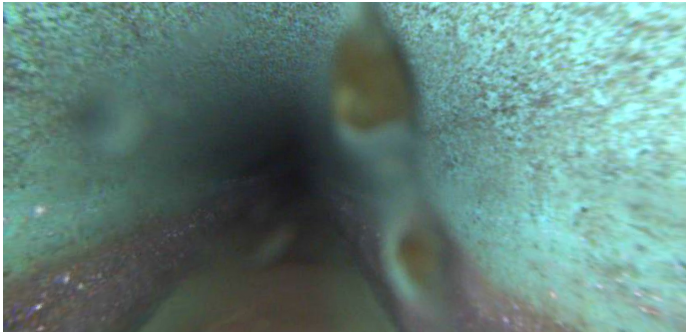
Code: **DAGS**
Description: **Deposits Attached Grease**

Distance (ft): **356.8**
Structural Grade: **0**
O&M Grade: **2**
Clock Start/From: **8**
Clock To: **4**
1st Value:
2nd Value:
Value Percent: **5.000**
Continuous Index: **S01**
Within 8" of Joint: **NO**
Remarks:

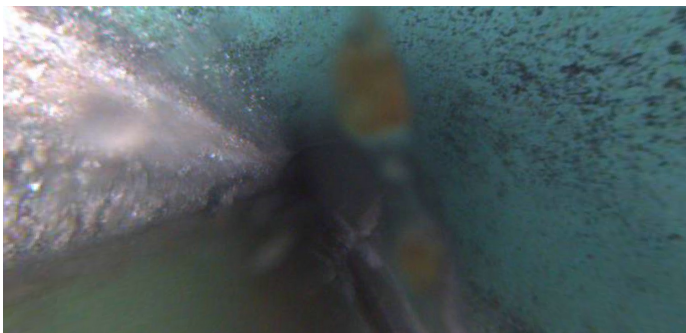
Code: **DAGS**
Description: **Deposits Attached Grease**

Distance (ft): **391.0**
Structural Grade: **0**
O&M Grade: **2**
Clock Start/From: **8**
Clock To: **4**
1st Value:
2nd Value:
Value Percent: **5.000**
Continuous Index: **F01**
Within 8" of Joint: **NO**
Remarks:

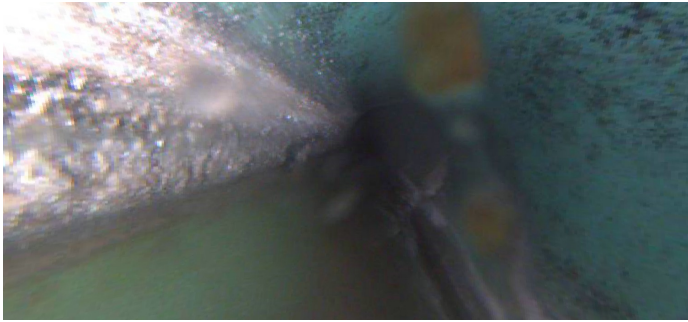
Code:	MSA
Description:	Abandoned Survey
Distance (ft):	391.0
Structural Grade:	0
O&M Grade:	0
Clock Start/From:	
Clock To:	
1st Value:	
2nd Value:	
Value Percent:	
Continuous Index:	
Within 8" of Joint:	NO
Remarks:	ROBOT TURNED OVER
