## Profile/Photo Observation Report

Street:	<b>OFF SAINT JOSEPH PL</b>	Flow Control:	<b>Not Controlled</b>
City:	<b>Hobart, IN</b>	Year Renewed:	
Location:	<b>Other</b>	Tape/Media #:	
Purpose:	<b>Not Known</b>	Dia/Height:	<b>10"</b>
Use:	<b>Sanitary</b>	Material:	<b>VCP</b>
Drain Area:	<b>NA</b>	Lining:	
Category:	<b>NA</b>		
Comment:

Location Details:		Direction of Survey:	<b>Downstream</b>
US MH:	<b>M-902-003.5</b>	DS MH:	<b>M-902-004</b>
		Total Length Surveyed (ft):	<b>28.2</b>

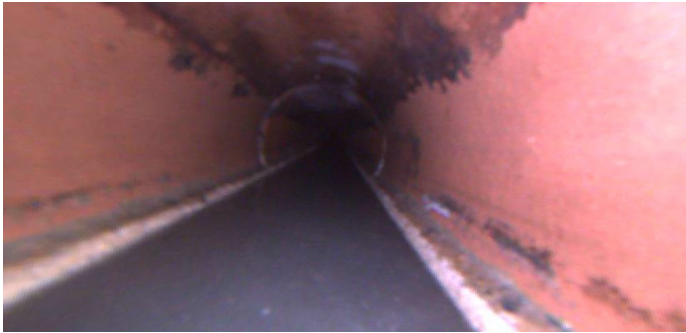
Code:	<b>MWL</b>
Description:	<b>Water Level</b>

Distance (ft):	<b>.0</b>
Structural Grade:	<b>0</b>
O&M Grade:	<b>0</b>
Clock Start/From:	
Clock To:	
1st Value:	
2nd Value:	
Value Percent:	<b>5.000</b>
Continuous Index:	
Within 8" of Joint:	<b>NO</b>
Remarks:

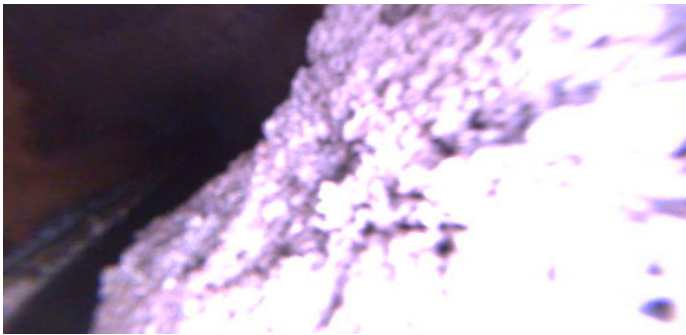
Code:	<b>DAZ</b>
Description:	<b>Deposits Attached Other</b>

Distance (ft):	<b>27.2</b>
Structural Grade:	<b>0</b>
O&M Grade:	<b>5</b>
Clock Start/From:	<b>1</b>
Clock To:	<b>6</b>
1st Value:	
2nd Value:	
Value Percent:	<b>40.000</b>
Continuous Index:	
Within 8" of Joint:	<b>YES</b>
Remarks:

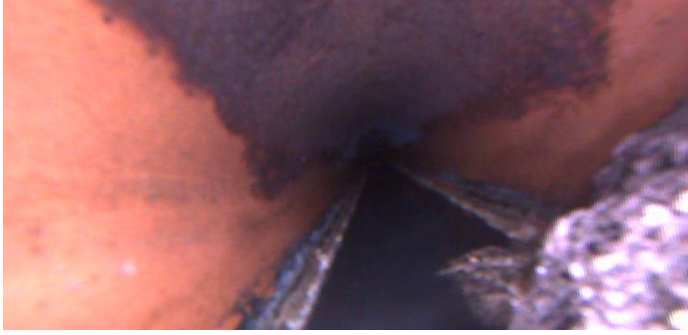
Code:	<b>MSA</b>
Description:	<b>Abandoned Survey</b>
Distance (ft):	<b>28.2</b>
Structural Grade:	<b>0</b>
O&M Grade:	<b>0</b>
Clock Start/From:	
Clock To:	
1st Value:	
2nd Value:	
Value Percent:	
Continuous Index:	
Within 8" of Joint:	<b>NO</b>
Remarks:	<b>camera stopped</b>
