## Profile/Photo Observation Report

Street:	<b>saint joesph pl</b>	Flow Control:	<b>Not Controlled</b>
City:	<b>Hobart, IN</b>	Year Renewed:	
Location:	<b>Other</b>	Tape/Media #:	
Purpose:	<b>Not Known</b>	Dia/Height:	<b>10"</b>
Use:	<b>Sanitary</b>	Material:	<b>VCP</b>
Drain Area:	<b>NA</b>	Lining:	
Category:	<b>NA</b>		
Comment:

Location Details:		Direction of Survey:	<b>Downstream</b>
US MH:	<b>M-902-003.5</b>	DS MH:	<b>M-902-004</b>
		Total Length Surveyed (ft):	<b>28.2</b>

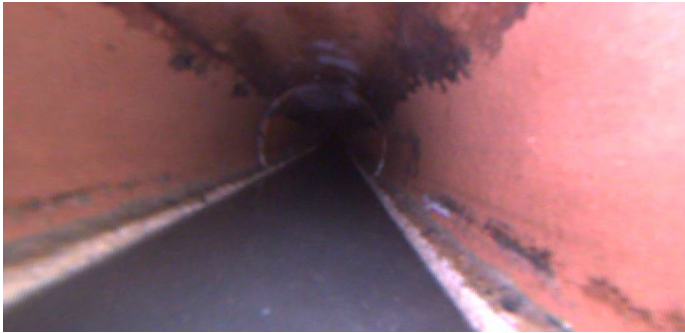
Code:	<b>MWL</b>
Description:	<b>Water Level</b>

Distance (ft):	<b>.0</b>
Structural Grade:	<b>0</b>
O&M Grade:	<b>0</b>
Clock Start/From:	
Clock To:	
1st Value:	
2nd Value:	
Value Percent:	<b>5.000</b>
Continuous Index:	
Within 8" of Joint:	<b>NO</b>
Remarks:

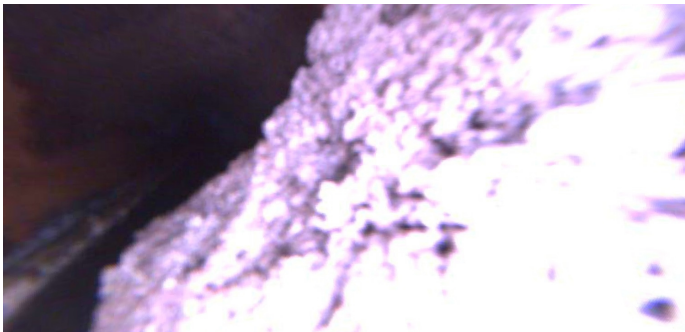
Code:	<b>DAZ</b>
Description:	<b>Deposits Attached Other</b>

Distance (ft):	<b>27.2</b>
Structural Grade:	<b>0</b>
O&M Grade:	<b>5</b>
Clock Start/From:	<b>1</b>
Clock To:	<b>6</b>
1st Value:	
2nd Value:	
Value Percent:	<b>40.000</b>
Continuous Index:	
Within 8" of Joint:	<b>YES</b>
Remarks:

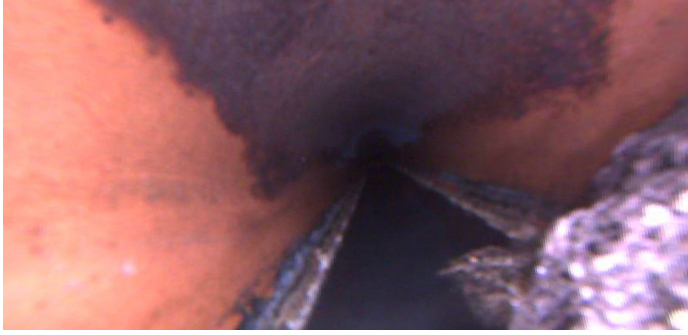
Code:	<b>MSA</b>
Description:	<b>Abandoned Survey</b>
Distance (ft):	<b>28.2</b>
Structural Grade:	<b>0</b>
O&M Grade:	<b>0</b>
Clock Start/From:	
Clock To:	
1st Value:	
2nd Value:	
Value Percent:	
Continuous Index:	
Within 8" of Joint:	<b>NO</b>
Remarks:	<b>camera stopped</b>
