Profile/Photo Observation Report

Date:	03/23/2018	Weather:		Coding:	PACP 6.0
Pipe Length (ft):	101.1	Owner:	NA	Pre Clean:	Not Known
P.O.#:		Surveyor:	Jen Costello	PSR:	P-902-006-007
Customer:		Clean Date:	01/01/1900	Shape:	C

Street:	E 34TH LN	Flow Control:	Not Controlled
City:	Hobart, IN	Year Renewed:	
Location:	Other	Tape/Media #:	
Purpose:	Not Known	Dia/Height:	10"
Use:	Sanitary	Material:	VCP
Drain Area:	NA	Lining:	
Category:	NA		
Comment:

Location Details:		Direction of Survey:	Downstream
US MH:	M-902-007	DS MH:	M-902-006
		Total Length Surveyed (ft):	6.1

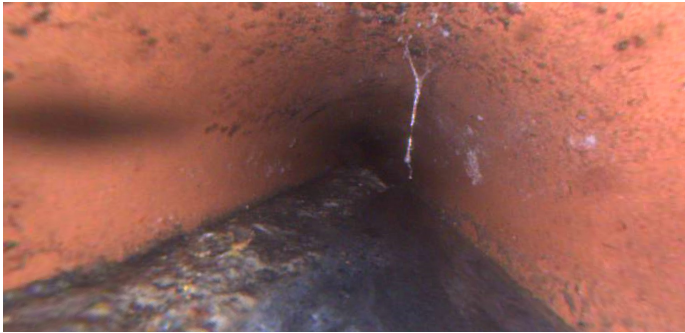
Code:	MWL
Description:	Water Level

Distance (ft):	.0
Structural Grade:	0
O&M Grade:	0
Clock Start/From:	
Clock To:	
1st Value:	
2nd Value:	
Value Percent:	40.000
Continuous Index:	
Within 8" of Joint:	NO
Remarks:

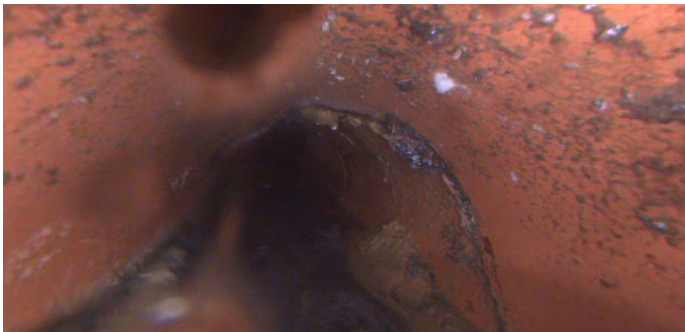
Code:	FC
Description:	Fracture Circumferential

Distance (ft):	5.1
Structural Grade:	2
O&M Grade:	0
Clock Start/From:	8
Clock To:	4
1st Value:	
2nd Value:	
Value Percent:	
Continuous Index:	
Within 8" of Joint:	
Remarks:

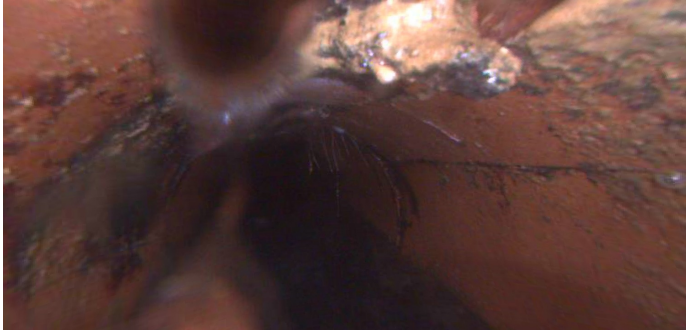
Code: **DAE**
Description: **Deposits Attached Encrustation**

Distance (ft): **5.9**
Structural Grade: **0**
O&M Grade: **2**
Clock Start/From: **8**
Clock To: **4**
1st Value:
2nd Value:
Value Percent: **10.000**
Continuous Index:
Within 8" of Joint: **NO**
Remarks:

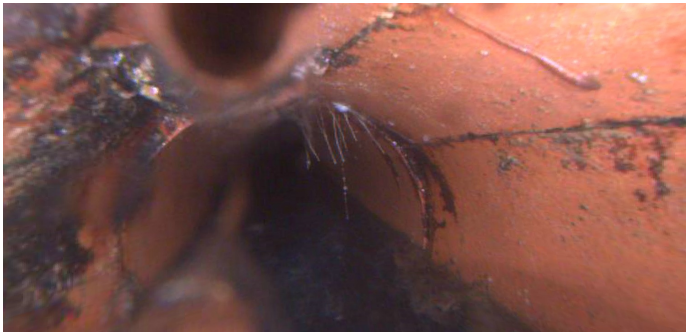
Code: **FM**
Description: **Fracture Multiple**

Distance (ft): **6.1**
Structural Grade: **4**
O&M Grade: **0**
Clock Start/From: **10**
Clock To: **2**
1st Value:
2nd Value:
Value Percent:
Continuous Index:
Within 8" of Joint: **YES**
Remarks:

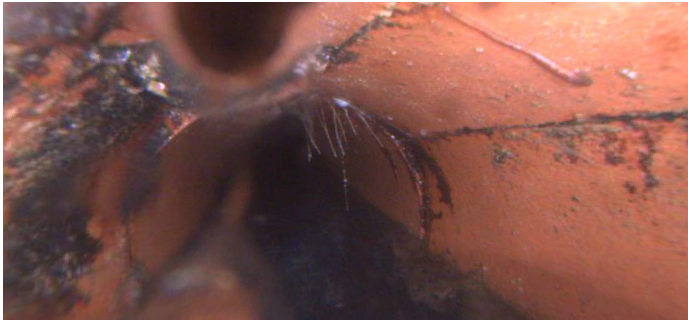
Code:	MSA
Description:	Abandoned Survey
Distance (ft):	6.1
Structural Grade:	0
O&M Grade:	0
Clock Start/From:	
Clock To:	
1st Value:	
2nd Value:	
Value Percent:	
Continuous Index:	
Within 8" of Joint:	NO
Remarks:	ROOTS
