Profile/Photo Observation Report

| Street: | e 34th In | Flow Control: | Not Controlled |
| City: | Hobart, IN | Year Renewed: | |

| US MH: | M-902-007 | DS MH: | M-902-006 |

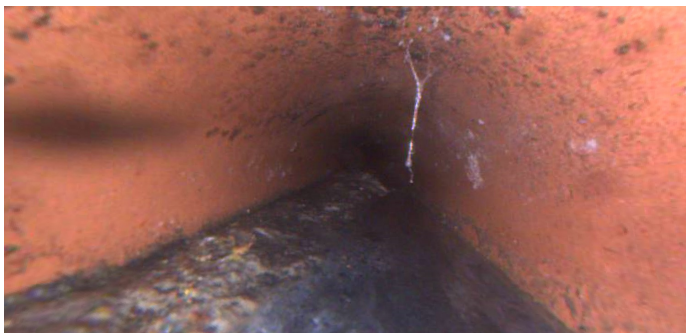
Code: **AMH**
Description: **Manhole**

Distance (ft): **.0**
Structural Grade: **0**
O&M Grade: **0**
Clock Start/From:
Clock To:
1st Value:
2nd Value:
Value Percent:
Continuous Index:
Within 8" of Joint: **NO**
Remarks: **M-902-007**

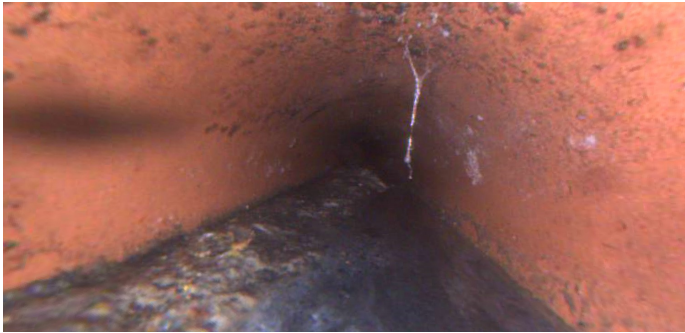
| Code: | MWL |
| Description: | Water Level |

| Value Percent: | 40.000 |

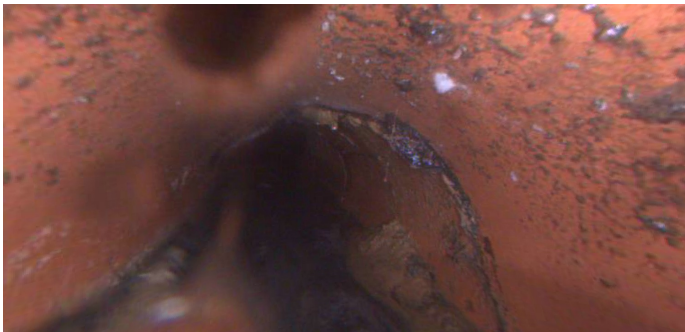
| | Position | Code | Observation | Video (sec) | Grade |
|--|---|---|---|---|---|
| | 5.1 | FC | Fracture Circumferential | 43 | S 2 |

| Code: | FC |
| Description: | Fracture Circumferential |

| Distance (ft): | 5.1 |
| Structural Grade: | 2 |
| Clock Start/From: | 8 |
| Clock To: | 4 |

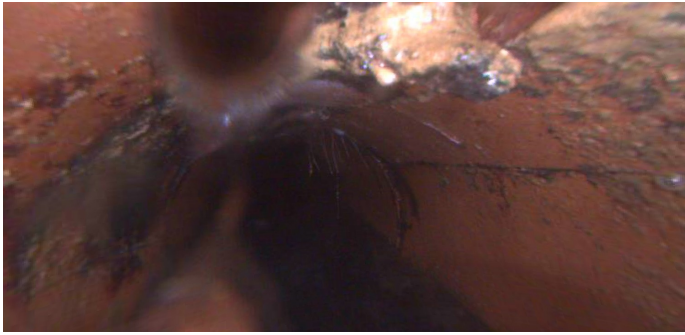
| | Position | Code | Observation | Video (sec) | Grade |
|--|---|---|---|---|---|
| | 5.9 | DAE | Deposits Attached Encrustation | 56 | M 2 |

Code: **DAE**
Description: **Deposits Attached Encrustation**

Distance (ft): **5.9**
Structural Grade: **0**
O&M Grade: **2**
Clock Start/From: **8**
Clock To: **4**
1st Value:
2nd Value:
Value Percent: **10.000**
Continuous Index:
Within 8" of Joint: **NO**
Remarks:

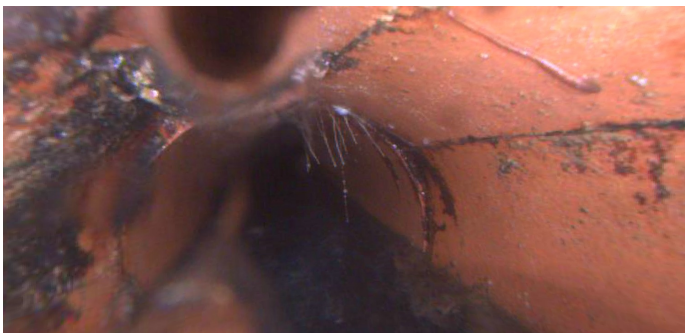
| | Position | Code | Observation | Video (sec) | Grade |
|--|---|---|---|---|---|
| | 6.1 | FM | Fracture Multiple | 69 | S 4 |

Code: **FM**
Description: **Fracture Multiple**

Distance (ft): **6.1**
Structural Grade: **4**
O&M Grade: **0**
Clock Start/From: **10**
Clock To: **2**
1st Value:
2nd Value:
Value Percent:
Continuous Index:
Within 8" of Joint: **YES**
Remarks:

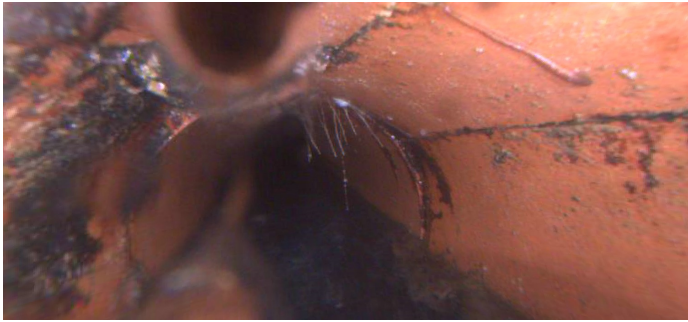
| Code: | MSA |
| Description: | Abandoned Survey |
| Distance (ft): | 6.1 |
| Remarks: | ROOTS |
