Profile/Photo Observation Report

Street:	E 34TH LN	Flow Control:	Not Controlled
City:	Hobart, IN	Year Renewed:	
Location:	Other	Tape/Media #:	
Purpose:	Not Known	Dia/Height:	10"
Use:	Sanitary	Material:	VCP
Drain Area:	NA	Lining:	
Category:	NA		
Comment:

Location Details:		Direction of Survey:	Downstream
US MH:	M-902-007	DS MH:	M-902-008
		Total Length Surveyed (ft):	3.8

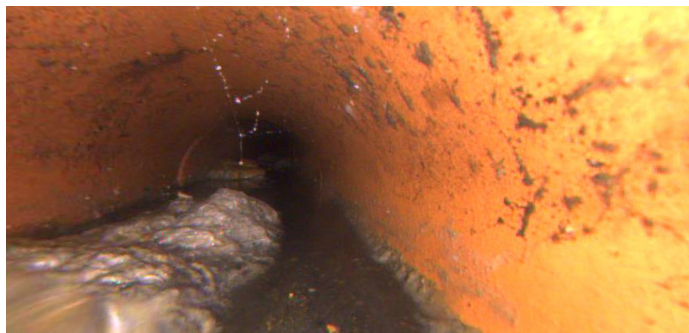
Code: **AMH**
Description: **Manhole**

Distance (ft): **.0**
Structural Grade: **0**
O&M Grade: **0**
Clock Start/From:
Clock To:
1st Value:
2nd Value:
Value Percent:
Continuous Index:
Within 8" of Joint: **NO**
Remarks: **M-902-007**

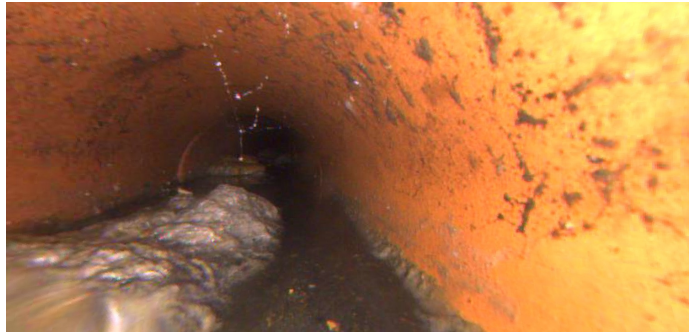
Code: **MWL**
Description: **Water Level**

Distance (ft): **.0**
Structural Grade: **0**
O&M Grade: **0**
Clock Start/From:
Clock To:
1st Value:
2nd Value:
Value Percent: **20.000**
Continuous Index:
Within 8" of Joint: **NO**
Remarks:

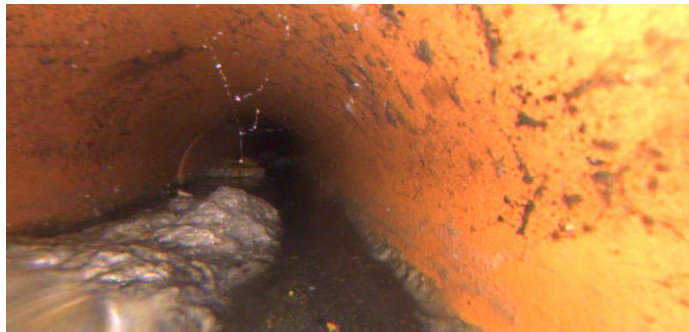
Code: **OBZ**
Description: **Obstacle Other**

Distance (ft): **.0**
Structural Grade: **0**
O&M Grade: **3**
Clock Start/From: **6**
Clock To: **8**
1st Value:
2nd Value:
Value Percent: **20.000**
Continuous Index:
Within 8" of Joint: **NO**
Remarks: **MISC**

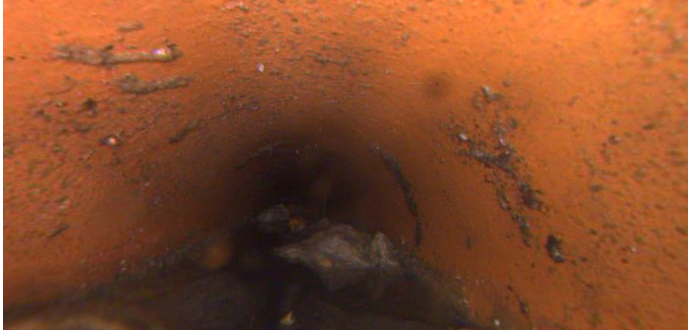
Code:	MSA
Description:	Abandoned Survey
Distance (ft):	3.8
Structural Grade:	0
O&M Grade:	0
Clock Start/From:	
Clock To:	
1st Value:	
2nd Value:	
Value Percent:	
Continuous Index:	
Within 8" of Joint:	NO
Remarks:	DEBRIS UNDER WATER
