## Profile/Photo Observation Report

Street:	<b>e 34th In</b>	Flow Control:	<b>Not Controlled</b>
City:	<b>Hobart, IN</b>	Year Renewed:	
Location:	<b>Other</b>	Tape/Media #:	
Purpose:	<b>Not Known</b>	Dia/Height:	<b>10"</b>
Use:	<b>Sanitary</b>	Material:	<b>VCP</b>
Drain Area:	<b>NA</b>	Lining:	
Category:	<b>NA</b>		
Comment:

Location Details:		Direction of Survey:	<b>Downstream</b>
US MH:	<b>M-902-007</b>	DS MH:	<b>M-902-008</b>
		Total Length Surveyed (ft):	<b>3.8</b>

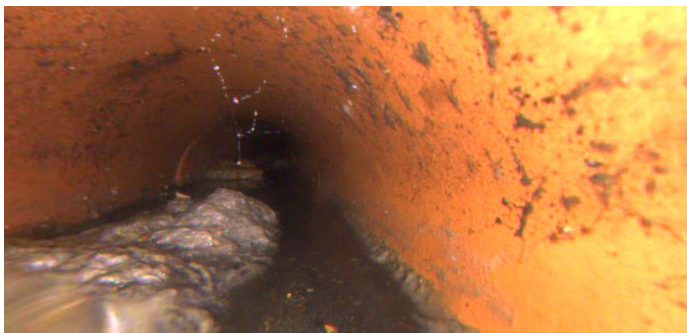
Code: **AMH**  
Description: **Manhole**

Distance (ft): **.0**  
Structural Grade: **0**  
O&M Grade: **0**  
Clock Start/From:  
Clock To:  
1st Value:  
2nd Value:  
Value Percent:  
Continuous Index:  
Within 8" of Joint: **NO**  
Remarks: **M-902-007**

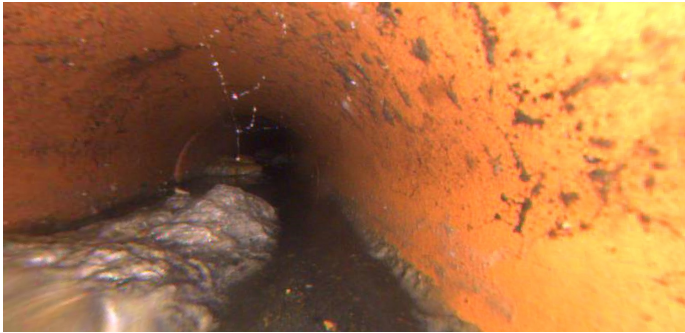
Code:	<b>MWL</b>
Description:	<b>Water Level</b>

Distance (ft):	<b>.0</b>
Structural Grade:	<b>0</b>
O&M Grade:	<b>0</b>
Clock Start/From:	
Clock To:	
1st Value:	
2nd Value:	
Value Percent:	<b>20.000</b>
Continuous Index:	
Within 8" of Joint:	<b>NO</b>
Remarks:

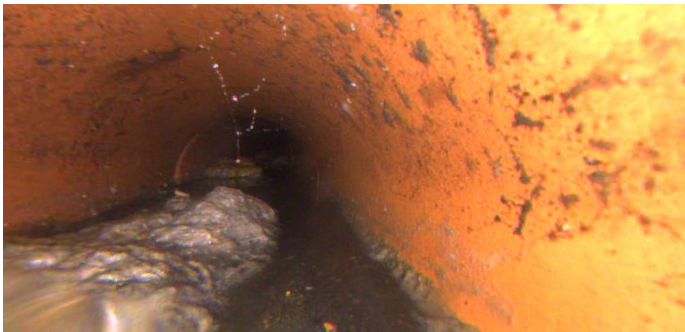
Code:	<b>OBZ</b>
Description:	<b>Obstacle Other</b>

Distance (ft):	<b>.0</b>
Structural Grade:	<b>0</b>
O&M Grade:	<b>3</b>
Clock Start/From:	<b>6</b>
Clock To:	<b>8</b>
1st Value:	
2nd Value:	
Value Percent:	<b>20.000</b>
Continuous Index:	
Within 8" of Joint:	<b>NO</b>
Remarks:	<b>MISC</b>

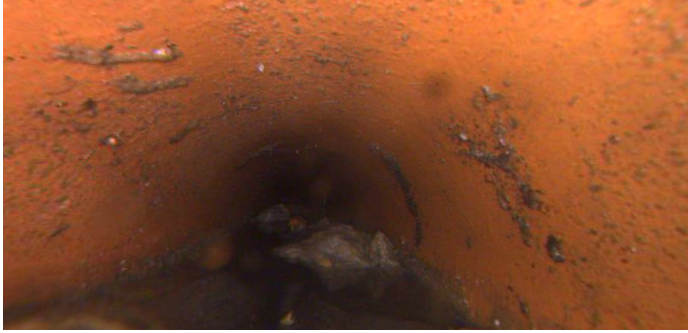
Code:	<b>MSA</b>
Description:	<b>Abandoned Survey</b>
Distance (ft):	<b>3.8</b>
Structural Grade:	<b>0</b>
O&M Grade:	<b>0</b>
Clock Start/From:	
Clock To:	
1st Value:	
2nd Value:	
Value Percent:	
Continuous Index:	
Within 8" of Joint:	<b>NO</b>
Remarks:	<b>DEBRIS UNDER WATER</b>
