Profile/Photo Observation Report

Date:	10/22/2021	Weather:		Coding:	PACP 6.0
Pipe Length (ft):		Owner:	Hobart, IN	Pre Clean:	Not Known
P.O.#:	971_1	Surveyor:	M. Pielacha	PSR:	P-902-009-045
Customer:	Hobart, IN	Clean Date:		Shape:	C

Street:	Off 34th Lane	Flow Control:	Not Controlled
City:	Hobart, IN	Year Renewed:	
Location:	Yard	Tape/Media #:	971
Purpose:	Routine Assessment	Dia/Height:	12"
Use:	Sanitary	Material:	VCP
Drain Area:		Lining:	
Category:	NA		
Comment:			
Location Details:		Direction of Survey:	Downstream
US MH:	M-902-9	DS MH:	M-902-45
		Total Length Surveyed (ft):	.1

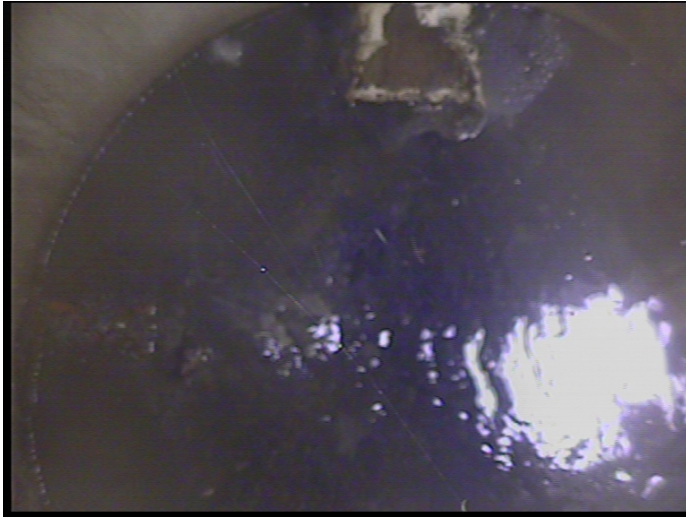
Code: **MWL**
Description: **Water Level**

Distance (ft): **.0**
Structural Grade: **0**
O&M Grade: **0**
Clock Start/From:
Clock To:
1st Value:
2nd Value:
Value Percent: **15.000**
Continuous Index:
Within 8" of Joint: **NO**
Remarks:

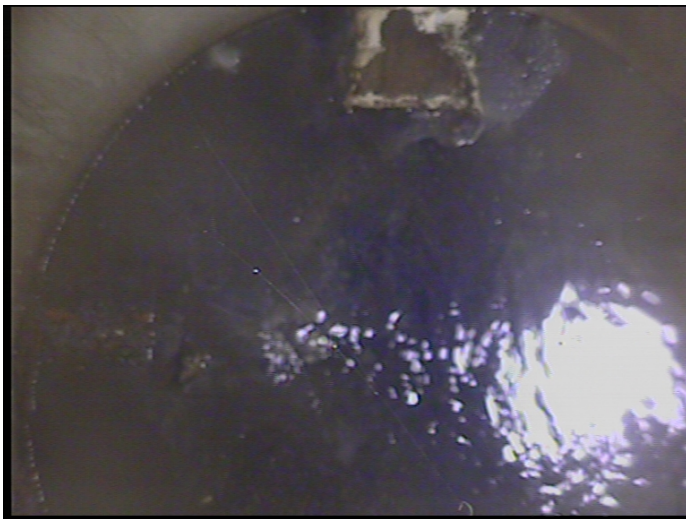
Code: **DSF**
Description: **Deposits Settled Fine**

Distance (ft): **.0**
Structural Grade: **0**
O&M Grade: **5**
Clock Start/From: **4**
Clock To: **8**
1st Value:
2nd Value:
Value Percent: **50.000**
Continuous Index:
Within 8" of Joint: **NO**
Remarks:

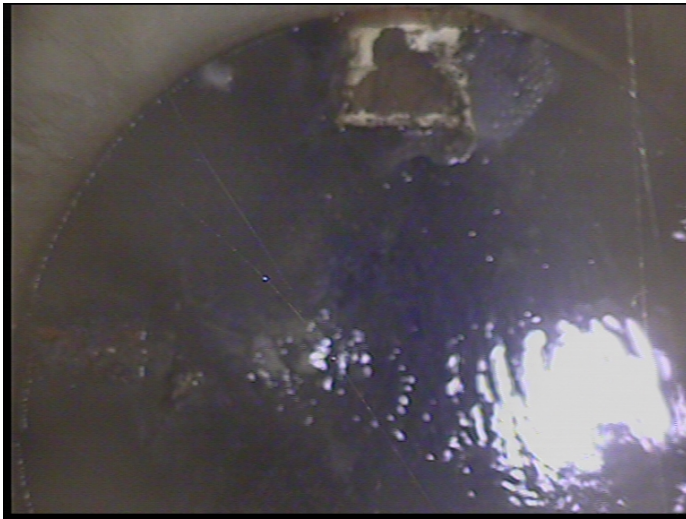
Code:	MSA
Description:	Abandoned Survey
Distance (ft):	.0
Structural Grade:	0
O&M Grade:	0
Clock Start/From:	
Clock To:	
1st Value:	
2nd Value:	
Value Percent:	
Continuous Index:	
Within 8" of Joint:	NO
Remarks:	sediment/ debris nearly blocking entire pipe.
