## Profile/Photo Observation Report

Date:	<b>08/01/2023</b>	Weather:		Coding:	<b>PACP 7.0</b>
Pipe Length (ft):	<b>196.0</b>	Owner:	<b>City of Hobart</b>	Pre Clean:	<b>Heavy Cleaning</b>
P.O.#:	<b>YES502259</b>	Surveyor:	<b>S. Bucklin</b>	PSR:	<b>P-902-010-011</b>
Customer:	<b>City of Hobart</b>	Clean Date:	<b>07/17/2023</b>	Shape:	<b>C</b>

Street:	<b>East 34th Court</b>	Flow Control:	<b>Not Controlled</b>
City:	<b>Hobart, IN</b>	Year Renewed:	
Location:	<b>Easement/Right of Way</b>	Tape/Media #:	
Purpose:	<b>Routine Assessment</b>	Dia/Height:	<b>8"</b>
Use:	<b>Sanitary Sewage Pipe</b>	Material:	<b>VCP</b>
Drain Area:		Lining:	<b>None</b>
Category:	<b>NA</b>		
Comment:			
Location Details:		Direction of Survey:	<b>Upstream</b>
US MH:	<b>M-902-010</b>	DS MH:	<b>M-902-011</b>
		Total Length Surveyed (ft):	<b>53.4</b>

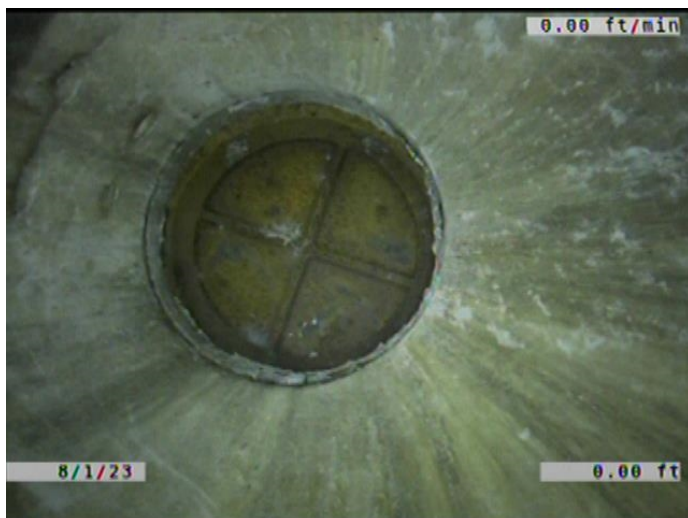
Code: **AMH**  
 Description: **Manhole**

Distance (ft): **.0**  
 Structural Grade: **0**  
 O&M Grade: **0**  
 Clock Start/From:  
 Clock To:  
 1st Value:  
 2nd Value:  
 Value Percent:  
 Continuous Index:  
 Within 8" of Joint: **NO**  
 Remarks: **M-902-011**

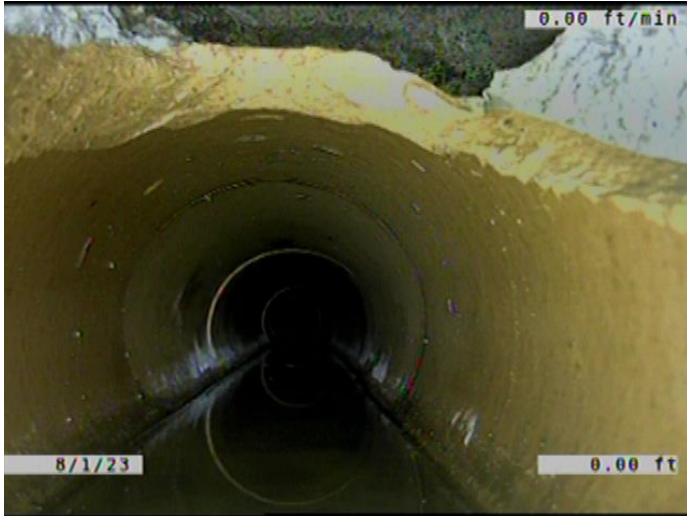
Code: **MWL**  
Description: **Miscellaneous Water Level**

Distance (ft): **.0**  
Structural Grade: **0**  
O&M Grade: **0**  
Clock Start/From:  
Clock To:  
1st Value:  
2nd Value:  
Value Percent: **5.000**  
Continuous Index:  
Within 8" of Joint: **NO**  
Remarks:

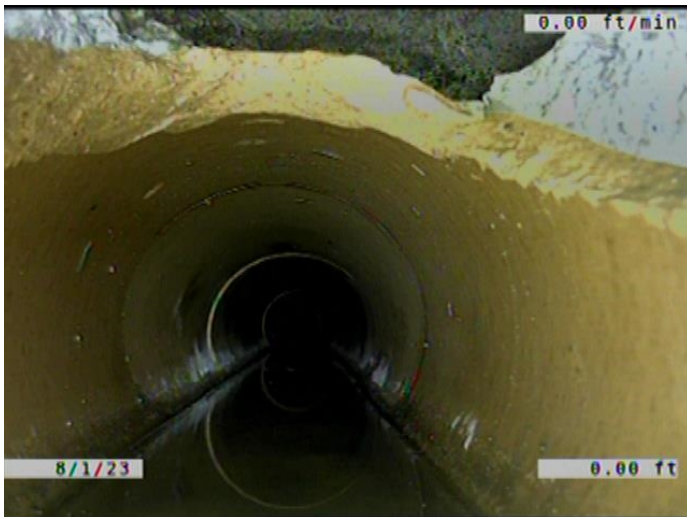
Code: **MWLS**  
Description: **Miscellaneous Water Level Sag**

Distance (ft): **.0**  
Structural Grade: **2**  
O&M Grade: **0**  
Clock Start/From:  
Clock To:  
1st Value:  
2nd Value:  
Value Percent: **10.000**  
Continuous Index: **S01**  
Within 8" of Joint: **NO**  
Remarks:

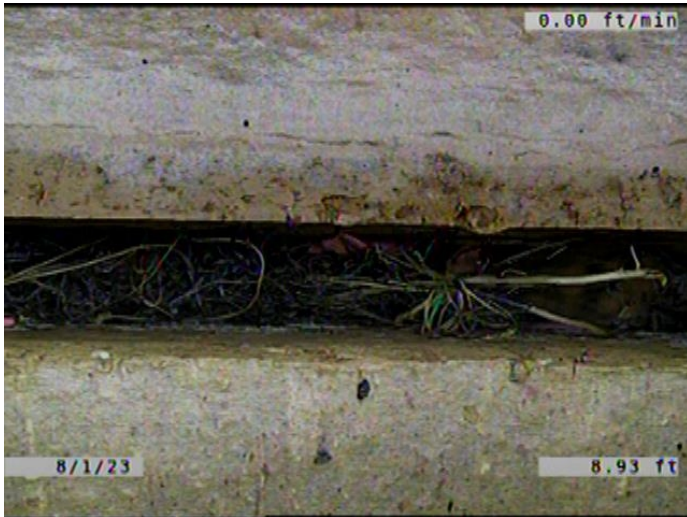
Code: **RFJ**  
Description: **Roots Fine Joint**

Distance (ft): **8.9**  
Structural Grade: **0**  
O&M Grade: **1**  
Clock Start/From: **10**  
Clock To: **3**  
1st Value:  
2nd Value:  
Value Percent:  
Continuous Index:  
Within 8" of Joint: **YES**  
Remarks:

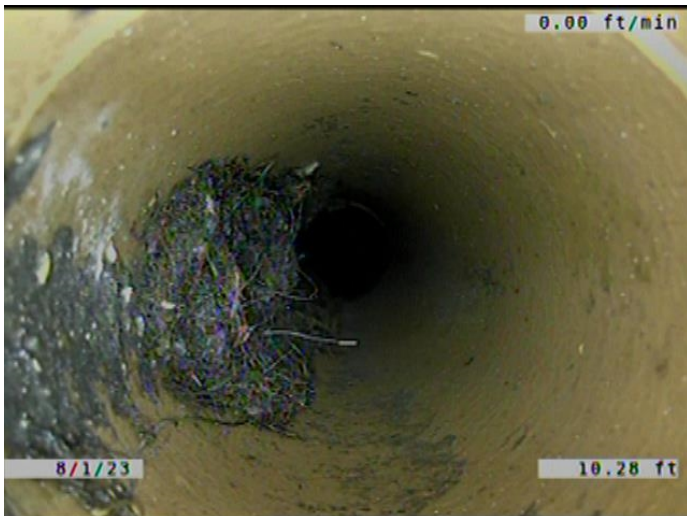
Code: **TF**  
Description: **Tap Factory**

Distance (ft): **10.3**  
Structural Grade: **0**  
O&M Grade: **0**  
Clock Start/From: **9**  
Clock To:  
1st Value: **6.000**  
2nd Value:  
Value Percent:  
Continuous Index:  
Within 8" of Joint: **YES**  
Remarks: **ROOTS GROWING IN THE SERVICE.  
SERVICE LOOKS TO BE 100% PLUGGED**

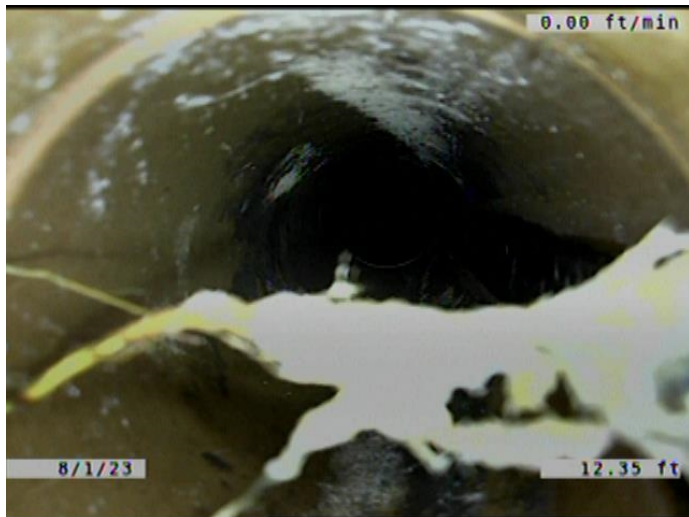
Code: **TF**  
Description: **Tap Factory**

Distance (ft): **12.4**  
Structural Grade: **0**  
O&M Grade: **0**  
Clock Start/From: **3**  
Clock To:  
1st Value: **6.000**  
2nd Value:  
Value Percent:  
Continuous Index:  
Within 8" of Joint: **YES**  
Remarks: **ROOTS GROWING IN THE SERVICE TO MAIN CONNECTION.**

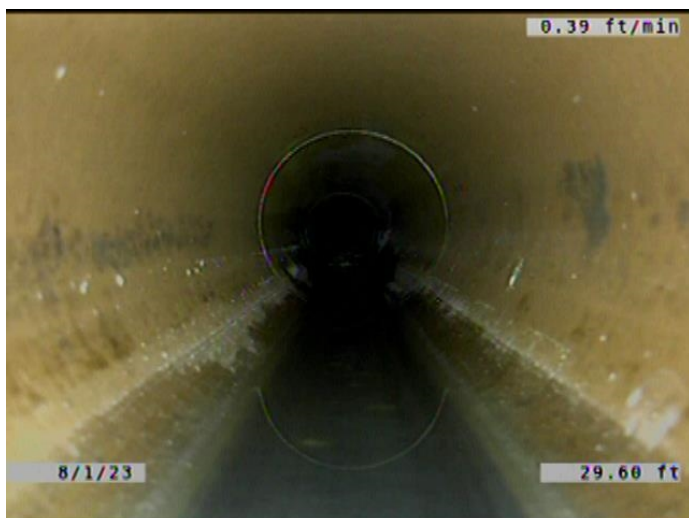
Code: **MWLS**  
Description: **Miscellaneous Water Level Sag**

Distance (ft): **29.6**  
Structural Grade: **2**  
O&M Grade: **0**  
Clock Start/From:  
Clock To:  
1st Value:  
2nd Value:  
Value Percent: **10.000**  
Continuous Index: **F01**  
Within 8" of Joint: **NO**  
Remarks:

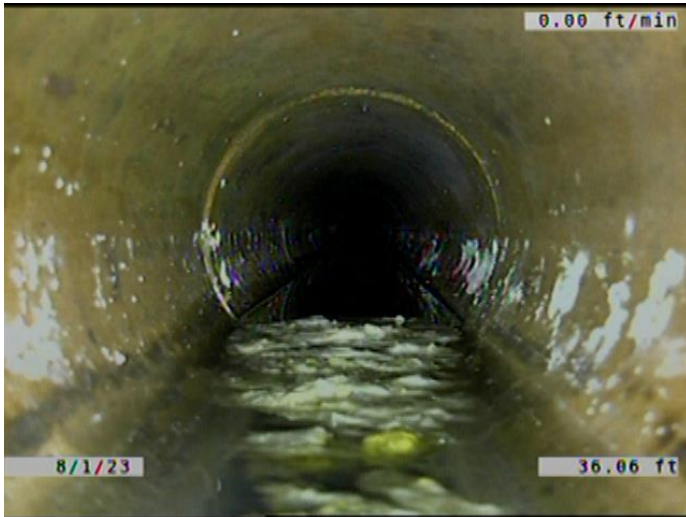
Code: **DSF**  
Description: **Deposits Settled Fine**

Distance (ft): **36.1**  
Structural Grade: **0**  
O&M Grade: **2**  
Clock Start/From: **5**  
Clock To: **7**  
1st Value:  
2nd Value:  
Value Percent: **5.000**  
Continuous Index: **S02**  
Within 8" of Joint: **YES**  
Remarks:

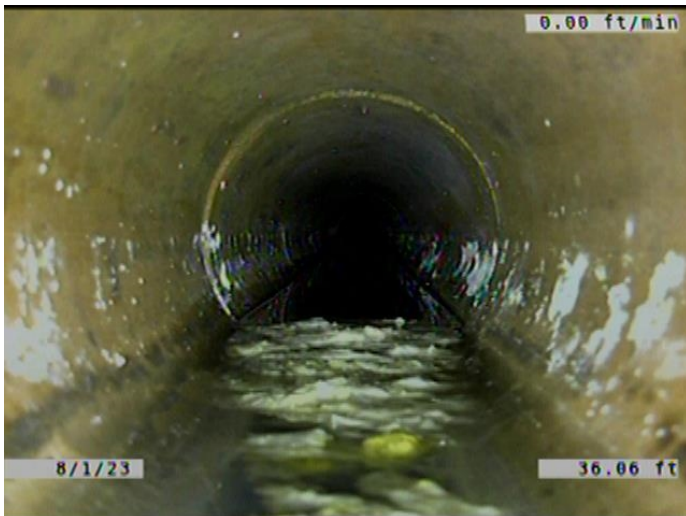
Code: **MWLS**  
Description: **Miscellaneous Water Level Sag**

Distance (ft): **36.1**  
Structural Grade: **2**  
O&M Grade: **0**  
Clock Start/From:  
Clock To:  
1st Value:  
2nd Value:  
Value Percent: **15.000**  
Continuous Index: **S03**  
Within 8" of Joint: **NO**  
Remarks:

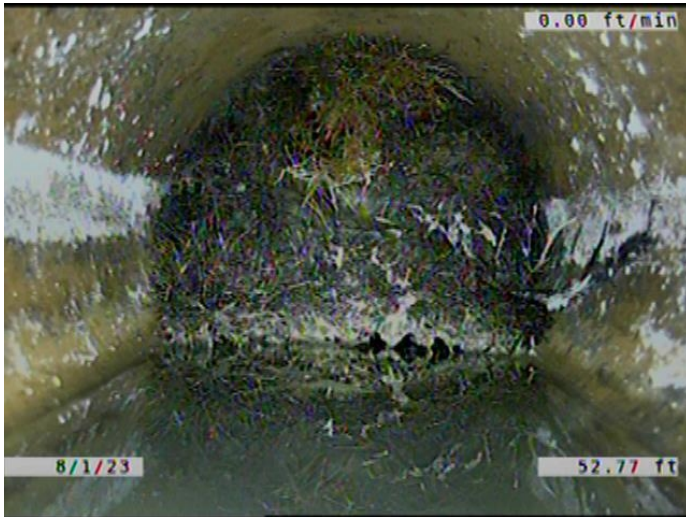
Code: **RBJ**  
Description: **Roots Ball Joint**

Distance (ft): **52.8**  
Structural Grade: **0**  
O&M Grade: **4**  
Clock Start/From: **7**  
Clock To: **5**  
1st Value:  
2nd Value:  
Value Percent: **85.000**  
Continuous Index:  
Within 8" of Joint: **YES**  
Remarks:

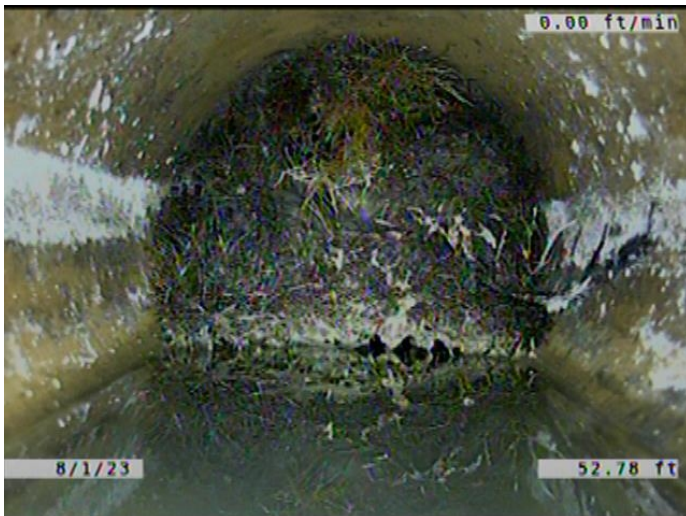
Code: **DSF**  
Description: **Deposits Settled Fine**

Distance (ft): **52.8**  
Structural Grade: **0**  
O&M Grade: **2**  
Clock Start/From: **5**  
Clock To: **7**  
1st Value:  
2nd Value:  
Value Percent: **5.000**  
Continuous Index: **F02**  
Within 8" of Joint: **YES**  
Remarks:

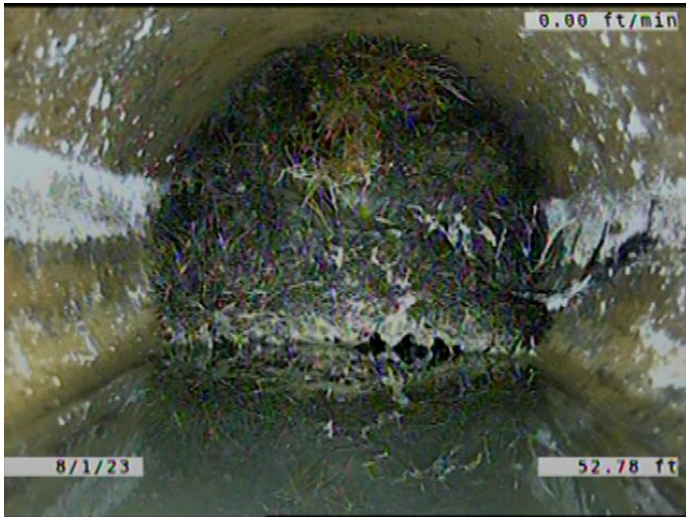
Code: **MWLS**  
Description: **Miscellaneous Water Level Sag**

Distance (ft): **52.8**  
Structural Grade: **2**  
O&M Grade: **0**  
Clock Start/From:  
Clock To:  
1st Value:  
2nd Value:  
Value Percent: **15.000**  
Continuous Index: **F03**  
Within 8" of Joint: **NO**  
Remarks:

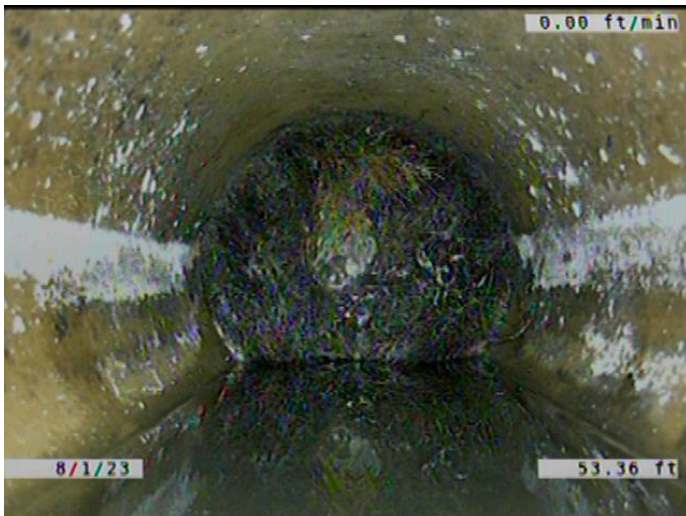
Code: **MSA**  
Description: **Miscellaneous Survey Abandoned**

Distance (ft): **53.4**  
Structural Grade: **0**  
O&M Grade: **0**  
Clock Start/From:  
Clock To:  
1st Value:  
2nd Value:  
Value Percent:  
Continuous Index:  
Within 8" of Joint: **NO**  
Remarks: **CAMERA CANT MAKE IT PAST ROOT BALL.**
