Profile/Photo Observation Report

Date:	03/24/2018	Weather:		Coding:	PACP 6.0
Pipe Length (ft):	140.8	Owner:	NA	Pre Clean:	Not Known
P.O.#:		Surveyor:	Byrd Fitzgerald	PSR:	P-902-018-017
Customer:		Clean Date:	01/01/1900	Shape:	C

Street:	E 34TH CT	Flow Control:	Not Controlled
City:	Hobart, IN	Year Renewed:	
Location:	Other	Tape/Media #:	
Purpose:	Not Known	Dia/Height:	10"
Use:	Sanitary	Material:	VCP
Drain Area:	NA	Lining:	
Category:	NA		
Comment:

Location Details:		Direction of Survey:	Downstream
US MH:	M-902-017	DS MH:	M-902-018
		Total Length Surveyed (ft):	45.2

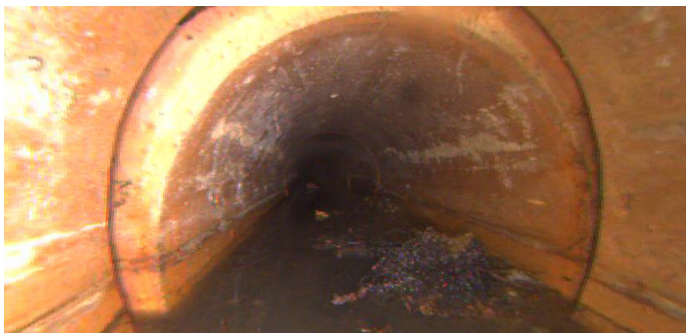
Code: **AMH**
Description: **Manhole**

Distance (ft): **.0**
Structural Grade: **0**
O&M Grade: **0**
Clock Start/From:
Clock To:
1st Value:
2nd Value:
Value Percent:
Continuous Index:
Within 8" of Joint: **NO**
Remarks: **M-902-017**

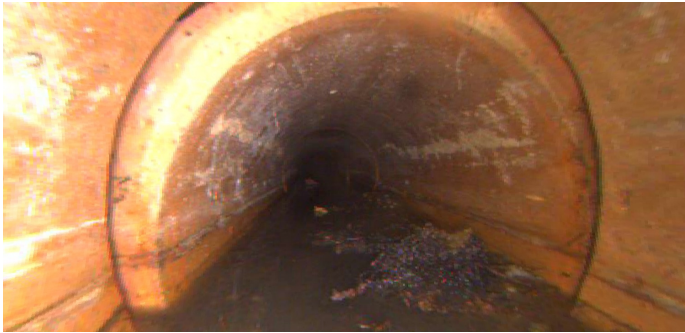
Code:	MWL
Description:	Water Level

Distance (ft):	.0
Structural Grade:	0
O&M Grade:	0
Clock Start/From:	
Clock To:	
1st Value:	
2nd Value:	
Value Percent:	5.000
Continuous Index:	
Within 8" of Joint:	NO
Remarks:

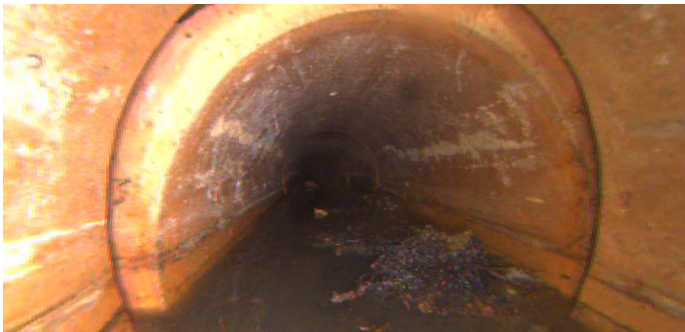
Code:	DSZ
Description:	Deposits Settled Other

Distance (ft):	.0
Structural Grade:	0
O&M Grade:	2
Clock Start/From:	6
Clock To:	
1st Value:	
2nd Value:	
Value Percent:	10.000
Continuous Index:	S01
Within 8" of Joint:	NO
Remarks:	loose roots/debris

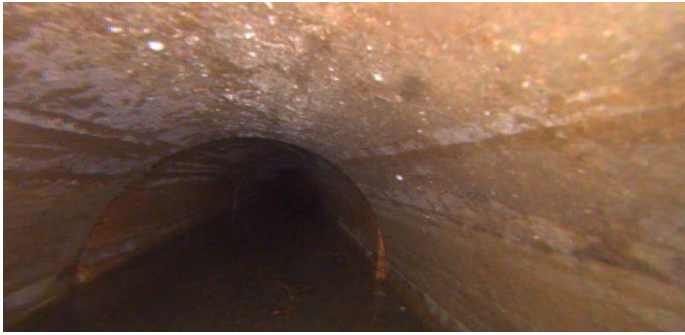
Code: **MWL**
Description: **Water Level**

Distance (ft): **15.0**
Structural Grade: **0**
O&M Grade: **0**
Clock Start/From:
Clock To:
1st Value:
2nd Value:
Value Percent: **25.000**
Continuous Index:
Within 8" of Joint: **NO**
Remarks:

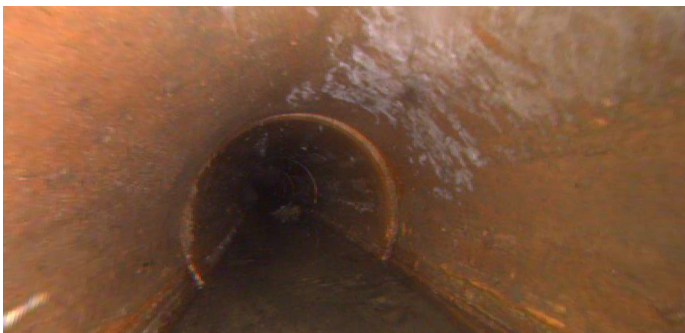
Code: **MWL**
Description: **Water Level**

Distance (ft): **40.9**
Structural Grade: **0**
O&M Grade: **0**
Clock Start/From:
Clock To:
1st Value:
2nd Value:
Value Percent: **5.000**
Continuous Index:
Within 8" of Joint: **NO**
Remarks:

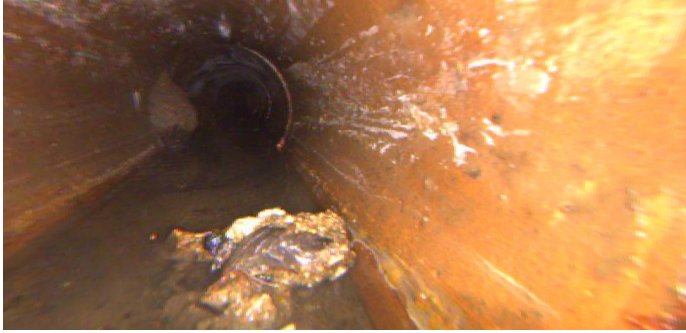
Code: **DSC**
Description: **Deposits Settled Compacted**

Distance (ft): **43.9**
Structural Grade: **0**
O&M Grade: **2**
Clock Start/From: **6**
Clock To:
1st Value:
2nd Value:
Value Percent: **10.000**
Continuous Index:
Within 8" of Joint: **NO**
Remarks: **hard deposits**

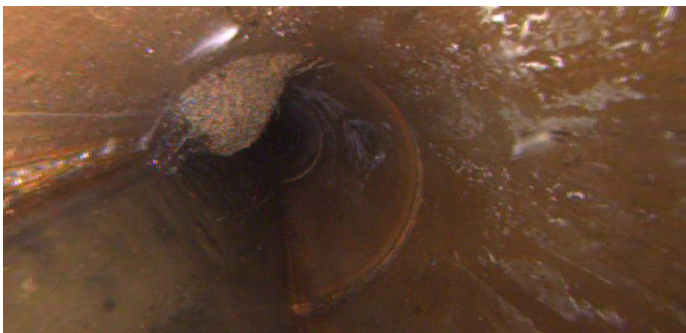
Code: **MSA**
Description: **Abandoned Survey**

Distance (ft): **45.2**
Structural Grade: **0**
O&M Grade: **0**
Clock Start/From:
Clock To:
1st Value:
2nd Value:
Value Percent:
Continuous Index:
Within 8" of Joint: **NO**
Remarks: **camera flipped**

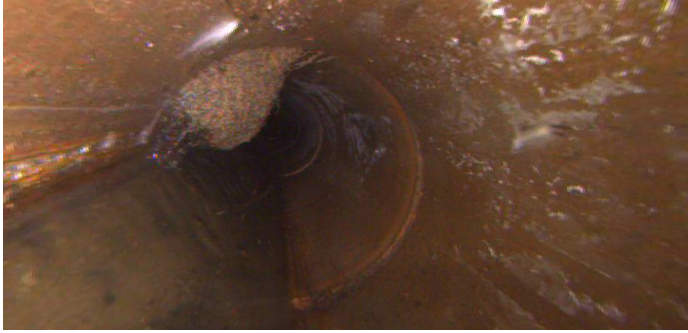
Code:	DSZ
Description:	Deposits Settled Other
Distance (ft):	45.2
Structural Grade:	0
O&M Grade:	2
Clock Start/From:	6
Clock To:	
1st Value:	
2nd Value:	
Value Percent:	10.000
Continuous Index:	F01
Within 8" of Joint:	NO
Remarks:	loose roots/debris
