Profile/Photo Observation Report

Date:	03/24/2018	Weather:		Coding:	PACP 6.0
Pipe Length (ft):	140.8	Owner:	NA	Pre Clean:	Not Known
P.O.#:		Surveyor:	Byrd Fitzgerald	PSR:	P-902-018-017
Customer:		Clean Date:	01/01/1900	Shape:	C

Street:	e 34th ct	Flow Control:	Not Controlled
City:	Hobart, IN	Year Renewed:	
Location:	Other	Tape/Media #:	
Purpose:	Not Known	Dia/Height:	10"
Use:	Sanitary	Material:	VCP
Drain Area:	NA	Lining:	
Category:	NA		
Comment:

Location Details:		Direction of Survey:	Downstream
US MH:	M-902-017	DS MH:	M-902-018
		Total Length Surveyed (ft):	45.2

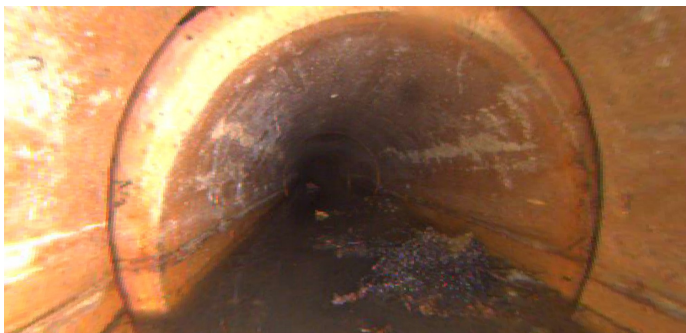
Code: **AMH**
Description: **Manhole**

Distance (ft): **.0**
Structural Grade: **0**
O&M Grade: **0**
Clock Start/From:
Clock To:
1st Value:
2nd Value:
Value Percent:
Continuous Index:
Within 8" of Joint: **NO**
Remarks: **M-902-017**

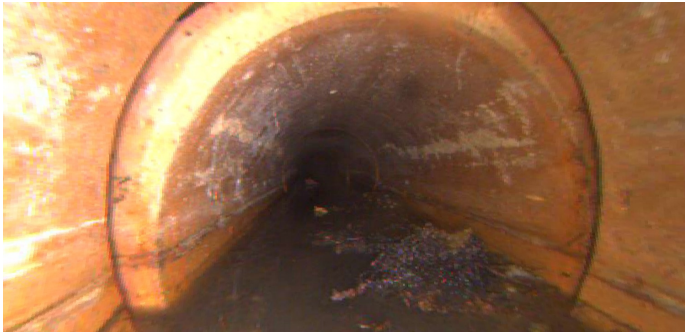
Code:	MWL
Description:	Water Level

Distance (ft):	.0
Structural Grade:	0
O&M Grade:	0
Clock Start/From:	
Clock To:	
1st Value:	
2nd Value:	
Value Percent:	5.000
Continuous Index:	
Within 8" of Joint:	NO
Remarks:

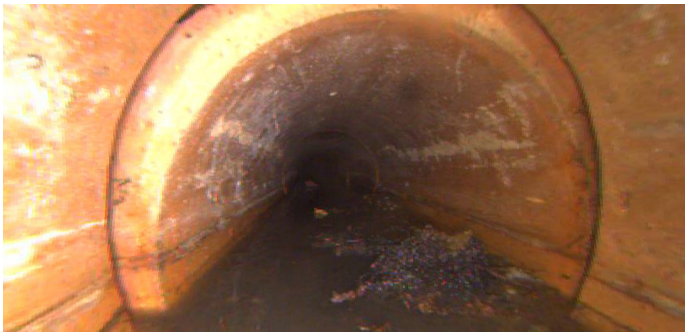
Code:	DSZ
Description:	Deposits Settled Other

Distance (ft):	.0
Structural Grade:	0
O&M Grade:	2
Clock Start/From:	6
Clock To:	
1st Value:	
2nd Value:	
Value Percent:	10.000
Continuous Index:	S01
Within 8" of Joint:	NO
Remarks:	loose roots/debris

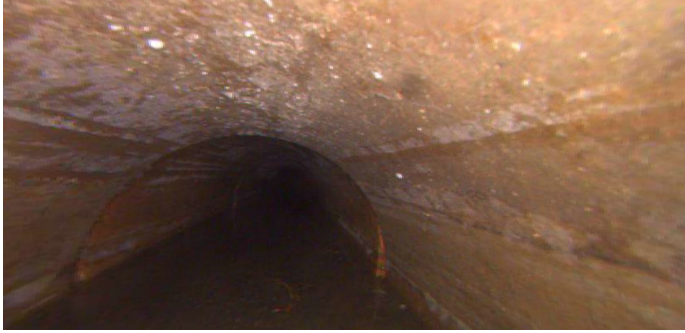
Code: **MWL**
Description: **Water Level**

Distance (ft): **15.0**
Structural Grade: **0**
O&M Grade: **0**
Clock Start/From:
Clock To:
1st Value:
2nd Value:
Value Percent: **25.000**
Continuous Index:
Within 8" of Joint: **NO**
Remarks:

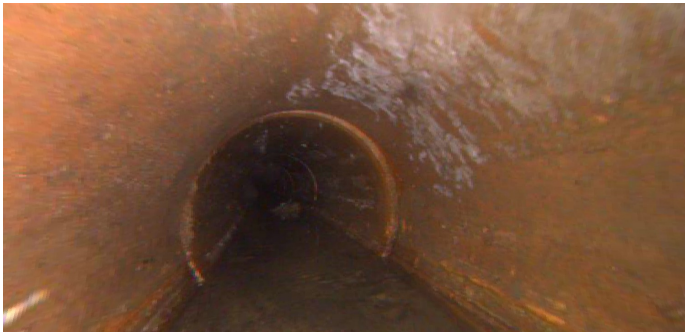
Code: **MWL**
Description: **Water Level**

Distance (ft): **40.9**
Structural Grade: **0**
O&M Grade: **0**
Clock Start/From:
Clock To:
1st Value:
2nd Value:
Value Percent: **5.000**
Continuous Index:
Within 8" of Joint: **NO**
Remarks:

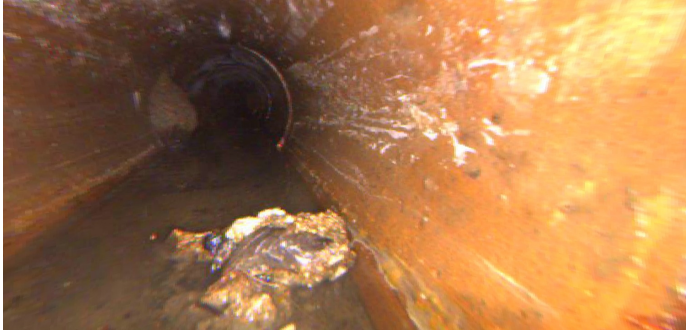
Code: **DSC**
Description: **Deposits Settled Compacted**

Distance (ft): **43.9**
Structural Grade: **0**
O&M Grade: **2**
Clock Start/From: **6**
Clock To:
1st Value:
2nd Value:
Value Percent: **10.000**
Continuous Index:
Within 8" of Joint: **NO**
Remarks: **hard deposits**

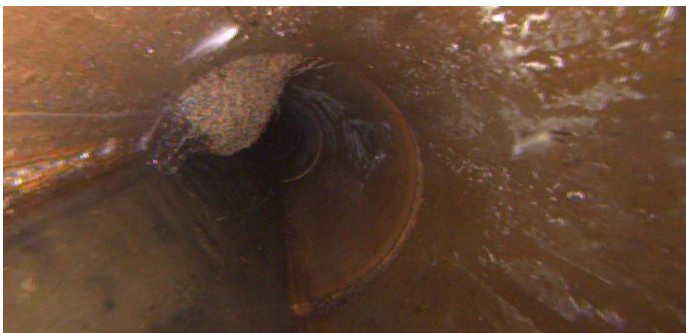
Code: **MSA**
Description: **Abandoned Survey**

Distance (ft): **45.2**
Structural Grade: **0**
O&M Grade: **0**
Clock Start/From:
Clock To:
1st Value:
2nd Value:
Value Percent:
Continuous Index:
Within 8" of Joint: **NO**
Remarks: **camera flipped**

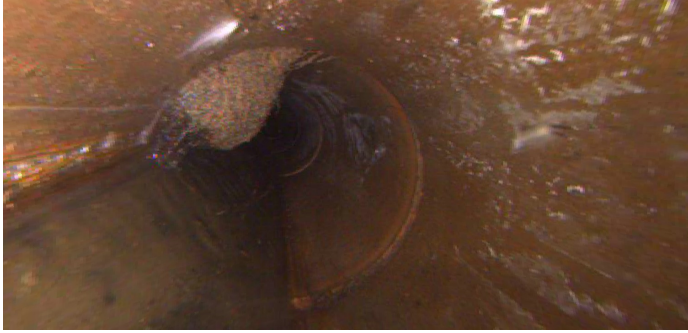
Code:	DSZ
Description:	Deposits Settled Other
Distance (ft):	45.2
Structural Grade:	0
O&M Grade:	2
Clock Start/From:	6
Clock To:	
1st Value:	
2nd Value:	
Value Percent:	10.000
Continuous Index:	F01
Within 8" of Joint:	NO
Remarks:	loose roots/debris
