Profile/Photo Observation Report

| Customer: | City of Hobart | Clean Date: | 06/01/2023 | Shape: | C |

| Street: | East 34th Court | Flow Control: | Not Controlled |
| US MH: | M-902-017 | DS MH: | M-902-018 |

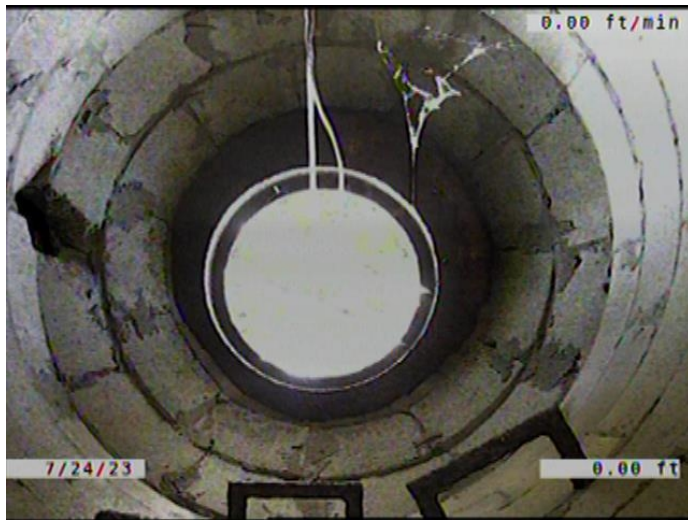
Code: **AMH**
Description: **Manhole**

Distance (ft): **.0**
Structural Grade: **0**
O&M Grade: **0**
Clock Start/From:
Clock To:
1st Value:
2nd Value:
Value Percent:
Continuous Index:
Within 8" of Joint: **NO**
Remarks: **M-902-017**

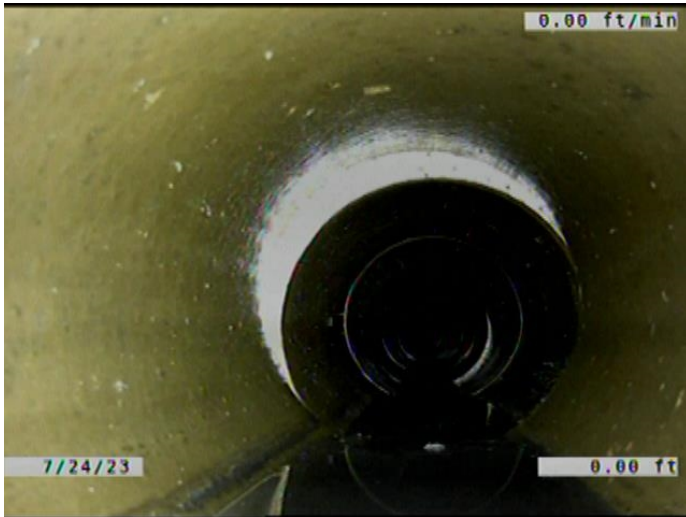
Code: **MWL**
Description: **Miscellaneous Water Level**

Distance (ft): **.0**
Structural Grade: **0**
O&M Grade: **0**
Clock Start/From:
Clock To:
1st Value:
2nd Value:
Value Percent: **5.000**
Continuous Index:
Within 8" of Joint: **NO**
Remarks:

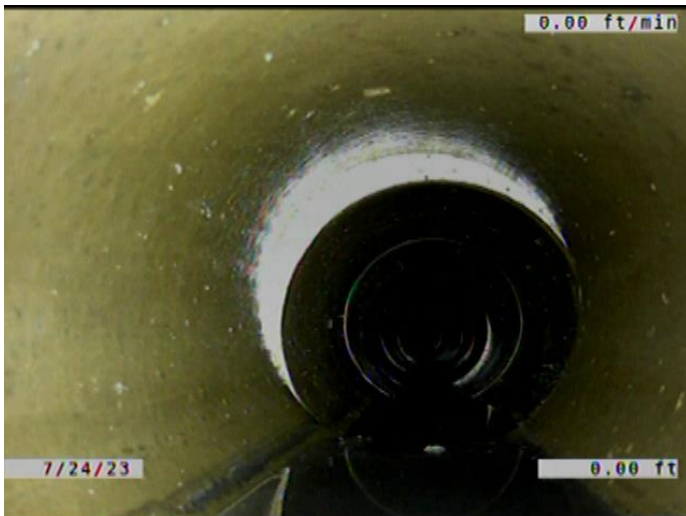
Code: **DSF**
Description: **Deposits Settled Fine**

Distance (ft): **.0**
Structural Grade: **0**
O&M Grade: **2**
Clock Start/From: **5**
Clock To: **7**
1st Value:
2nd Value:
Value Percent: **5.000**
Continuous Index: **S01**
Within 8" of Joint: **YES**
Remarks:

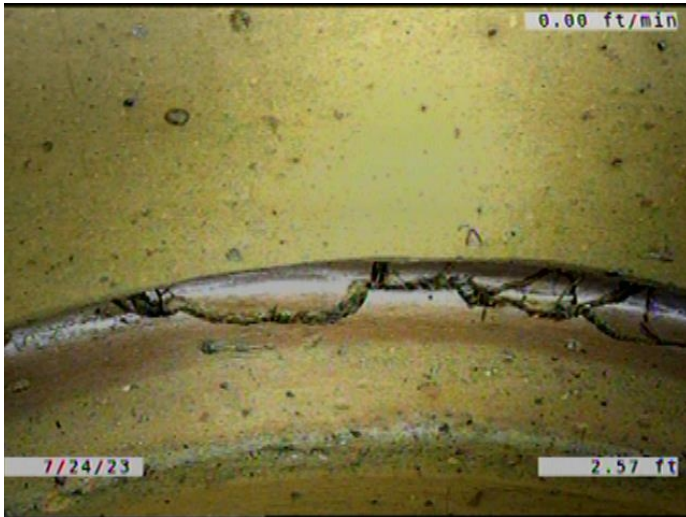
Code: **B**
 Description: **Broken**

Distance (ft): **2.6**
 Structural Grade: **4**
 O&M Grade: **0**
 Clock Start/From: **10**
 Clock To: **2**
 1st Value:
 2nd Value:
 Value Percent:
 Continuous Index:
 Within 8" of Joint: **YES**
 Remarks:

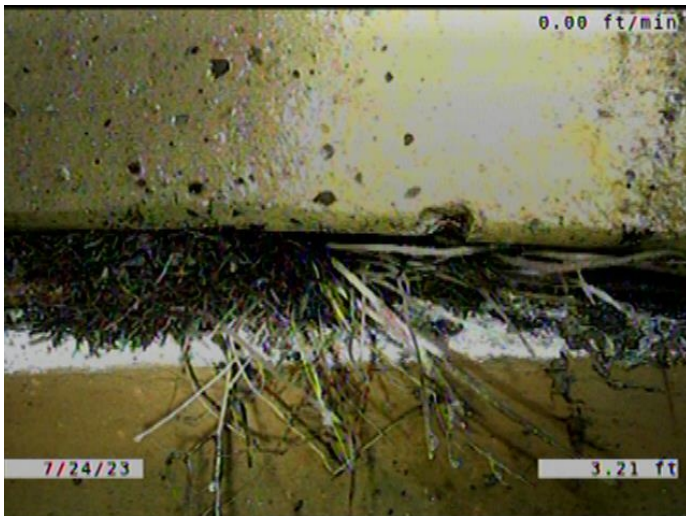
Code: **RFJ**
 Description: **Roots Fine Joint**

Distance (ft): **3.2**
 Structural Grade: **0**
 O&M Grade: **1**
 Clock Start/From: **7**
 Clock To: **5**
 1st Value:
 2nd Value:
 Value Percent:
 Continuous Index:
 Within 8" of Joint: **YES**
 Remarks:

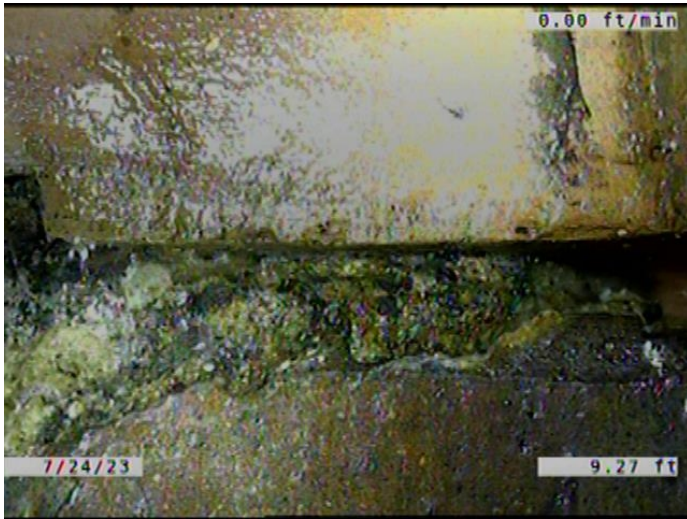
Code: **DAE**
Description: **Deposits Attached Encrustation**

Distance (ft): **9.3**
Structural Grade: **0**
O&M Grade: **2**
Clock Start/From: **4**
Clock To: **8**
1st Value:
2nd Value:
Value Percent: **5.000**
Continuous Index: **S02**
Within 8" of Joint: **YES**
Remarks:

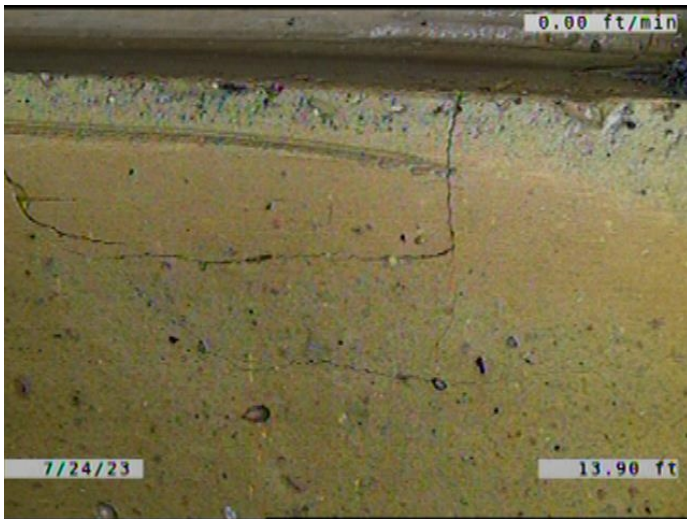
Code: **CM**
Description: **Crack Multiple**

Distance (ft): **13.9**
Structural Grade: **3**
O&M Grade: **0**
Clock Start/From: **1**
Clock To: **4**
1st Value:
2nd Value:
Value Percent:
Continuous Index:
Within 8" of Joint: **YES**
Remarks:

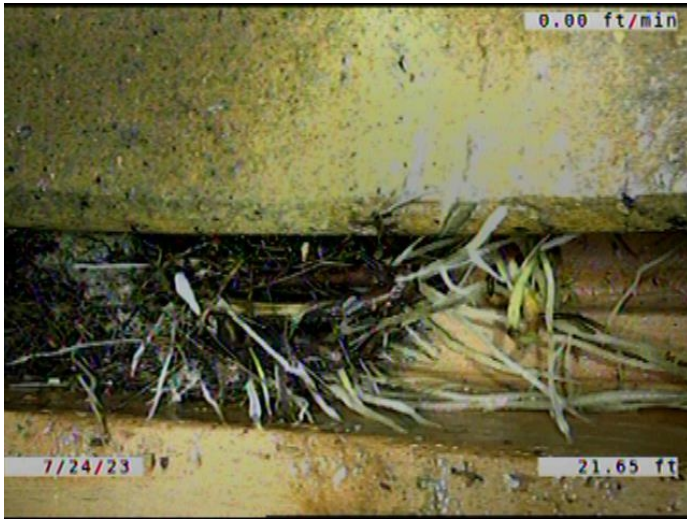
Code: **RFJ**
Description: **Roots Fine Joint**

Distance (ft): **21.6**
Structural Grade: **0**
O&M Grade: **1**
Clock Start/From: **8**
Clock To: **4**
1st Value:
2nd Value:
Value Percent:
Continuous Index:
Within 8" of Joint: **YES**
Remarks:

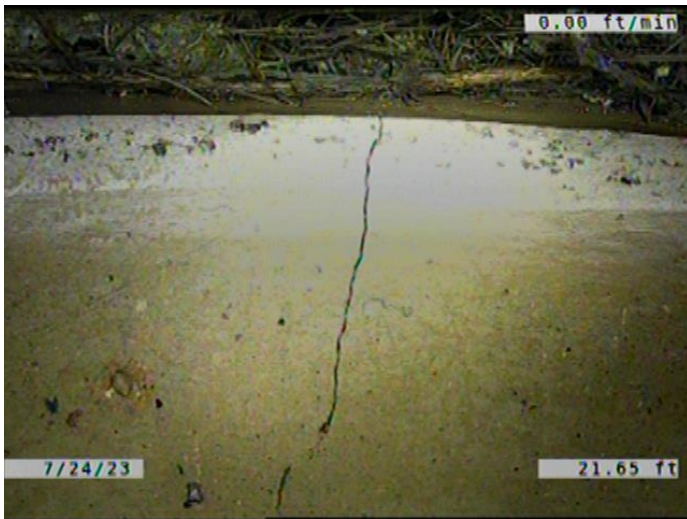
Code: **CM**
Description: **Crack Multiple**

Distance (ft): **21.6**
Structural Grade: **3**
O&M Grade: **0**
Clock Start/From: **11**
Clock To: **1**
1st Value:
2nd Value:
Value Percent:
Continuous Index:
Within 8" of Joint: **YES**
Remarks:

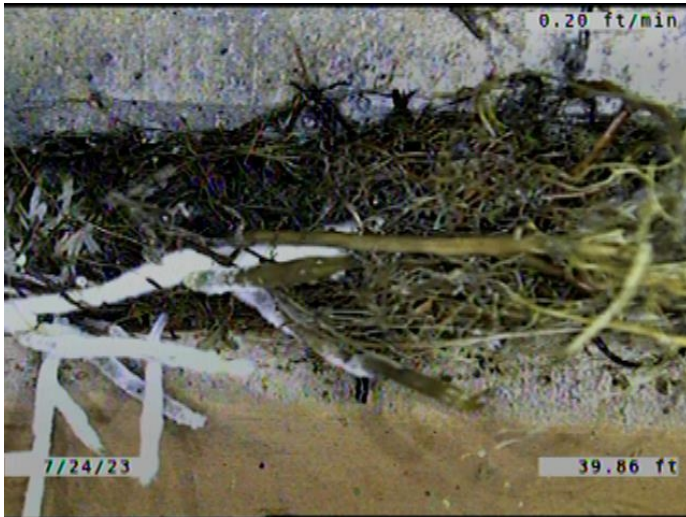
Code: **RMJ**
Description: **Roots Medium Joint**

Distance (ft): **39.8**
Structural Grade: **0**
O&M Grade: **3**
Clock Start/From: **8**
Clock To: **4**
1st Value:
2nd Value:
Value Percent: **5.000**
Continuous Index: **S03**
Within 8" of Joint: **YES**
Remarks:

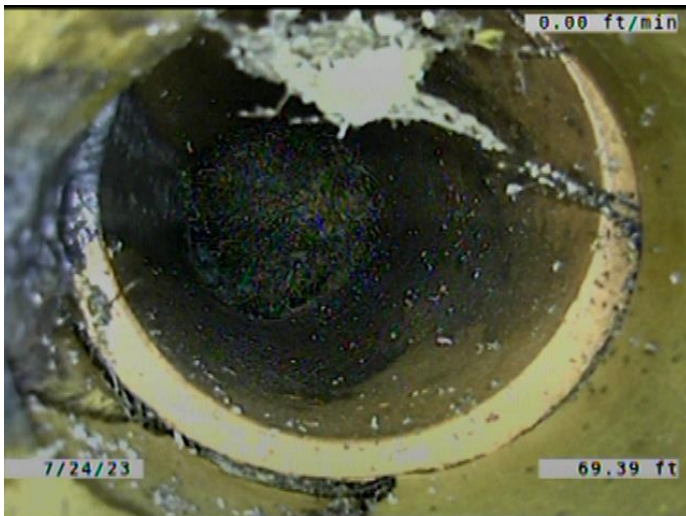
Code: **TFD**
Description: **Tap Factory Defective**

Distance (ft): **69.4**
Structural Grade: **0**
O&M Grade: **3**
Clock Start/From: **10**
Clock To:
1st Value: **6.000**
2nd Value:
Value Percent:
Continuous Index:
Within 8" of Joint: **YES**
Remarks: **TAP BROKEN. SOIL VISIBLE. SERVICE 95% PLUGGED WITH ROOTS.**

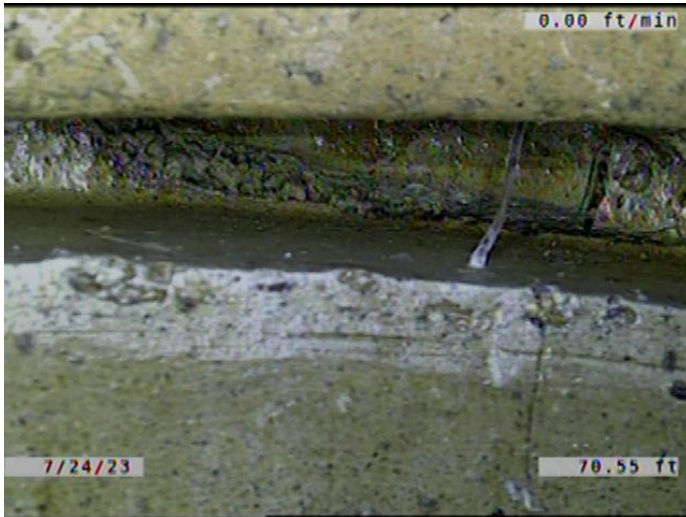
Code: **B**
Description: **Broken**

Distance (ft): **70.5**
Structural Grade: **4**
O&M Grade: **0**
Clock Start/From: **9**
Clock To: **4**
1st Value:
2nd Value:
Value Percent:
Continuous Index:
Within 8" of Joint: **YES**
Remarks:

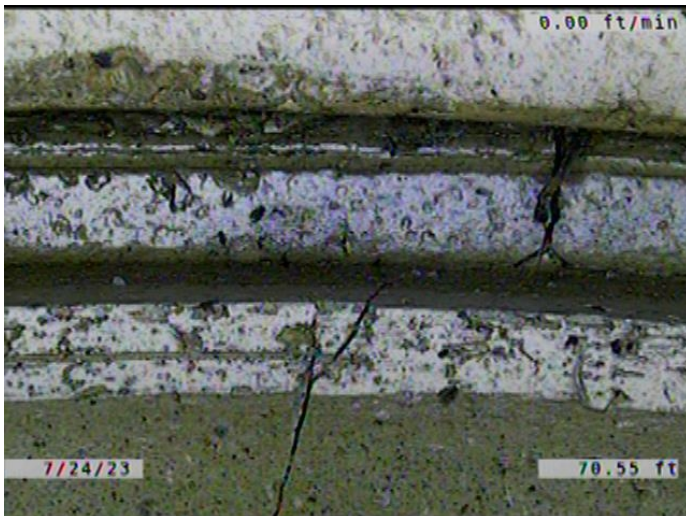
Code: **JAM**
Description: **Joint Angular Medium**

Distance (ft): **70.5**
Structural Grade: **3**
O&M Grade: **0**
Clock Start/From:
Clock To:
1st Value:
2nd Value:
Value Percent:
Continuous Index:
Within 8" of Joint: **NO**
Remarks:

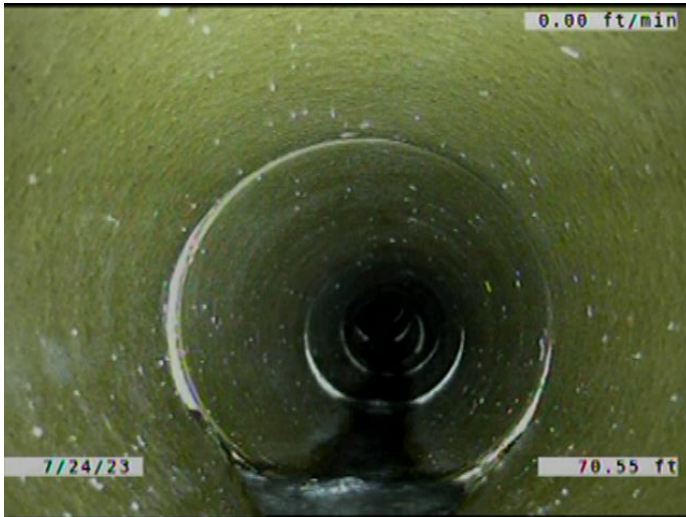
Code: **LD**
Description: **Line Down**

Distance (ft): **70.6**
Structural Grade: **0**
O&M Grade: **1**
Clock Start/From:
Clock To:
1st Value:
2nd Value:
Value Percent: **10.000**
Continuous Index:
Within 8" of Joint: **NO**
Remarks:

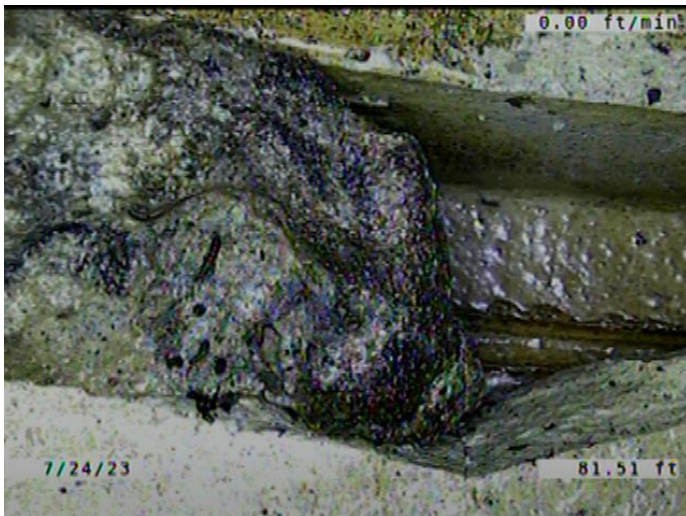
Code: **JAL**
Description: **Joint Angular Large**

Distance (ft): **81.5**
Structural Grade: **4**
O&M Grade: **0**
Clock Start/From:
Clock To:
1st Value:
2nd Value:
Value Percent:
Continuous Index:
Within 8" of Joint: **NO**
Remarks:

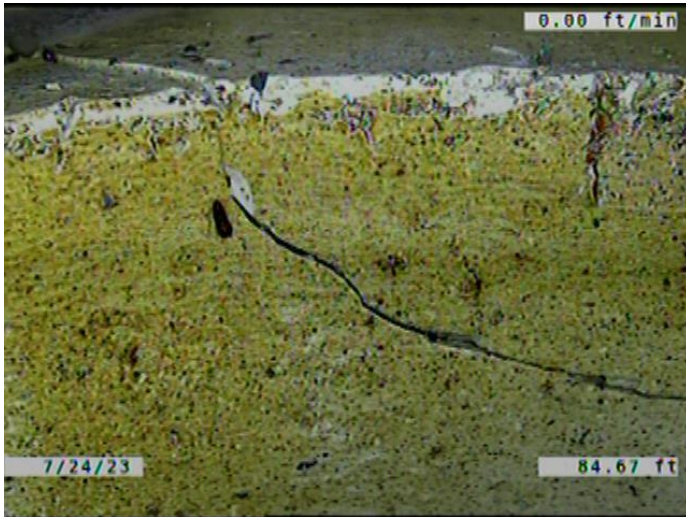
Code: **B**
Description: **Broken**

Distance (ft): **84.7**
Structural Grade: **4**
O&M Grade: **0**
Clock Start/From: **7**
Clock To: **2**
1st Value:
2nd Value:
Value Percent:
Continuous Index:
Within 8" of Joint: **YES**
Remarks:

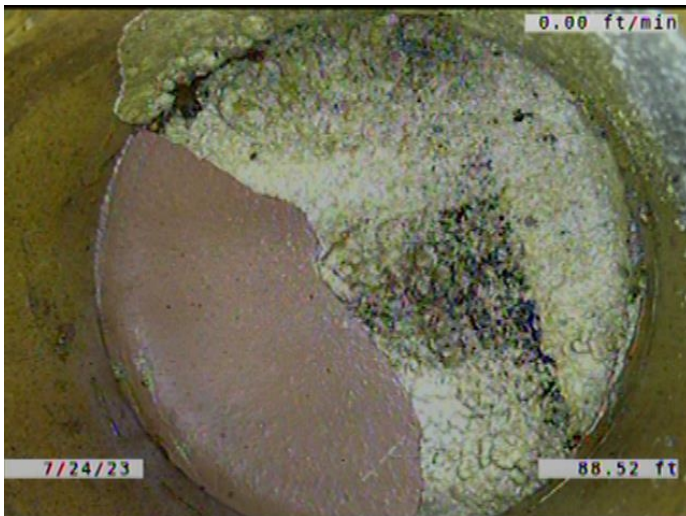
Code: **TFD**
Description: **Tap Factory Defective**

Distance (ft): **88.5**
Structural Grade: **0**
O&M Grade: **3**
Clock Start/From: **2**
Clock To:
1st Value: **6.000**
2nd Value:
Value Percent:
Continuous Index:
Within 8" of Joint: **YES**
Remarks: **CAPPED. ENCRUSTATION COMING AROUND THE CAP.**

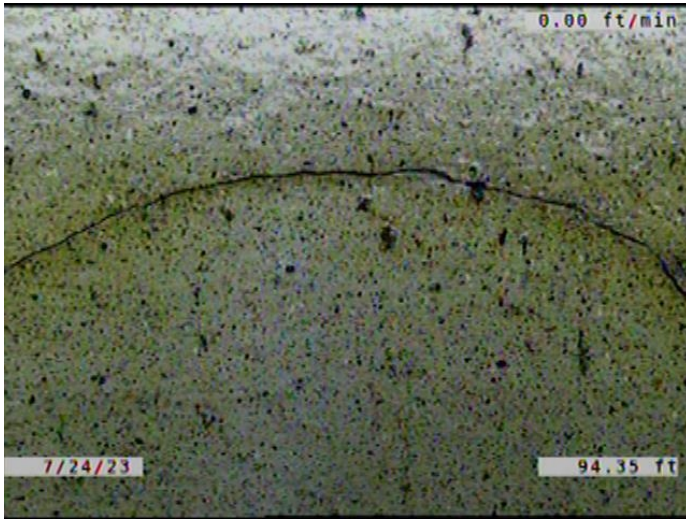
Code: **CM**
Description: **Crack Multiple**

Distance (ft): **94.3**
Structural Grade: **3**
O&M Grade: **0**
Clock Start/From: **9**
Clock To: **3**
1st Value:
2nd Value:
Value Percent:
Continuous Index:
Within 8" of Joint: **YES**
Remarks:

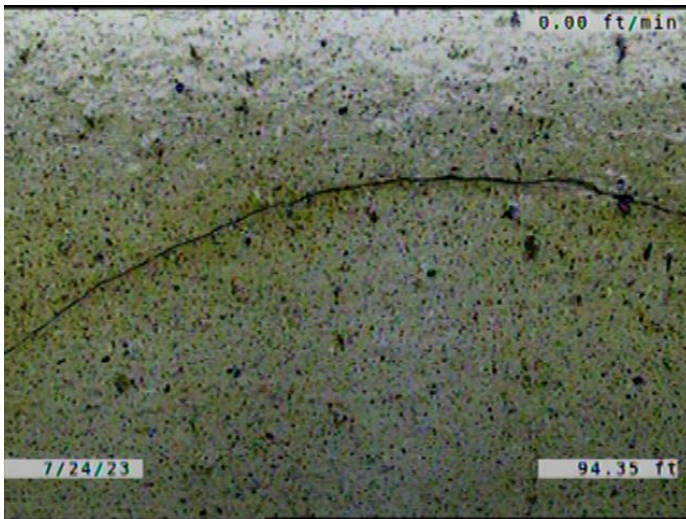
Code: **IWB**
Description: **Infiltration Weeper Barrel**

Distance (ft): **94.3**
Structural Grade: **0**
O&M Grade: **2**
Clock Start/From: **9**
Clock To: **3**
1st Value:
2nd Value:
Value Percent:
Continuous Index:
Within 8" of Joint: **YES**
Remarks:

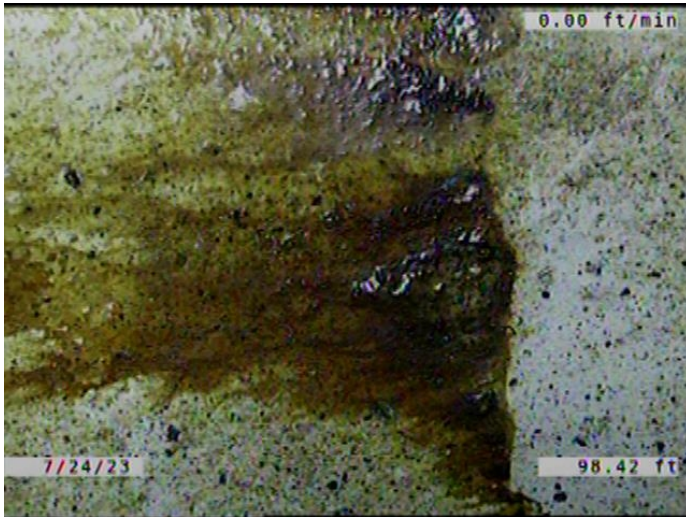
Code: **ISB**
 Description: **Infiltration Stain Barrel**

Distance (ft): **98.4**
 Structural Grade: **0**
 O&M Grade: **1**
 Clock Start/From: **7**
 Clock To: **10**
 1st Value:
 2nd Value:
 Value Percent:
 Continuous Index:
 Within 8" of Joint: **YES**
 Remarks:

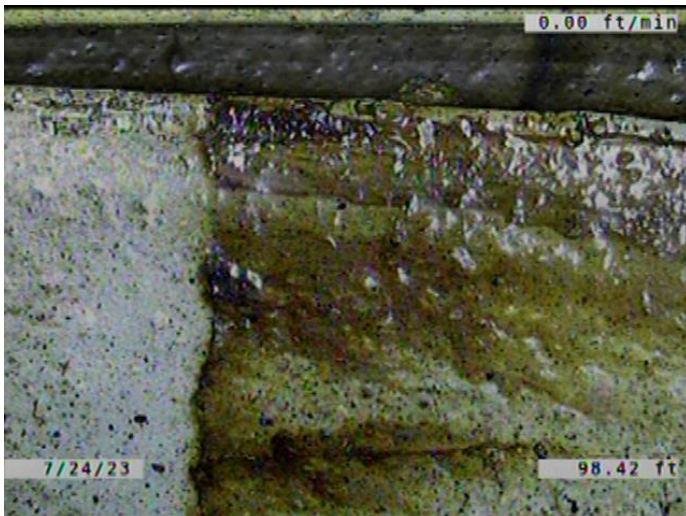
Code: **CM**
 Description: **Crack Multiple**

Distance (ft): **98.4**
 Structural Grade: **3**
 O&M Grade: **0**
 Clock Start/From: **9**
 Clock To: **3**
 1st Value:
 2nd Value:
 Value Percent:
 Continuous Index:
 Within 8" of Joint: **YES**
 Remarks:

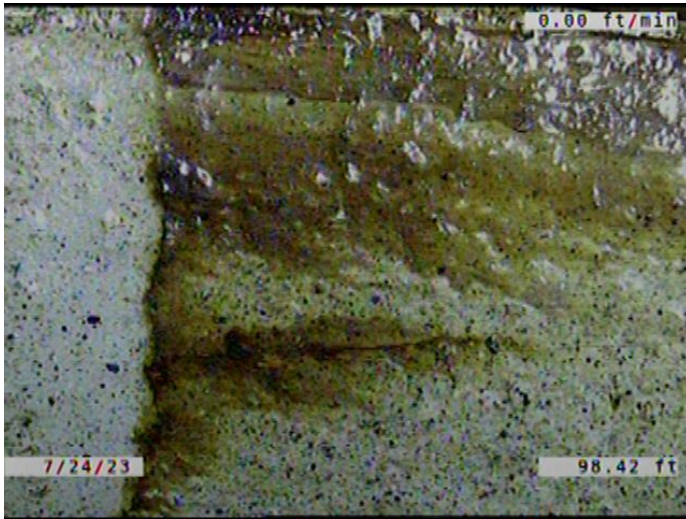
Code: **ISB**
Description: **Infiltration Stain Barrel**

Distance (ft): **98.4**
Structural Grade: **0**
O&M Grade: **1**
Clock Start/From: **1**
Clock To: **5**
1st Value:
2nd Value:
Value Percent:
Continuous Index:
Within 8" of Joint: **YES**
Remarks:

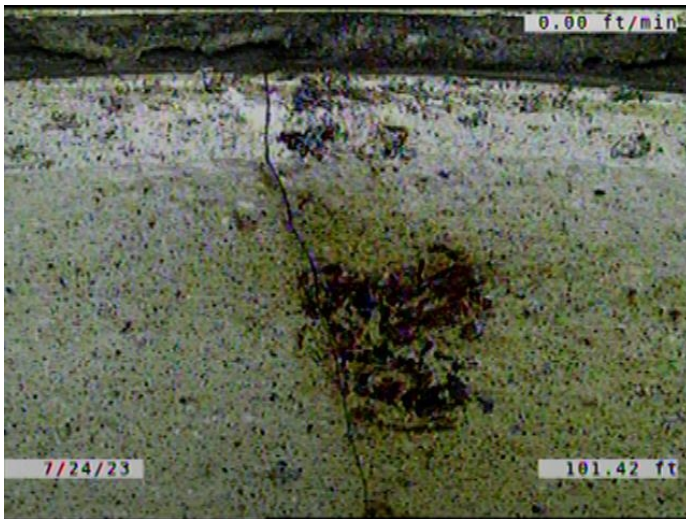
Code: **CM**
Description: **Crack Multiple**

Distance (ft): **101.4**
Structural Grade: **3**
O&M Grade: **0**
Clock Start/From: **12**
Clock To: **2**
1st Value:
2nd Value:
Value Percent:
Continuous Index:
Within 8" of Joint: **YES**
Remarks:

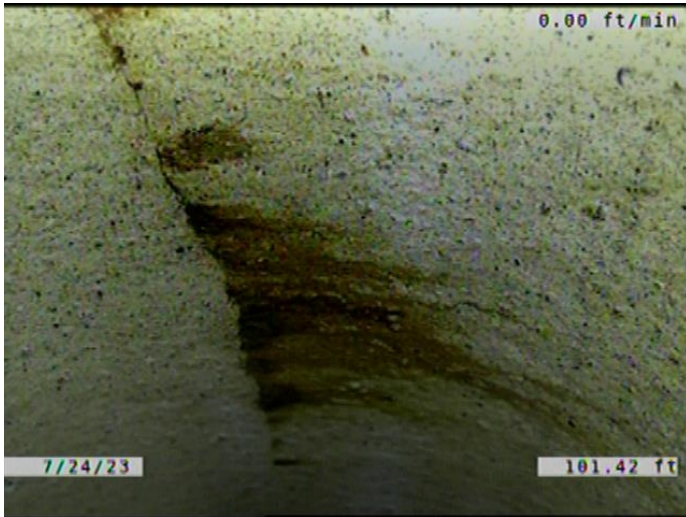
Code: **ISB**
Description: **Infiltration Stain Barrel**

Distance (ft): **101.4**
Structural Grade: **0**
O&M Grade: **1**
Clock Start/From: **12**
Clock To: **4**
1st Value:
2nd Value:
Value Percent:
Continuous Index:
Within 8" of Joint: **YES**
Remarks:

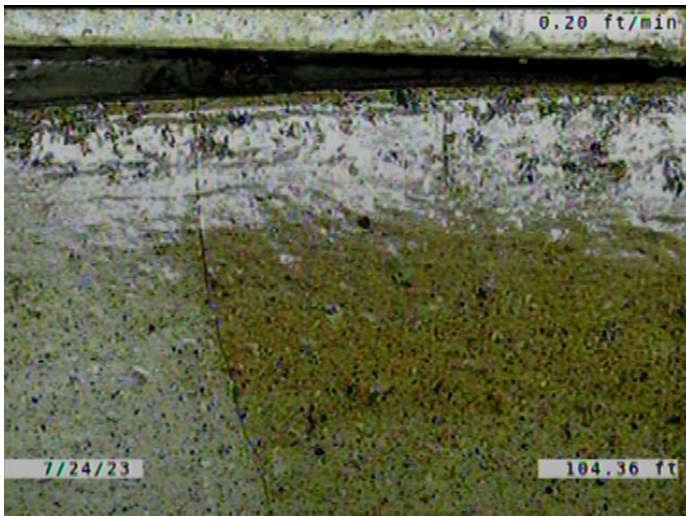
Code: **CM**
Description: **Crack Multiple**

Distance (ft): **104.4**
Structural Grade: **3**
O&M Grade: **0**
Clock Start/From: **1**
Clock To: **2**
1st Value:
2nd Value:
Value Percent:
Continuous Index:
Within 8" of Joint: **YES**
Remarks:

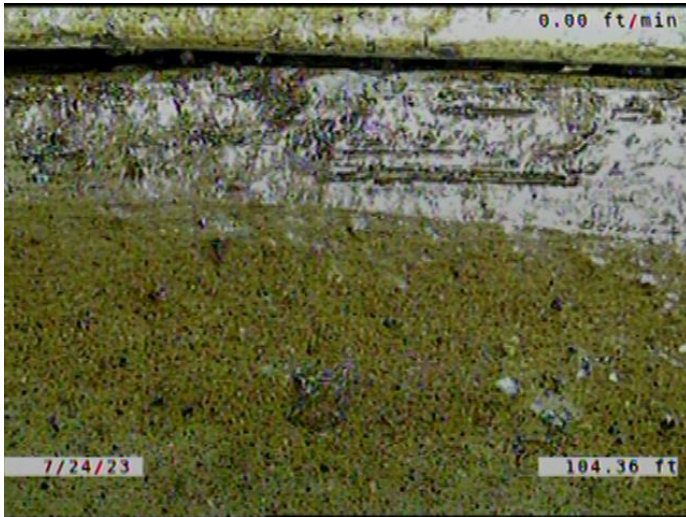
Code: **ISB**
Description: **Infiltration Stain Barrel**

Distance (ft): **104.4**
Structural Grade: **0**
O&M Grade: **1**
Clock Start/From: **1**
Clock To: **5**
1st Value:
2nd Value:
Value Percent:
Continuous Index:
Within 8" of Joint: **YES**
Remarks:

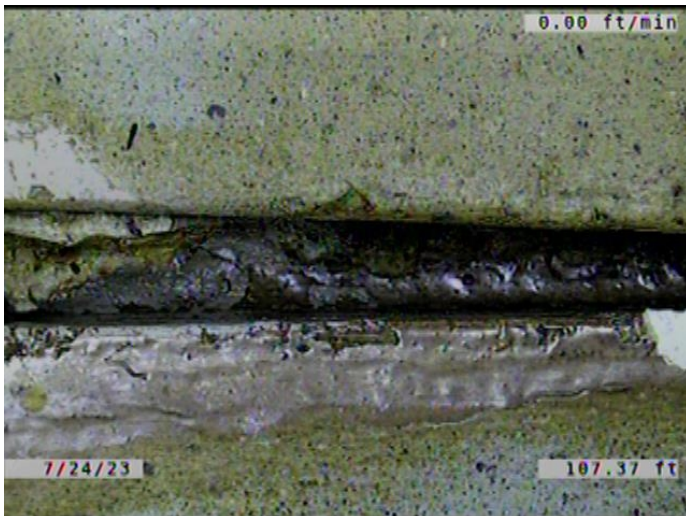
Code: **ISJ**
Description: **Infiltration Stain Joint**

Distance (ft): **107.4**
Structural Grade: **0**
O&M Grade: **1**
Clock Start/From: **7**
Clock To: **12**
1st Value:
2nd Value:
Value Percent:
Continuous Index:
Within 8" of Joint: **YES**
Remarks:

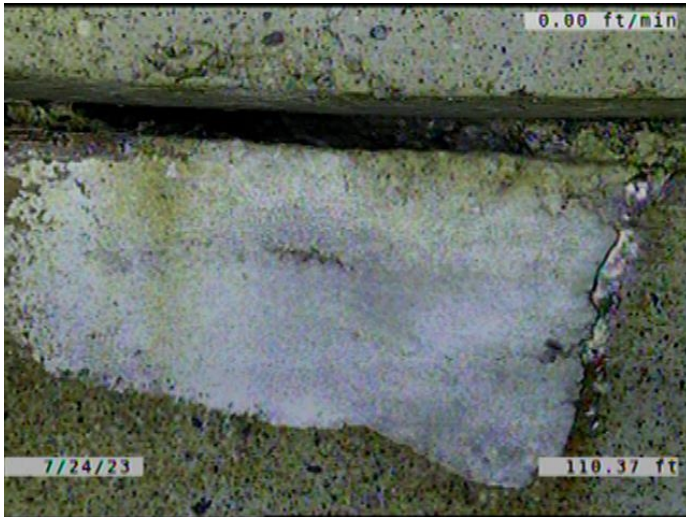
Code: **DAE**
Description: **Deposits Attached Encrustation**

Distance (ft): **110.4**
Structural Grade: **0**
O&M Grade: **2**
Clock Start/From: **7**
Clock To: **2**
1st Value:
2nd Value:
Value Percent: **5.000**
Continuous Index:
Within 8" of Joint: **YES**
Remarks:

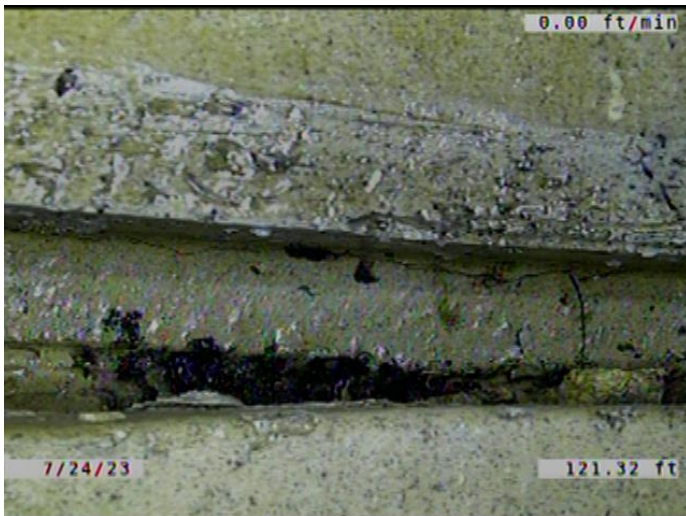
Code: **CM**
Description: **Crack Multiple**

Distance (ft): **121.3**
Structural Grade: **3**
O&M Grade: **0**
Clock Start/From: **7**
Clock To: **5**
1st Value:
2nd Value:
Value Percent:
Continuous Index:
Within 8" of Joint: **YES**
Remarks:

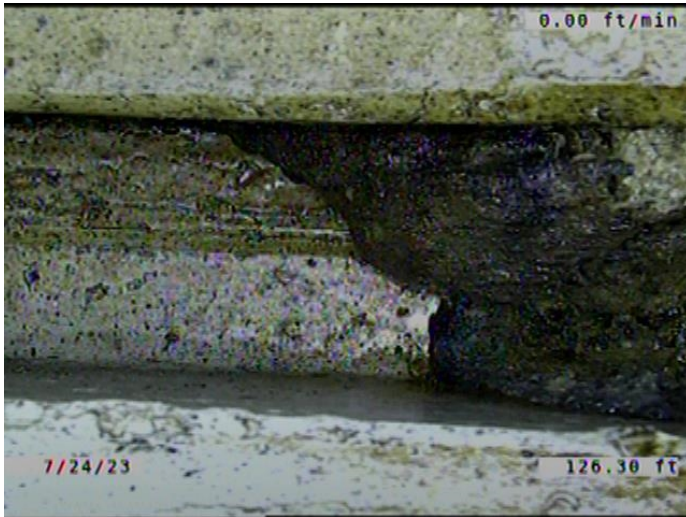
Code: **JAL**
Description: **Joint Angular Large**

Distance (ft): **126.3**
Structural Grade: **4**
O&M Grade: **0**
Clock Start/From:
Clock To:
1st Value:
2nd Value:
Value Percent:
Continuous Index:
Within 8" of Joint: **NO**
Remarks:

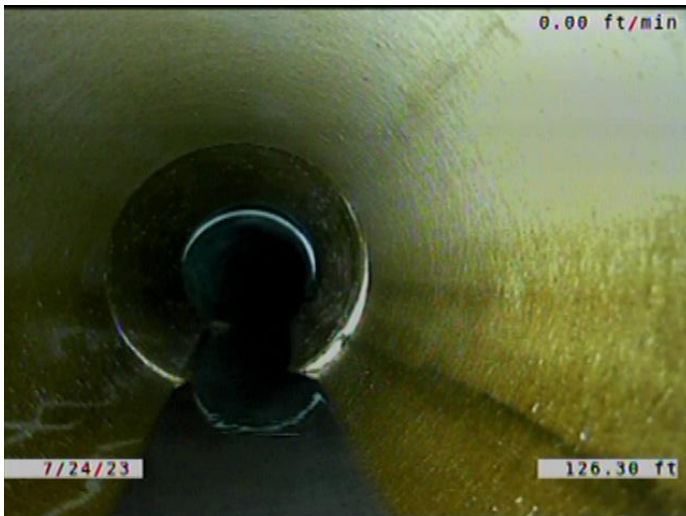
Code: **LL**
Description: **Line Left**

Distance (ft): **126.3**
Structural Grade: **0**
O&M Grade: **1**
Clock Start/From:
Clock To:
1st Value:
2nd Value:
Value Percent: **10.000**
Continuous Index:
Within 8" of Joint: **NO**
Remarks:

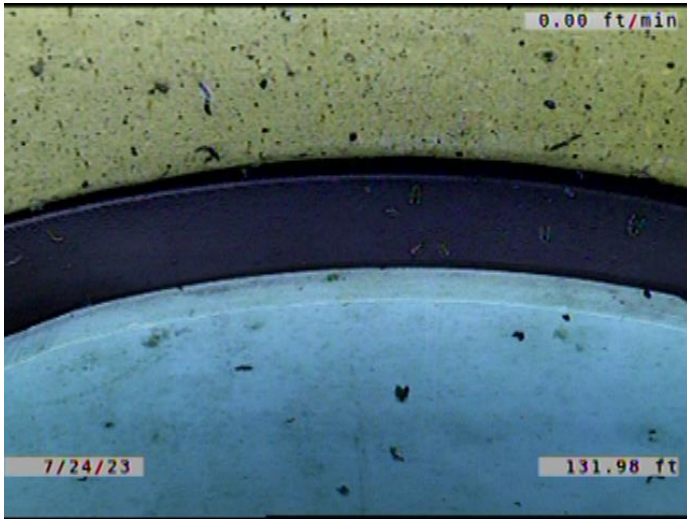
Code: **JAM**
Description: **Joint Angular Medium**

Distance (ft): **132.0**
Structural Grade: **3**
O&M Grade: **0**
Clock Start/From:
Clock To:
1st Value:
2nd Value:
Value Percent:
Continuous Index:
Within 8" of Joint: **NO**
Remarks:

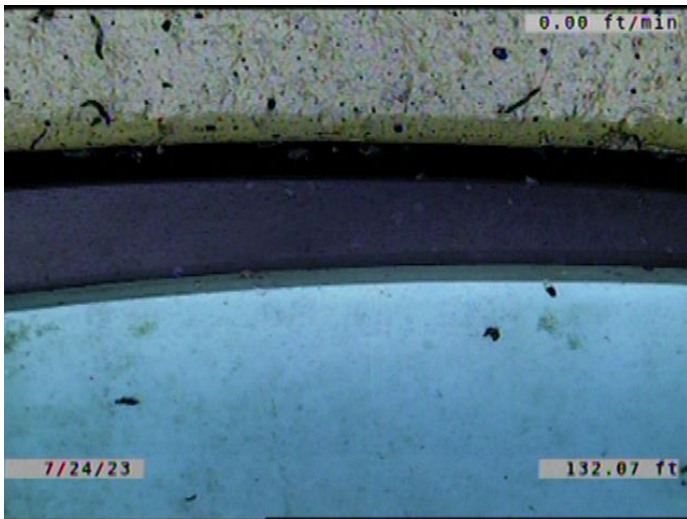
Code: **MMC**
Description: **Miscellaneous Material Change**

Distance (ft): **132.1**
Structural Grade: **0**
O&M Grade: **0**
Clock Start/From:
Clock To:
1st Value:
2nd Value:
Value Percent:
Continuous Index:
Within 8" of Joint: **NO**
Remarks: **VCP TO PVC**

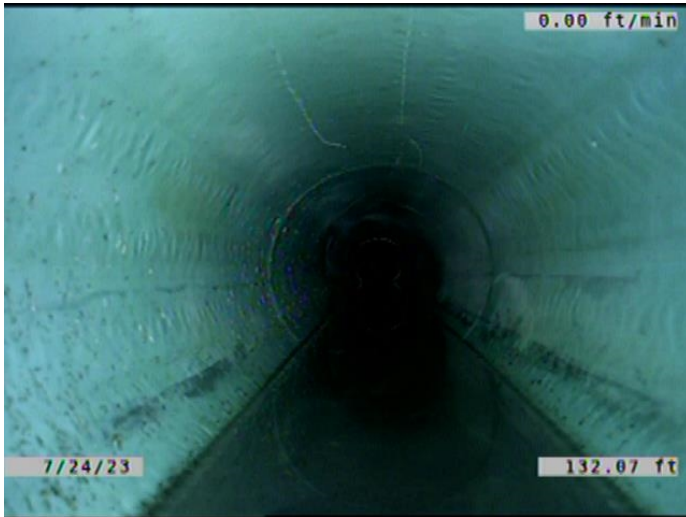
Code: **MWLS**
Description: **Miscellaneous Water Level Sag**

Distance (ft): **132.1**
Structural Grade: **2**
O&M Grade: **0**
Clock Start/From:
Clock To:
1st Value:
2nd Value:
Value Percent: **15.000**
Continuous Index: **S04**
Within 8" of Joint: **NO**
Remarks:

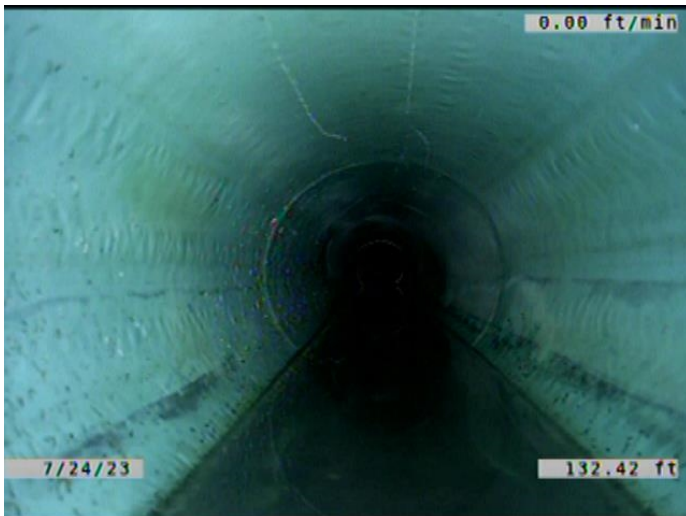
Code: **RMJ**
Description: **Roots Medium Joint**

Distance (ft): **132.4**
Structural Grade: **0**
O&M Grade: **3**
Clock Start/From: **8**
Clock To: **4**
1st Value:
2nd Value:
Value Percent: **5.000**
Continuous Index: **F03**
Within 8" of Joint: **YES**
Remarks:

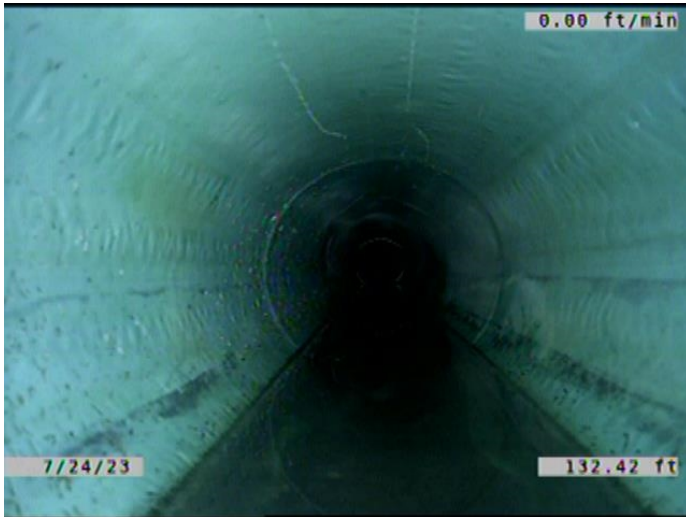
Code: **DAE**
Description: **Deposits Attached Encrustation**

Distance (ft): **132.4**
Structural Grade: **0**
O&M Grade: **2**
Clock Start/From: **4**
Clock To: **8**
1st Value:
2nd Value:
Value Percent: **5.000**
Continuous Index: **F02**
Within 8" of Joint: **YES**
Remarks:

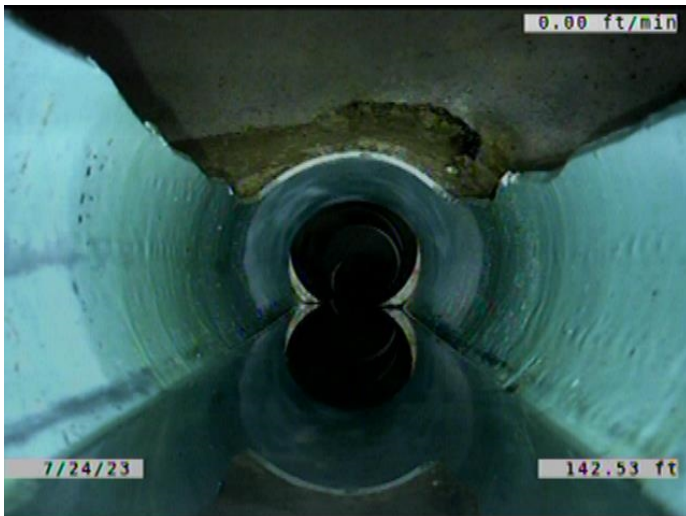
Code: **DSF**
Description: **Deposits Settled Fine**

Distance (ft): **142.5**
Structural Grade: **0**
O&M Grade: **2**
Clock Start/From: **5**
Clock To: **7**
1st Value:
2nd Value:
Value Percent: **5.000**
Continuous Index: **F01**
Within 8" of Joint: **YES**
Remarks:

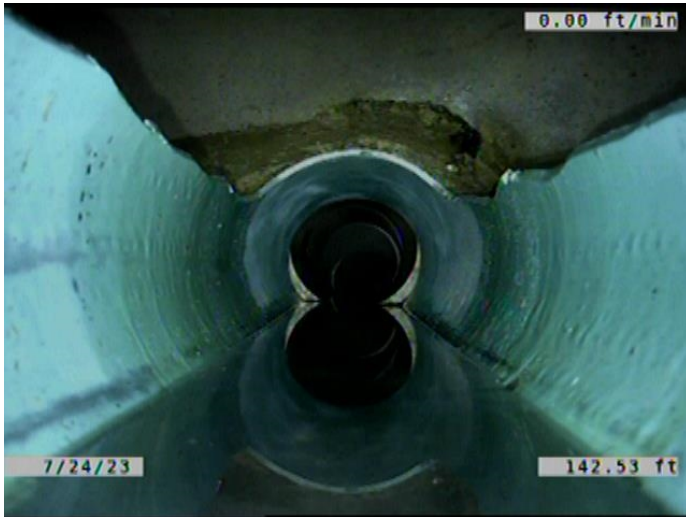
Code: **MWLS**
 Description: **Miscellaneous Water Level Sag**

Distance (ft): **142.5**
 Structural Grade: **2**
 O&M Grade: **0**
 Clock Start/From:
 Clock To:
 1st Value:
 2nd Value:
 Value Percent: **15.000**
 Continuous Index: **F04**
 Within 8" of Joint: **NO**
 Remarks:

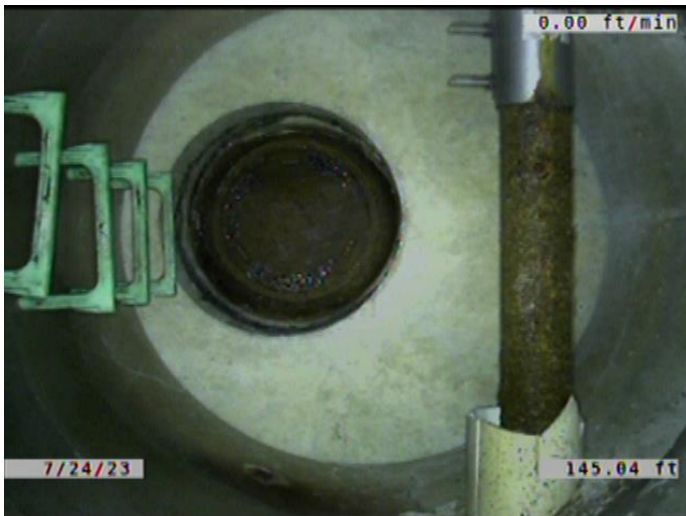
Code: **AMH**
 Description: **Manhole**

Distance (ft): **145.0**
 Structural Grade: **0**
 O&M Grade: **0**
 Clock Start/From:
 Clock To:
 1st Value:
 2nd Value:
 Value Percent:
 Continuous Index:
 Within 8" of Joint: **NO**
 Remarks: **M-902-018**
