Profile/Photo Observation Report

Date:	10/15/2021	Weather:		Coding:	PACP 6.0
Pipe Length (ft):		Owner:	Hobart, IN	Pre Clean:	Not Known
P.O.#:	809_1	Surveyor:	M. Pielacha	PSR:	P-902-019B-022
Customer:	Hobart, IN	Clean Date:		Shape:	C

Street:	Off 34th Court	Flow Control:	
City:	Hobart, IN	Year Renewed:	
Location:	Yard	Tape/Media #:	809
Purpose:	Routine Assessment	Dia/Height:	12"
Use:	Sanitary	Material:	VCP
Drain Area:		Lining:	
Category:	NA		
Comment:

Location Details:		Direction of Survey:	Downstream
US MH:	M-902-019B	DS MH:	M-902-22
		Total Length Surveyed (ft):	397.7

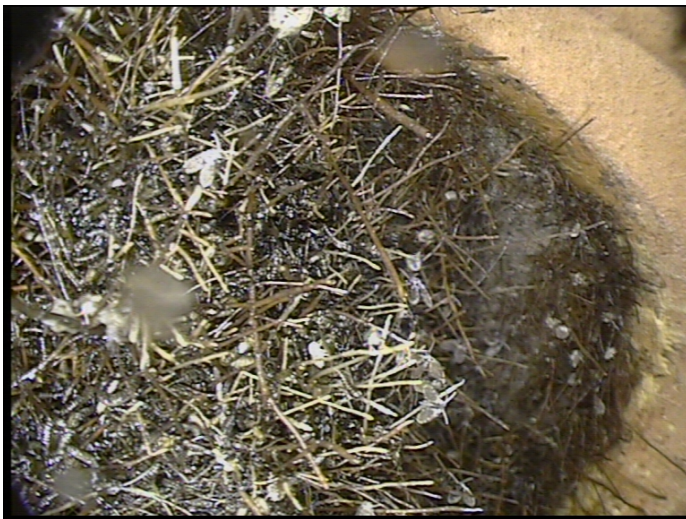
Code: **TFD**
Description: **Tap Factory Defective**

Distance (ft): **86.0**
Structural Grade: **0**
O&M Grade: **2**
Clock Start/From: **9**
Clock To:
1st Value: **4.000**
2nd Value:
Value Percent:
Continuous Index:
Within 8" of Joint: **NO**
Remarks: **roots**

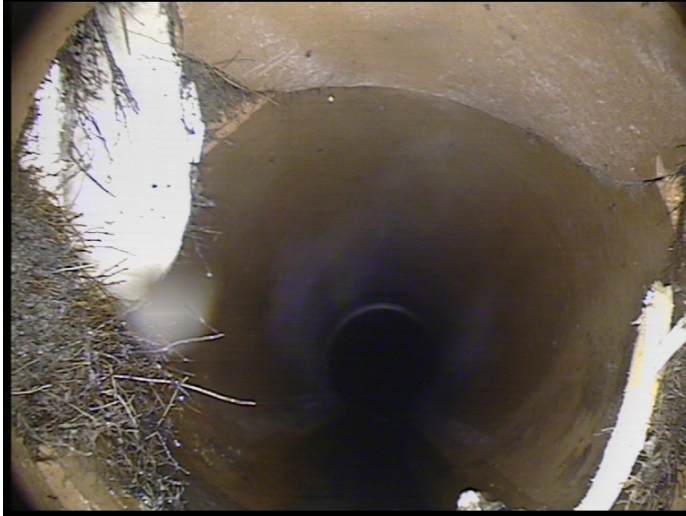
Code: **RFJ**
Description: **Roots Fine Joint**

Distance (ft): **98.0**
Structural Grade: **0**
O&M Grade: **1**
Clock Start/From: **7**
Clock To: **5**
1st Value:
2nd Value:
Value Percent:
Continuous Index:
Within 8" of Joint: **YES**
Remarks:

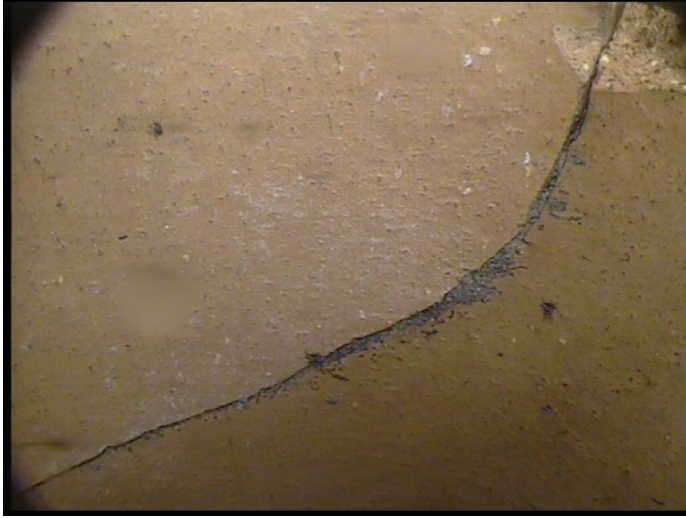
Code:	FC
Description:	Fracture Circumferential
Distance (ft):	98.0
Structural Grade:	2
O&M Grade:	0
Clock Start/From:	9
Clock To:	3
1st Value:	
2nd Value:	
Value Percent:	
Continuous Index:	
Within 8" of Joint:	YES
Remarks:

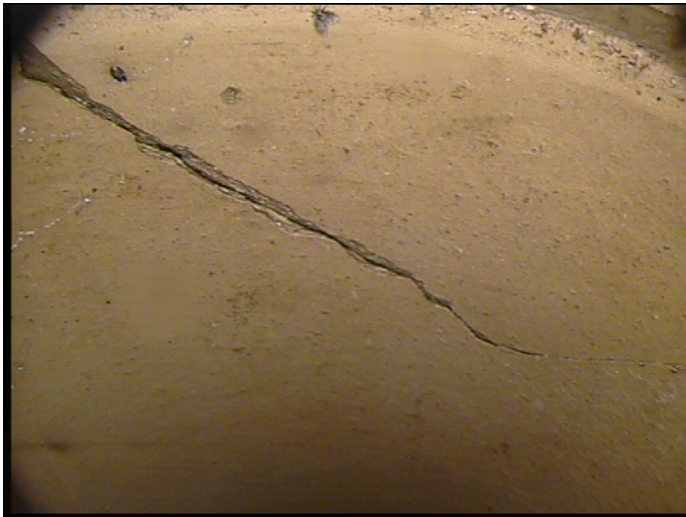
Code:	FC
Description:	Fracture Circumferential
Distance (ft):	127.3
Structural Grade:	2
O&M Grade:	0
Clock Start/From:	12
Clock To:	4
1st Value:	
2nd Value:	
Value Percent:	
Continuous Index:	
Within 8" of Joint:	YES
Remarks:

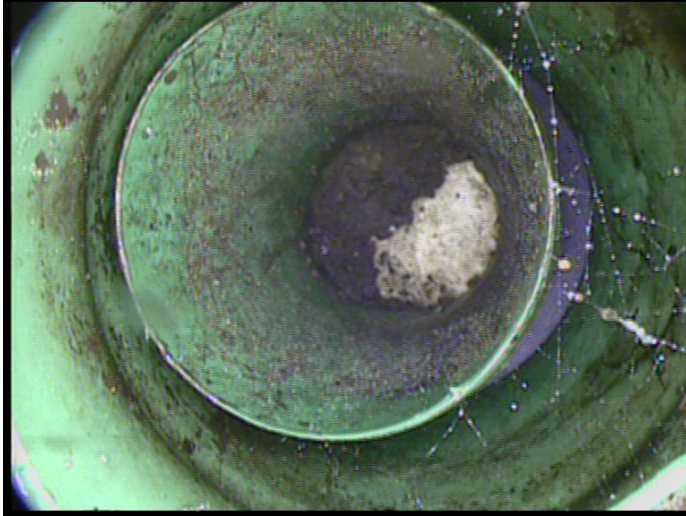
Code:	TBD
Description:	Tap Break-in Defective
Distance (ft):	130.5
Structural Grade:	0
O&M Grade:	3
Clock Start/From:	12
Clock To:	
1st Value:	4.000
2nd Value:	
Value Percent:	
Continuous Index:	
Within 8" of Joint:	NO
Remarks:	Defective

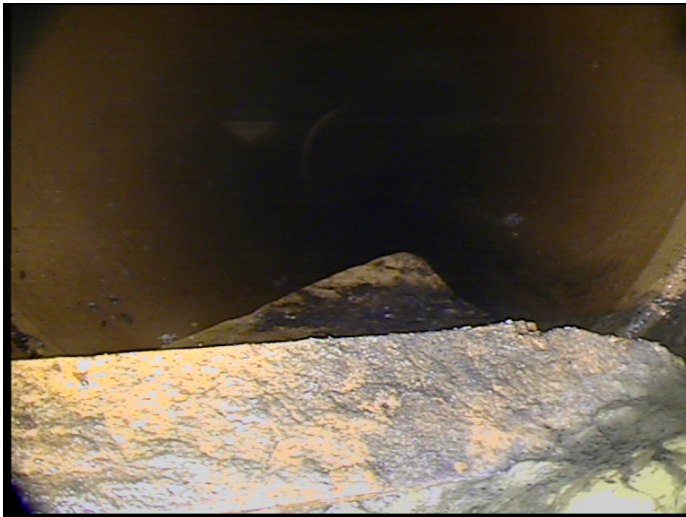
Code: **OBB**
Description: **Obstacle Brick**

Distance (ft): **336.5**
Structural Grade: **0**
O&M Grade: **3**
Clock Start/From: **4**
Clock To: **8**
1st Value:
2nd Value:
Value Percent: **15.000**
Continuous Index:
Within 8" of Joint: **NO**
Remarks:
