Profile/Photo Observation Report

Date:	05/08/2018	Weather:		Coding:	PACP 4.2
Pipe Length (ft):	41.4	Owner:	City of Hobart	Pre Clean:	No Pre-Cleaning
P.O.#:	2004	Surveyor:	SAN	PSR:	P-902-022-LS021
Customer:	Red Zone	Clean Date:		Shape:	C

Street:	3800 E 33rd Ln	Flow Control:	Not Controlled
City:	Hobart In	Year Renewed:	
Location:	Other	Tape/Media #:	Deliverable 1
Purpose:	Routine Assessment	Dia/Height:	12"
Use:	Sanitary	Material:	RCP
Drain Area:	Northeast	Lining:	
Category:	NA		
Comment:	456-1/DSMH was not shown on mapping.		
Location Details:	Lift station	Direction of Survey:	Downstream
US MH:	M-902-022	DS MH:	M-902-022A
		Total Length Surveyed (ft):	41.4

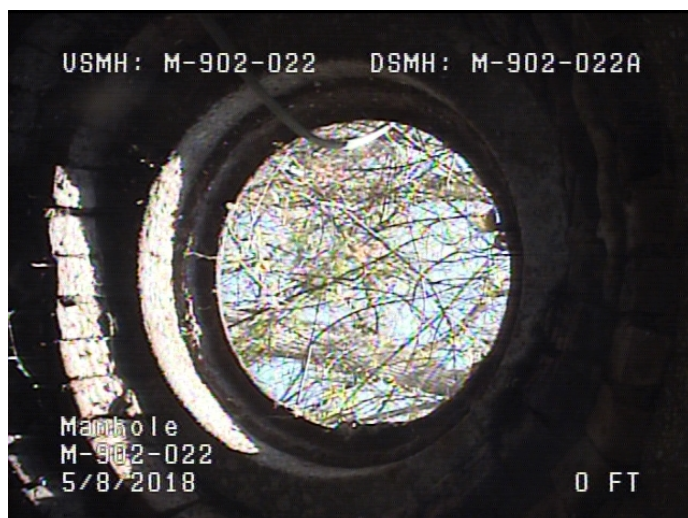
Code: **AMH**
Description: **Manhole**

Distance (ft): **.0**
Structural Grade: **0**
O&M Grade: **0**
Clock Start/From:
Clock To:
1st Value:
2nd Value:
Value Percent:
Continuous Index:
Within 8" of Joint: **NO**
Remarks: **M-902-022**

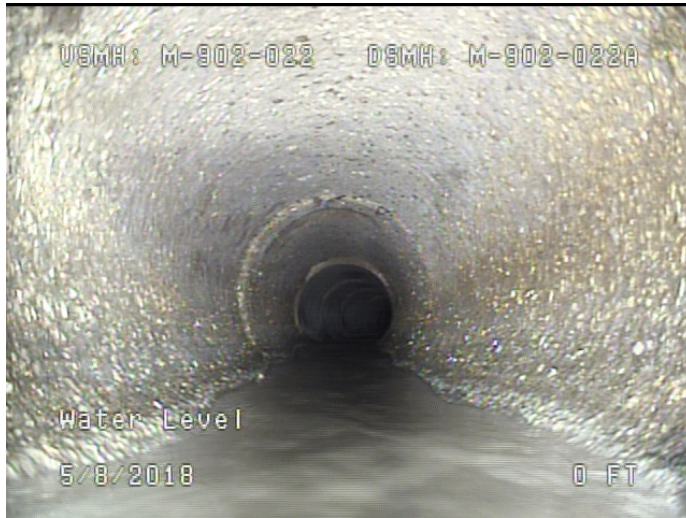
Code:	MWL
Description:	Water Level
Distance (ft):	.0
Structural Grade:	0
O&M Grade:	0
Clock Start/From:	
Clock To:	
1st Value:	
2nd Value:	
Value Percent:	10.000
Continuous Index:	
Within 8" of Joint:	NO
Remarks:

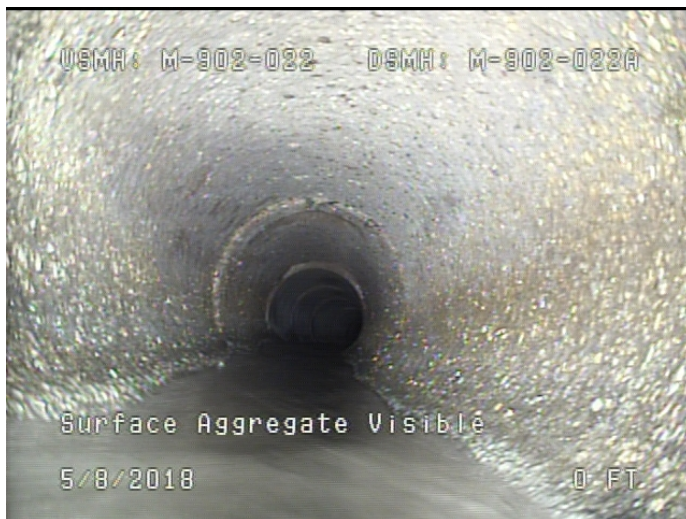
Code:	SAV
Description:	Surface Aggregate Visible
Distance (ft):	.0
Structural Grade:	3
O&M Grade:	0
Clock Start/From:	12
Clock To:	
1st Value:	
2nd Value:	
Value Percent:	
Continuous Index:	S01
Within 8" of Joint:	NO
Remarks:

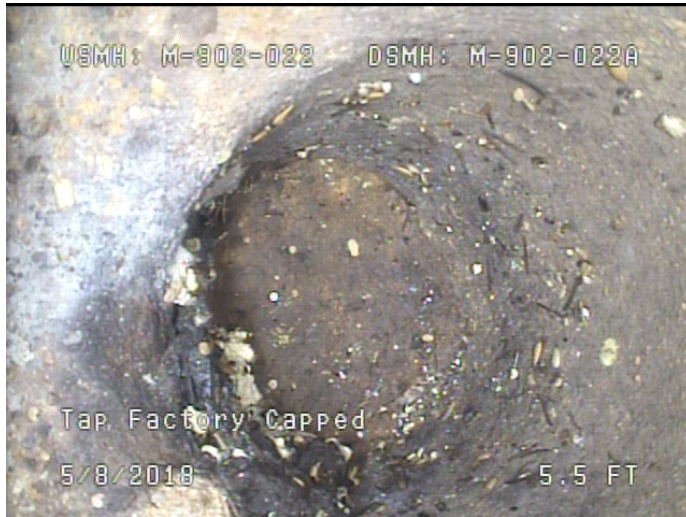
Code:	TFC
Description:	Tap Factory Capped
Distance (ft):	5.5
Structural Grade:	0
O&M Grade:	0
Clock Start/From:	12
Clock To:	
1st Value:	6.000
2nd Value:	
Value Percent:	
Continuous Index:	
Within 8" of Joint:	NO
Remarks:

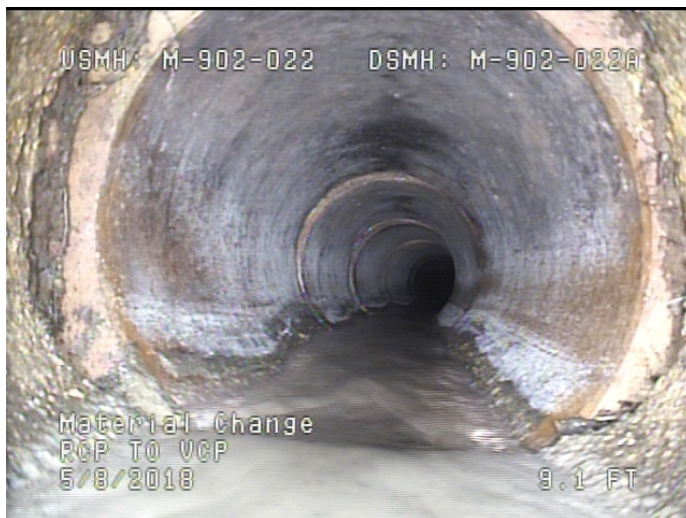
Code:	MMC
Description:	Material Change
Distance (ft):	9.1
Structural Grade:	0
O&M Grade:	0
Clock Start/From:	
Clock To:	
1st Value:	
2nd Value:	
Value Percent:	
Continuous Index:	
Within 8" of Joint:	NO
Remarks:	RCP TO VCP

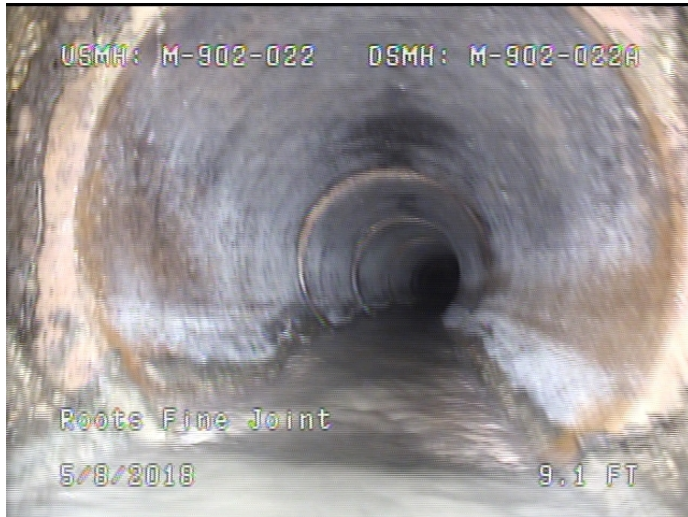
Code:	RFJ
Description:	Roots Fine Joint
Distance (ft):	9.1
Structural Grade:	0
O&M Grade:	1
Clock Start/From:	7
Clock To:	5
1st Value:	
2nd Value:	
Value Percent:	
Continuous Index:	
Within 8" of Joint:	YES
Remarks:

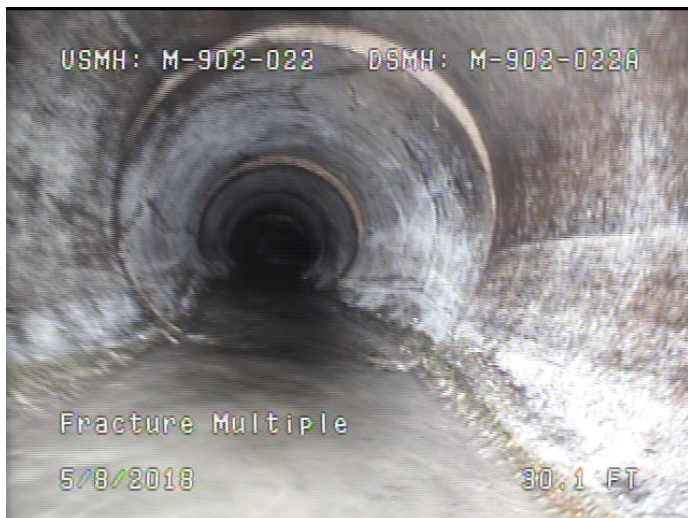
Code:	FM
Description:	Fracture Multiple
Distance (ft):	30.1
Structural Grade:	4
O&M Grade:	0
Clock Start/From:	8
Clock To:	4
1st Value:	
2nd Value:	
Value Percent:	
Continuous Index:	S02
Within 8" of Joint:	NO
Remarks:

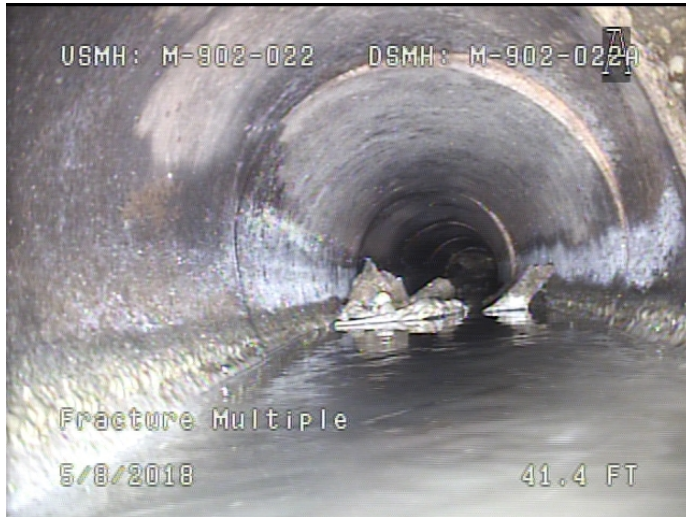
Code:	FM
Description:	Fracture Multiple
Distance (ft):	41.4
Structural Grade:	4
O&M Grade:	0
Clock Start/From:	8
Clock To:	4
1st Value:	
2nd Value:	
Value Percent:	
Continuous Index:	F02
Within 8" of Joint:	NO
Remarks:

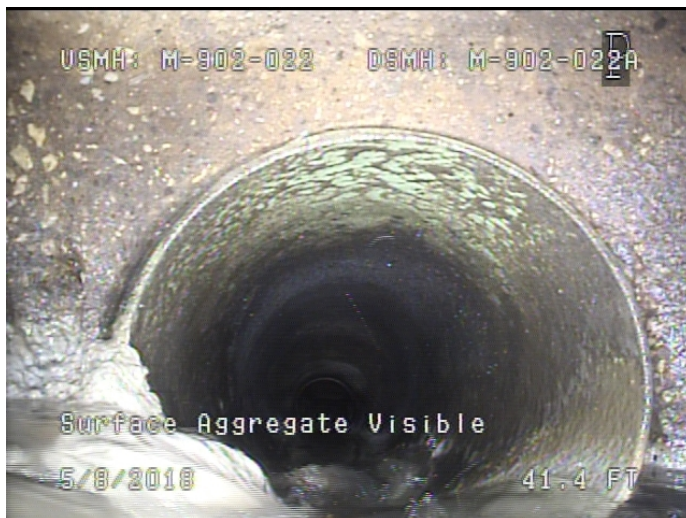
Code:	SAV
Description:	Surface Aggregate Visible
Distance (ft):	41.4
Structural Grade:	3
O&M Grade:	0
Clock Start/From:	12
Clock To:	
1st Value:	
2nd Value:	
Value Percent:	
Continuous Index:	F01
Within 8" of Joint:	NO
Remarks:

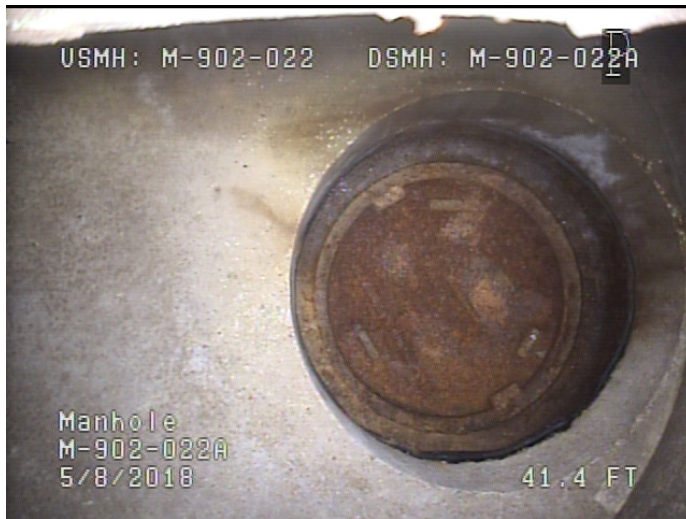
Code:	AMH
Description:	Manhole
Distance (ft):	41.4
Structural Grade:	0
O&M Grade:	0
Clock Start/From:	
Clock To:	
1st Value:	
2nd Value:	
Value Percent:	
Continuous Index:	
Within 8" of Joint:	NO
Remarks:	M-902-022A
