Profile/Photo Observation Report

Date:	08/03/2023	Weather:		Coding:	PACP 7.0
Pipe Length (ft):	330.0	Owner:	City of Hobart	Pre Clean:	Heavy Cleaning
P.O.#:	YES502259	Surveyor:	S. Bucklin	PSR:	P-902-024-023
Customer:	City of Hobart	Clean Date:	07/04/2023	Shape:	C

Street:	East 33rd Lane	Flow Control:	Not Controlled
City:	Hobart, IN	Year Renewed:	
Location:	Easement/Right of Way	Tape/Media #:	
Purpose:	Routine Assessment	Dia/Height:	8"
Use:	Sanitary Sewage Pipe	Material:	VCP
Drain Area:		Lining:	None
Category:	NA		
Comment:

Location Details:		Direction of Survey:	Upstream
US MH:	M-902-024	DS MH:	M-902-023
		Total Length Surveyed (ft):	116.1

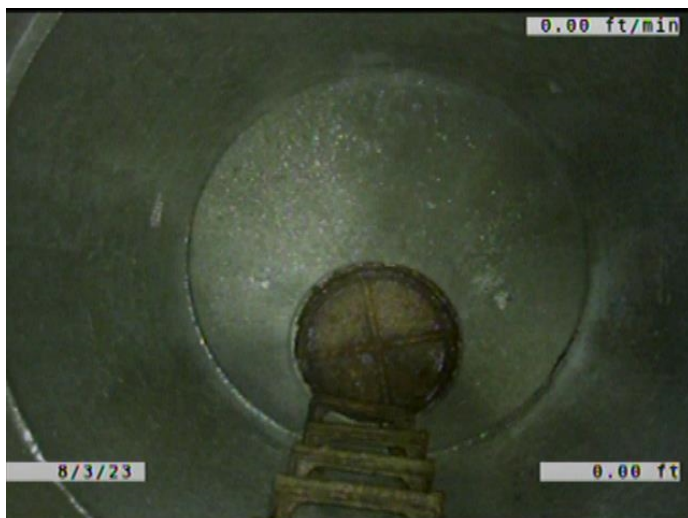
Code: **AMH**
 Description: **Manhole**

Distance (ft): **.0**
 Structural Grade: **0**
 O&M Grade: **0**
 Clock Start/From:
 Clock To:
 1st Value:
 2nd Value:
 Value Percent:
 Continuous Index:
 Within 8" of Joint: **NO**
 Remarks: **M-902-023**

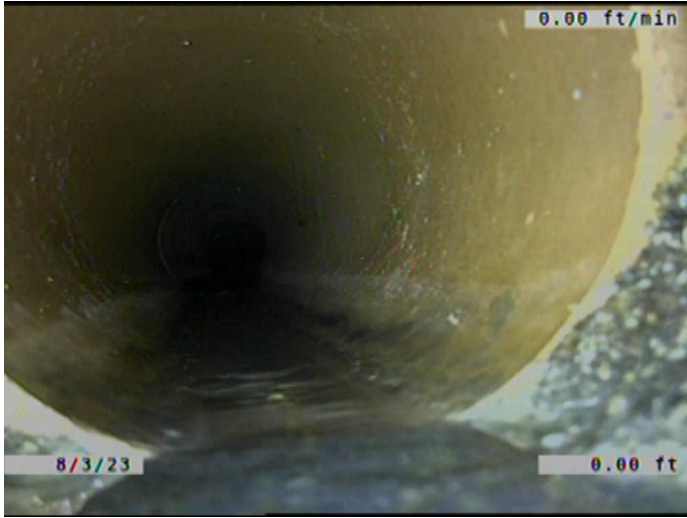
Code: **MWL**
Description: **Miscellaneous Water Level**

Distance (ft): **.0**
Structural Grade: **0**
O&M Grade: **0**
Clock Start/From:
Clock To:
1st Value:
2nd Value:
Value Percent: **5.000**
Continuous Index:
Within 8" of Joint: **NO**
Remarks:

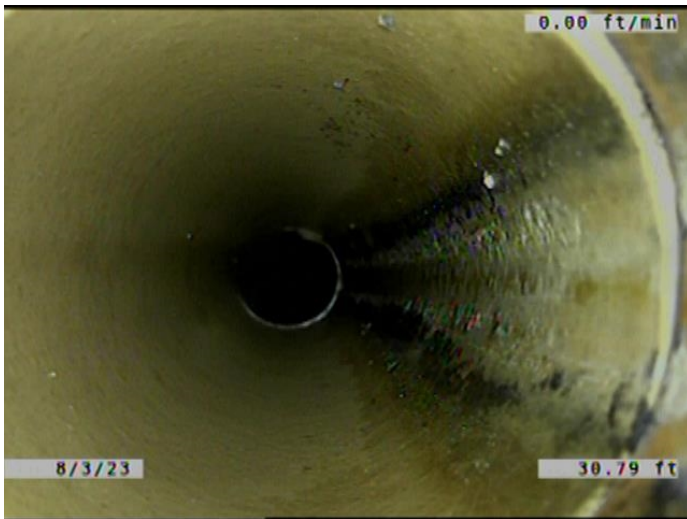
Code: **TF**
Description: **Tap Factory**

Distance (ft): **30.8**
Structural Grade: **0**
O&M Grade: **0**
Clock Start/From: **2**
Clock To:
1st Value: **6.000**
2nd Value:
Value Percent:
Continuous Index:
Within 8" of Joint: **YES**
Remarks:

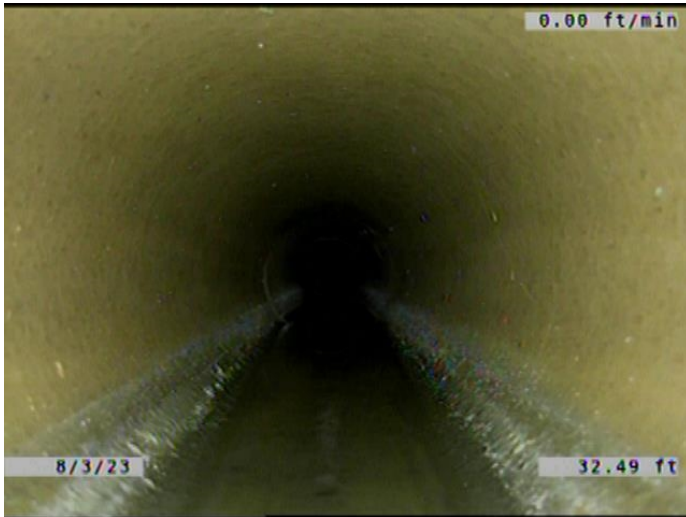
Code: **MWLS**
Description: **Miscellaneous Water Level Sag**

Distance (ft): **32.5**
Structural Grade: **2**
O&M Grade: **0**
Clock Start/From:
Clock To:
1st Value:
2nd Value:
Value Percent: **10.000**
Continuous Index: **S01**
Within 8" of Joint: **NO**
Remarks:

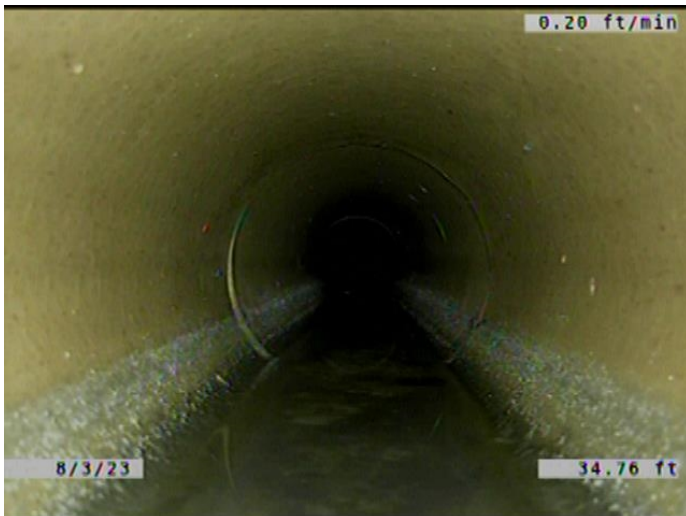
Code: **DSF**
Description: **Deposits Settled Fine**

Distance (ft): **34.8**
Structural Grade: **0**
O&M Grade: **2**
Clock Start/From: **5**
Clock To: **7**
1st Value:
2nd Value:
Value Percent: **5.000**
Continuous Index: **S02**
Within 8" of Joint: **YES**
Remarks:

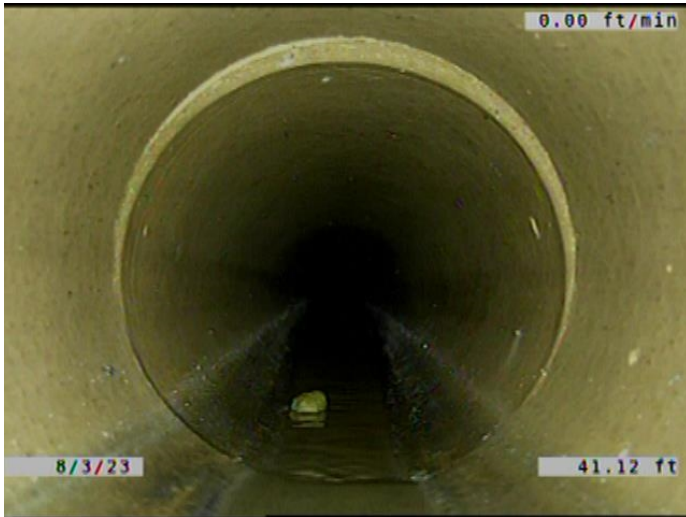
Code: **MWLS**
Description: **Miscellaneous Water Level Sag**

Distance (ft): **41.1**
Structural Grade: **2**
O&M Grade: **0**
Clock Start/From:
Clock To:
1st Value:
2nd Value:
Value Percent: **10.000**
Continuous Index: **F01**
Within 8" of Joint: **NO**
Remarks:

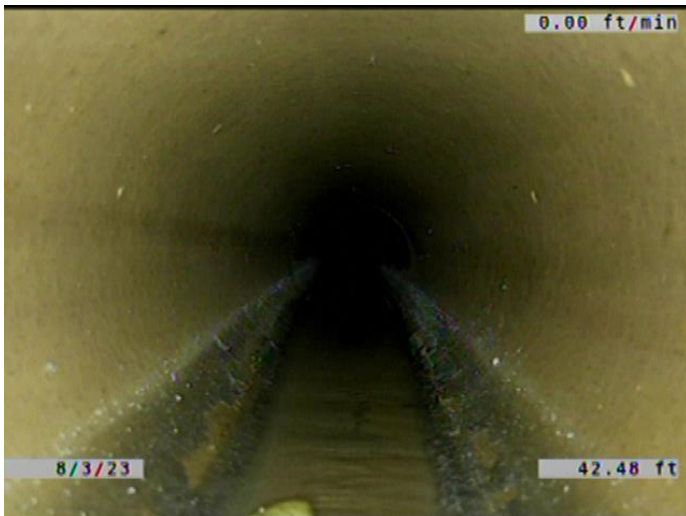
Code: **MWLS**
Description: **Miscellaneous Water Level Sag**

Distance (ft): **42.5**
Structural Grade: **2**
O&M Grade: **0**
Clock Start/From:
Clock To:
1st Value:
2nd Value:
Value Percent: **10.000**
Continuous Index: **S03**
Within 8" of Joint: **NO**
Remarks:

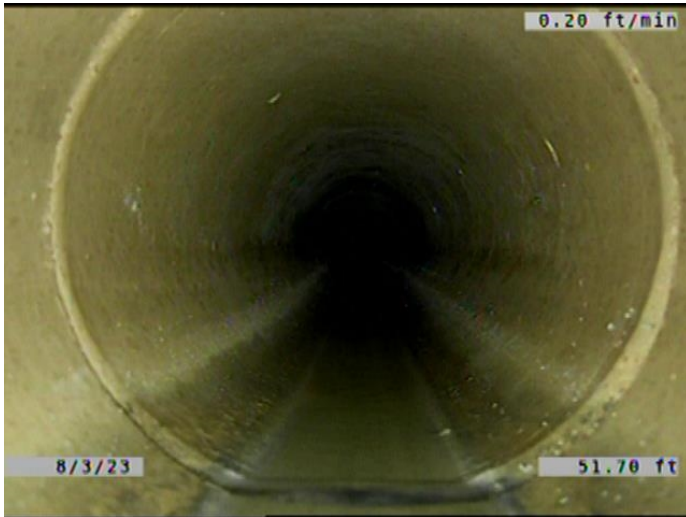
Code: **MWLS**
Description: **Miscellaneous Water Level Sag**

Distance (ft): **51.7**
Structural Grade: **2**
O&M Grade: **0**
Clock Start/From:
Clock To:
1st Value:
2nd Value:
Value Percent: **10.000**
Continuous Index: **F03**
Within 8" of Joint: **NO**
Remarks:

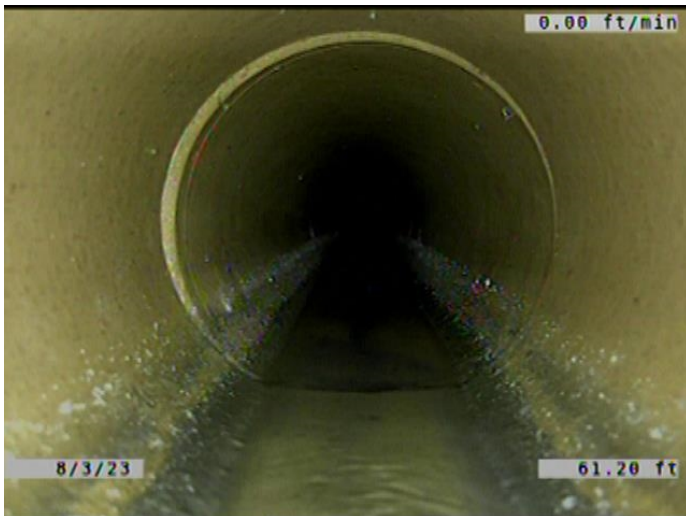
Code: **MWLS**
Description: **Miscellaneous Water Level Sag**

Distance (ft): **61.2**
Structural Grade: **2**
O&M Grade: **0**
Clock Start/From:
Clock To:
1st Value:
2nd Value:
Value Percent: **10.000**
Continuous Index: **S04**
Within 8" of Joint: **NO**
Remarks:

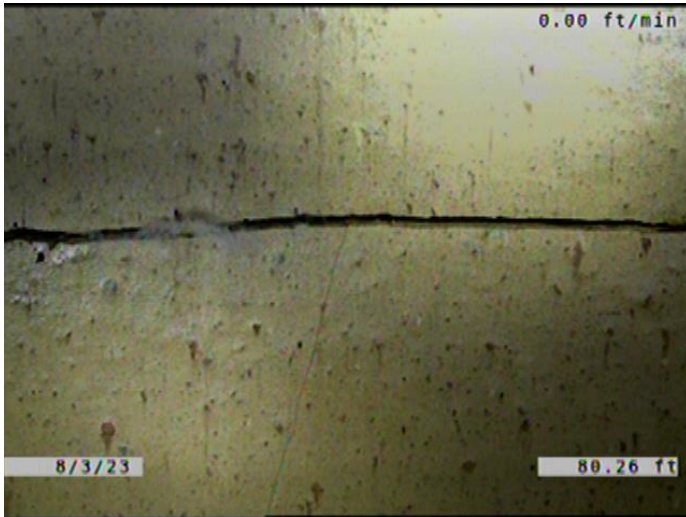
Code: **FC**
Description: **Fracture Circumferential**

Distance (ft): **80.3**
Structural Grade: **2**
O&M Grade: **0**
Clock Start/From: **8**
Clock To: **4**
1st Value:
2nd Value:
Value Percent:
Continuous Index:
Within 8" of Joint: **YES**
Remarks:

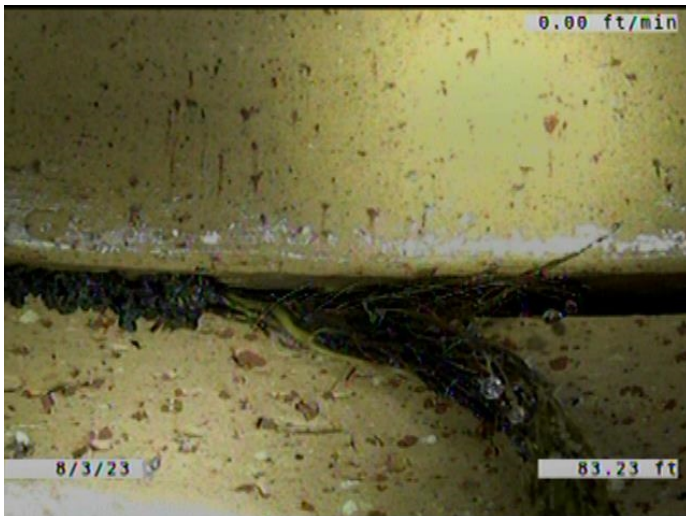
Code: **RFJ**
Description: **Roots Fine Joint**

Distance (ft): **83.2**
Structural Grade: **0**
O&M Grade: **1**
Clock Start/From: **8**
Clock To: **9**
1st Value:
2nd Value:
Value Percent:
Continuous Index:
Within 8" of Joint: **YES**
Remarks:

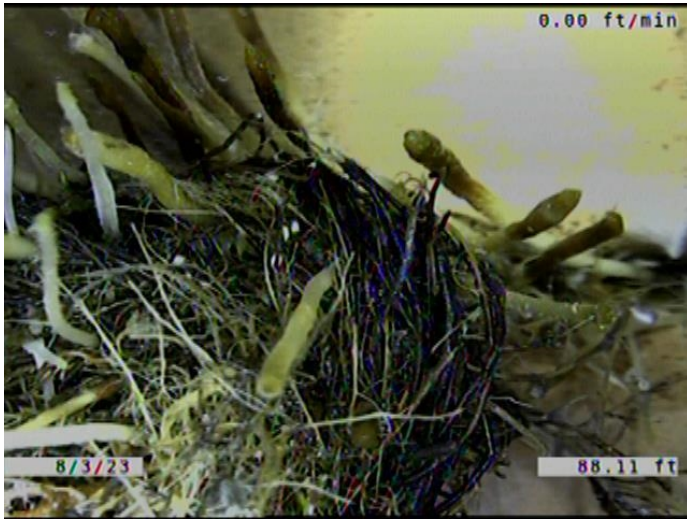
Code: **RMJ**
 Description: **Roots Medium Joint**

Distance (ft): **88.1**
 Structural Grade: **0**
 O&M Grade: **3**
 Clock Start/From: **7**
 Clock To: **11**
 1st Value:
 2nd Value:
 Value Percent: **5.000**
 Continuous Index: **S05**
 Within 8" of Joint: **YES**
 Remarks:

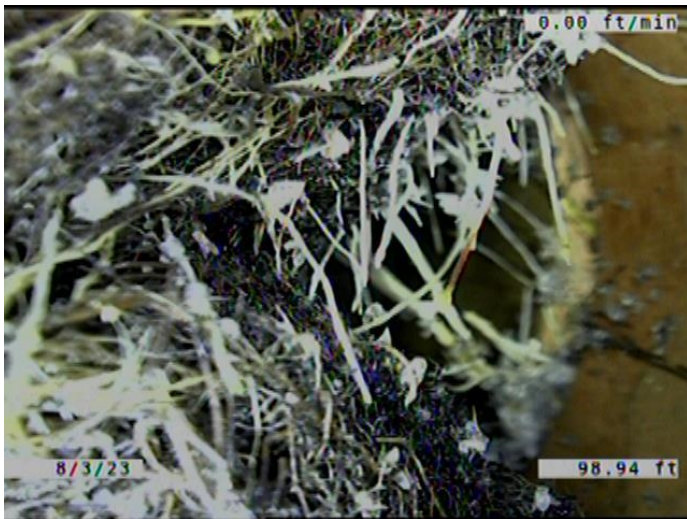
Code: **TFD**
 Description: **Tap Factory Defective**

Distance (ft): **98.9**
 Structural Grade: **0**
 O&M Grade: **3**
 Clock Start/From: **10**
 Clock To:
 1st Value: **6.000**
 2nd Value:
 Value Percent:
 Continuous Index:
 Within 8" of Joint: **YES**
 Remarks: **85% PLUGGED WITH ROOTS. ROOTS GROWING OUT OF THE SERVICE INT**

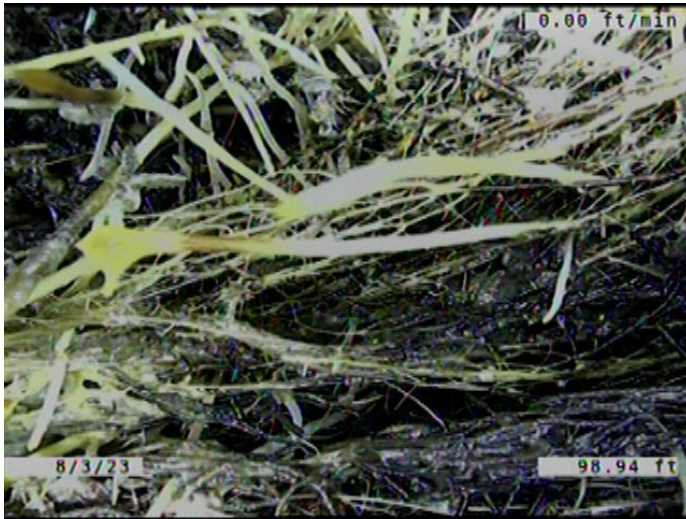
Code: **RML**
 Description: **Roots Medium Lateral**

Distance (ft): **98.9**
 Structural Grade: **0**
 O&M Grade: **3**
 Clock Start/From: **9**
 Clock To: **10**
 1st Value:
 2nd Value:
 Value Percent: **10.000**
 Continuous Index:
 Within 8" of Joint: **NO**
 Remarks:

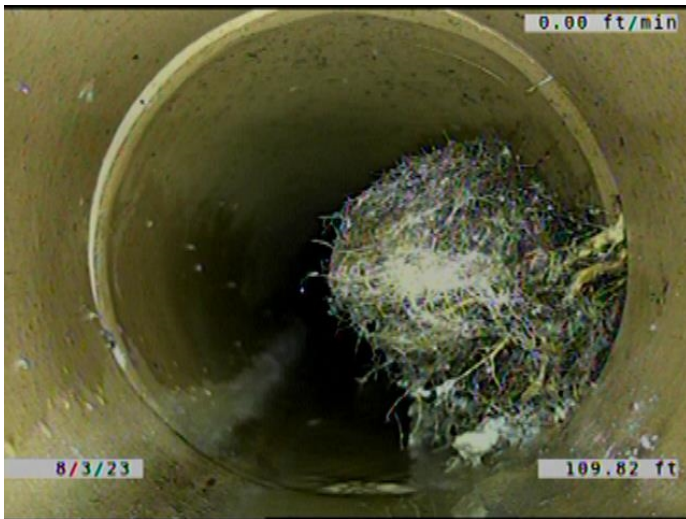
Code: **RMJ**
 Description: **Roots Medium Joint**

Distance (ft): **109.8**
 Structural Grade: **0**
 O&M Grade: **3**
 Clock Start/From: **2**
 Clock To: **4**
 1st Value:
 2nd Value:
 Value Percent: **25.000**
 Continuous Index:
 Within 8" of Joint: **YES**
 Remarks:

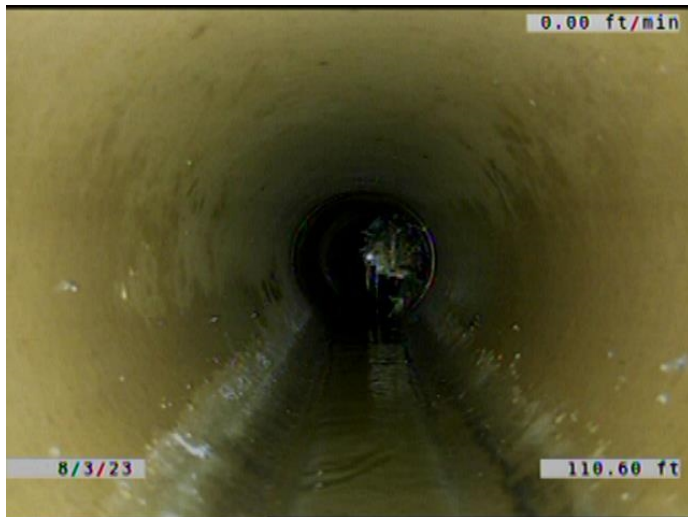
Code: **MWLS**
Description: **Miscellaneous Water Level Sag**

Distance (ft): **110.6**
Structural Grade: **2**
O&M Grade: **0**
Clock Start/From:
Clock To:
1st Value:
2nd Value:
Value Percent: **10.000**
Continuous Index: **F04**
Within 8" of Joint: **NO**
Remarks:

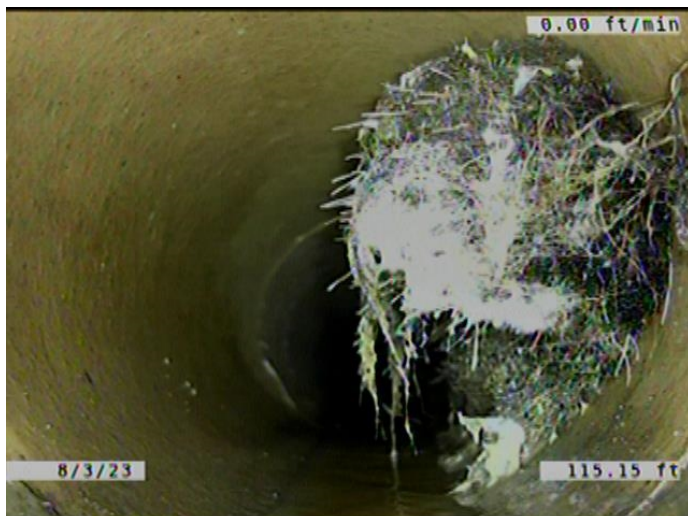
Code: **RML**
Description: **Roots Medium Lateral**

Distance (ft): **115.2**
Structural Grade: **0**
O&M Grade: **3**
Clock Start/From: **2**
Clock To: **4**
1st Value:
2nd Value:
Value Percent: **45.000**
Continuous Index:
Within 8" of Joint: **NO**
Remarks:

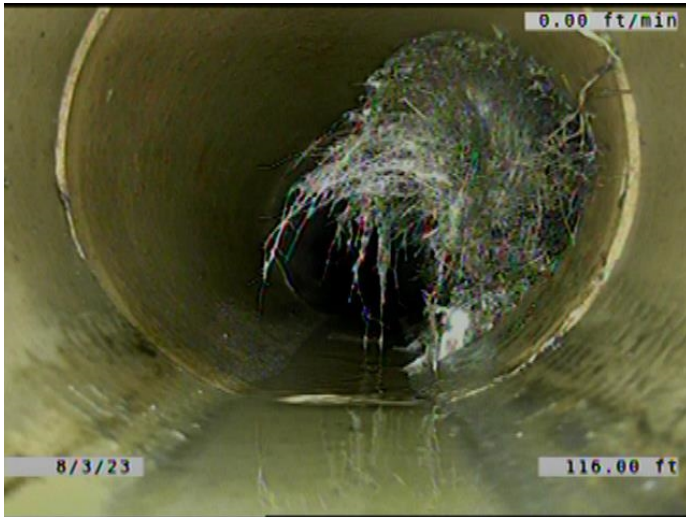
Code: **DSF**
Description: **Deposits Settled Fine**

Distance (ft): **116.0**
Structural Grade: **0**
O&M Grade: **2**
Clock Start/From: **5**
Clock To: **7**
1st Value:
2nd Value:
Value Percent: **5.000**
Continuous Index: **F02**
Within 8" of Joint: **YES**
Remarks:

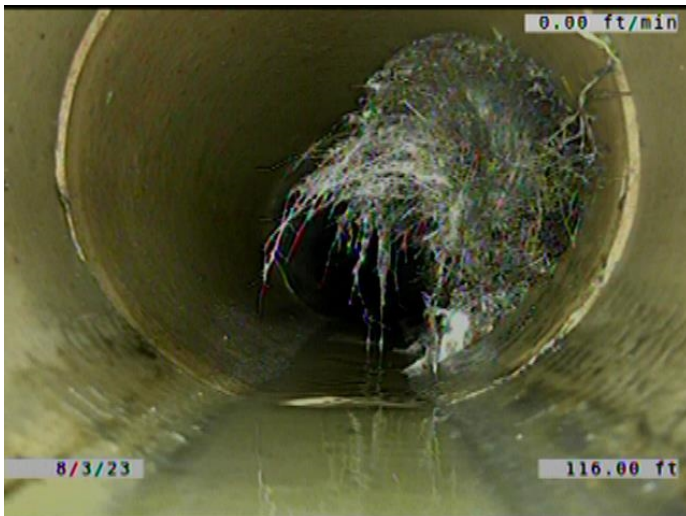
Code: **RMJ**
Description: **Roots Medium Joint**

Distance (ft): **116.0**
Structural Grade: **0**
O&M Grade: **3**
Clock Start/From: **7**
Clock To: **11**
1st Value:
2nd Value:
Value Percent: **5.000**
Continuous Index: **F05**
Within 8" of Joint: **YES**
Remarks:

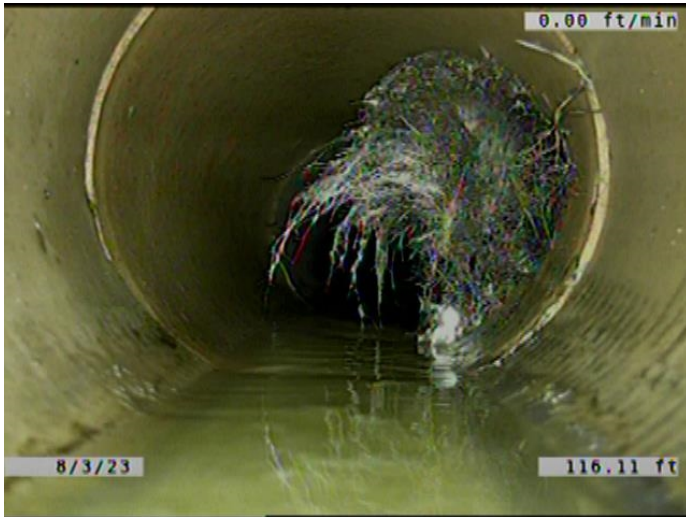
Code:	MSA
Description:	Miscellaneous Survey Abandoned
Distance (ft):	116.1
Structural Grade:	0
O&M Grade:	0
Clock Start/From:	
Clock To:	
1st Value:	
2nd Value:	
Value Percent:	
Continuous Index:	
Within 8" of Joint:	NO
Remarks:	CAMERA CANT MAKE IT PAST ROOTS COMING THE SERVICE.
