Profile/Photo Observation Report

Date:	03/20/2018	Weather:		Coding:	PACP 6.0
Pipe Length (ft):	316.7	Owner:	NA	Pre Clean:	Not Known
P.O.#:		Surveyor:	John Kuglmaier	PSR:	P-902-025-024
Customer:		Clean Date:	01/01/1900	Shape:	C

Street:	Randolph Pl	Flow Control:	Not Controlled
City:	Hobart, IN	Year Renewed:	
Location:	Main Highway - Suburban/Rural	Tape/Media #:	
Purpose:	Resurvey	Dia/Height:	10"
Use:	Sanitary	Material:	VCP
Drain Area:	NA	Lining:	
Category:	NA		
Comment:

Location Details:		Direction of Survey:	Downstream
US MH:	M-902-025	DS MH:	M-902-024
		Total Length Surveyed (ft):	199.9

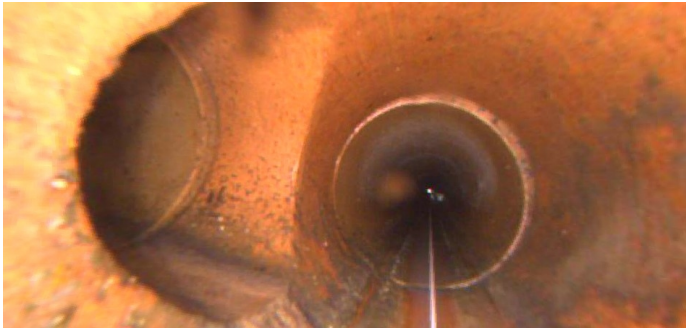
Code: **TF**
Description: **Tap Factory**

Distance (ft): **57.8**
Structural Grade: **0**
O&M Grade: **0**
Clock Start/From: **3**
Clock To:
1st Value: **4.000**
2nd Value:
Value Percent:
Continuous Index:
Within 8" of Joint:
Remarks:

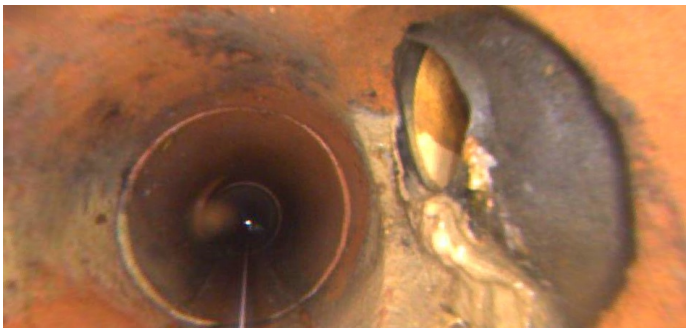
Code: **TB**
Description: **Tap Break-in**

Distance (ft): **59.7**
Structural Grade: **0**
O&M Grade: **0**
Clock Start/From: **10**
Clock To:
1st Value: **4.000**
2nd Value:
Value Percent:
Continuous Index:
Within 8" of Joint:
Remarks:

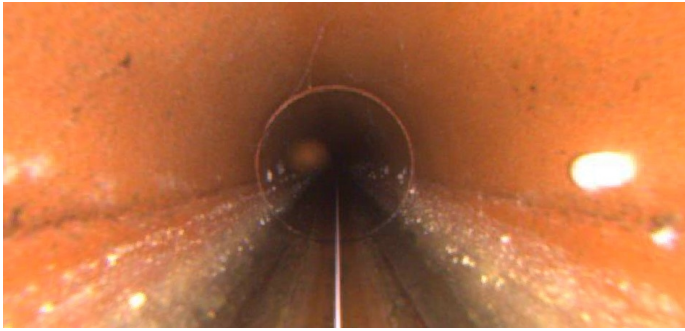
Code: **DAGS**
Description: **Deposits Attached Grease**

Distance (ft): **136.5**
Structural Grade: **0**
O&M Grade: **2**
Clock Start/From: **4**
Clock To: **8**
1st Value:
2nd Value:
Value Percent: **5.000**
Continuous Index: **S01**
Within 8" of Joint: **NO**
Remarks:

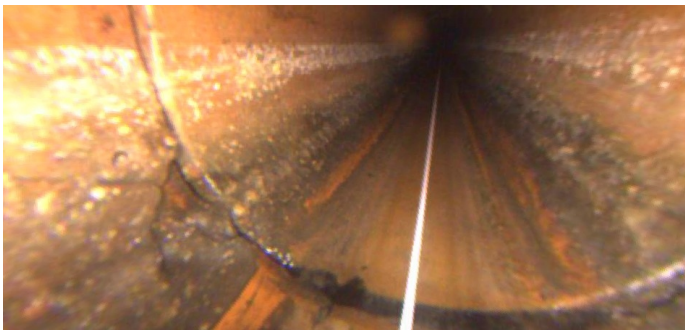
Code: **FM**
Description: **Fracture Multiple**

Distance (ft): **145.5**
Structural Grade: **4**
O&M Grade: **0**
Clock Start/From: **4**
Clock To: **5**
1st Value:
2nd Value:
Value Percent:
Continuous Index:
Within 8" of Joint: **YES**
Remarks:

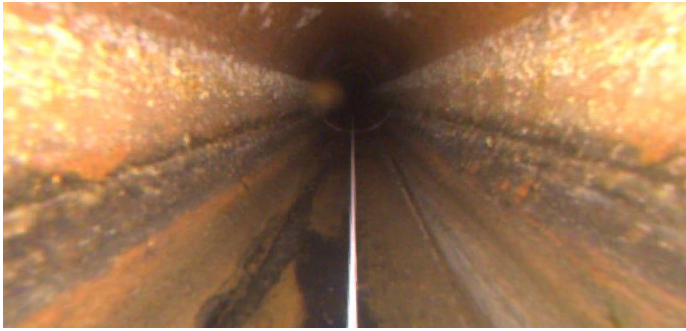
Code: **DSF**
Description: **Deposits Settled Fine**

Distance (ft): **149.5**
Structural Grade: **0**
O&M Grade: **2**
Clock Start/From: **5**
Clock To: **7**
1st Value:
2nd Value:
Value Percent: **5.000**
Continuous Index: **S02**
Within 8" of Joint: **NO**
Remarks:

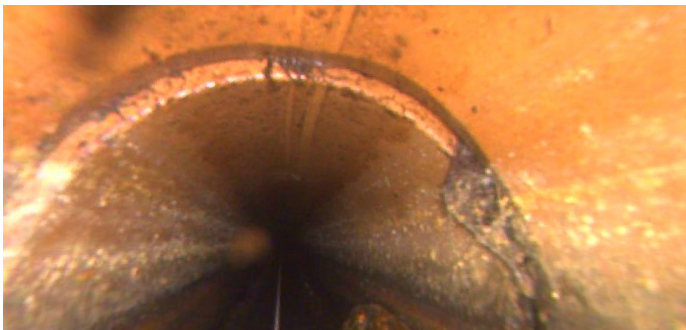
Code: **RFJ**
Description: **Roots Fine Joint**

Distance (ft): **170.3**
Structural Grade: **0**
O&M Grade: **1**
Clock Start/From: **8**
Clock To: **12**
1st Value:
2nd Value:
Value Percent:
Continuous Index:
Within 8" of Joint: **YES**
Remarks:

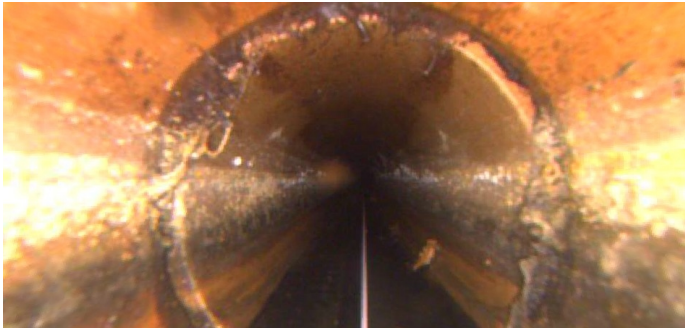
Code: **RFJ**
Description: **Roots Fine Joint**

Distance (ft): **180.4**
Structural Grade: **0**
O&M Grade: **1**
Clock Start/From: **7**
Clock To: **3**
1st Value:
2nd Value:
Value Percent:
Continuous Index:
Within 8" of Joint: **YES**
Remarks:

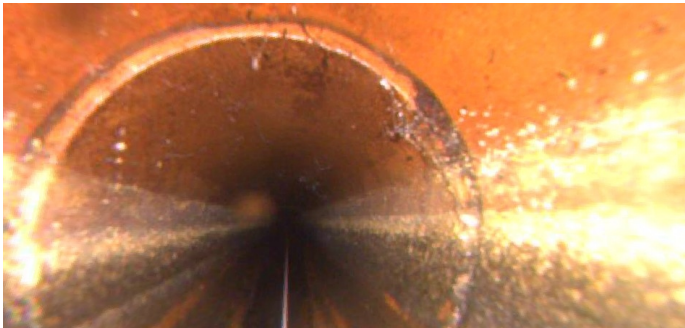
Code: **RFJ**
Description: **Roots Fine Joint**

Distance (ft): **190.2**
Structural Grade: **0**
O&M Grade: **1**
Clock Start/From: **9**
Clock To: **10**
1st Value:
2nd Value:
Value Percent:
Continuous Index:
Within 8" of Joint: **YES**
Remarks:

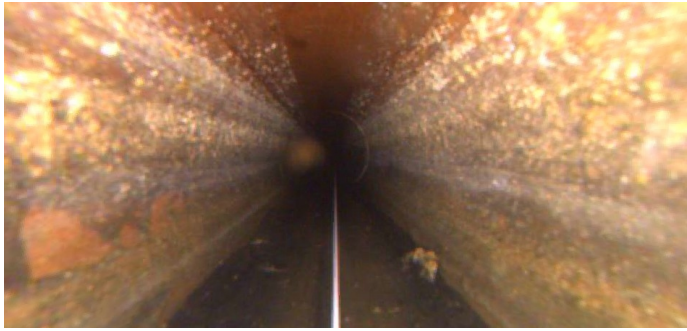
Code: **DSF**
Description: **Deposits Settled Fine**

Distance (ft): **197.1**
Structural Grade: **0**
O&M Grade: **2**
Clock Start/From: **5**
Clock To: **7**
1st Value:
2nd Value:
Value Percent: **5.000**
Continuous Index: **F02**
Within 8" of Joint: **NO**
Remarks: **Clock positions vary**

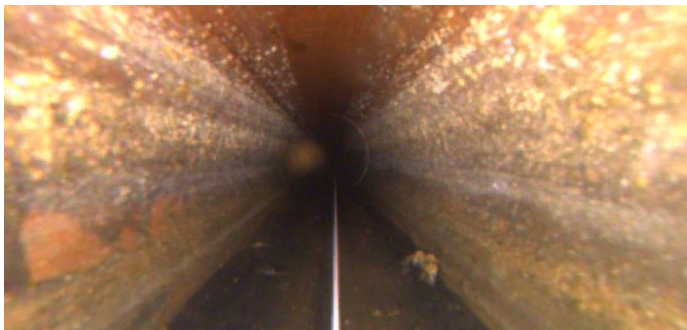
Code: **DAGS**
Description: **Deposits Attached Grease**

Distance (ft): **197.1**
Structural Grade: **0**
O&M Grade: **2**
Clock Start/From: **4**
Clock To: **8**
1st Value:
2nd Value:
Value Percent: **5.000**
Continuous Index: **F01**
Within 8" of Joint: **NO**
Remarks: **Clock positions vary**

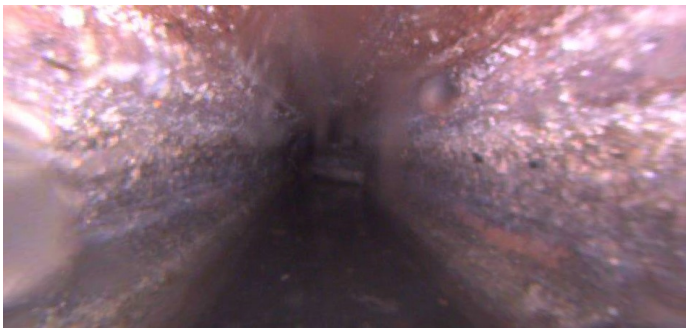
Code: **DAGS**
Description: **Deposits Attached Grease**

Distance (ft): **197.1**
Structural Grade: **0**
O&M Grade: **2**
Clock Start/From: **8**
Clock To: **5**
1st Value:
2nd Value:
Value Percent: **10.000**
Continuous Index:
Within 8" of Joint: **NO**
Remarks:

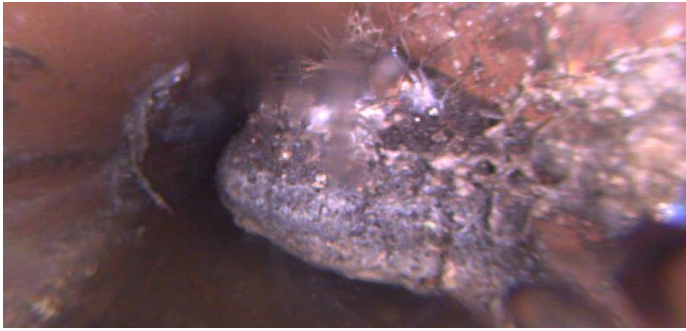
Code: **RBC**
Description: **Roots Ball Connection**

Distance (ft): **199.0**
Structural Grade: **0**
O&M Grade: **4**
Clock Start/From: **12**
Clock To: **5**
1st Value:
2nd Value:
Value Percent: **60.000**
Continuous Index:
Within 8" of Joint: **NO**
Remarks:

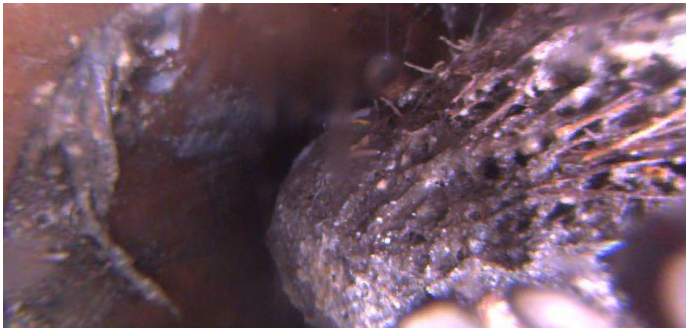
Code: **MSA**
Description: **Abandoned Survey**

Distance (ft): **199.9**
Structural Grade: **0**
O&M Grade: **0**
Clock Start/From:
Clock To:
1st Value:
2nd Value:
Value Percent:
Continuous Index:
Within 8" of Joint: **NO**
Remarks: **RBC**
