Profile/Photo Observation Report

Date:	04/12/2018	Weather:		Coding:	PACP 4.2
Pipe Length (ft):	281.9	Owner:	City of Hobart	Pre Clean:	No Pre-Cleaning
P.O.#:	2004	Surveyor:	SAN	PSR:	P-902-027-023
Customer:	Red Zone	Clean Date:		Shape:	C

Street:	377 E 33rd Ln	Flow Control:	Not Controlled
City:	Hobart In	Year Renewed:	
Location:	Easement/Right of Way	Tape/Media #:	Deliverable 1
Purpose:	Routine Assessment	Dia/Height:	18"
Use:	Sanitary	Material:	RCP
Drain Area:	Northeast	Lining:	
Category:	NA		
Comment:	408-1/ Incomplete line-needs cleaning.		
Location Details:	Backyards	Direction of Survey:	Downstream
US MH:	M-902-027	DS MH:	M-902-023
		Total Length Surveyed (ft):	10.8

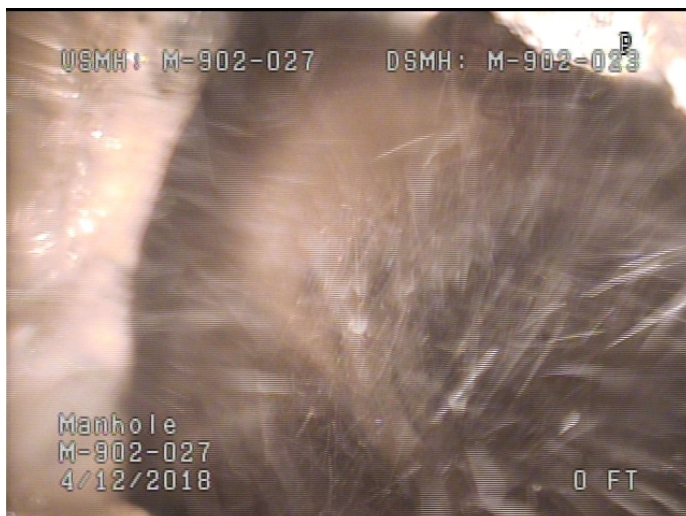
Code: **AMH**
Description: **Manhole**

Distance (ft): **.0**
Structural Grade: **0**
O&M Grade: **0**
Clock Start/From:
Clock To:
1st Value:
2nd Value:
Value Percent:
Continuous Index:
Within 8" of Joint: **NO**
Remarks: **M-902-027**

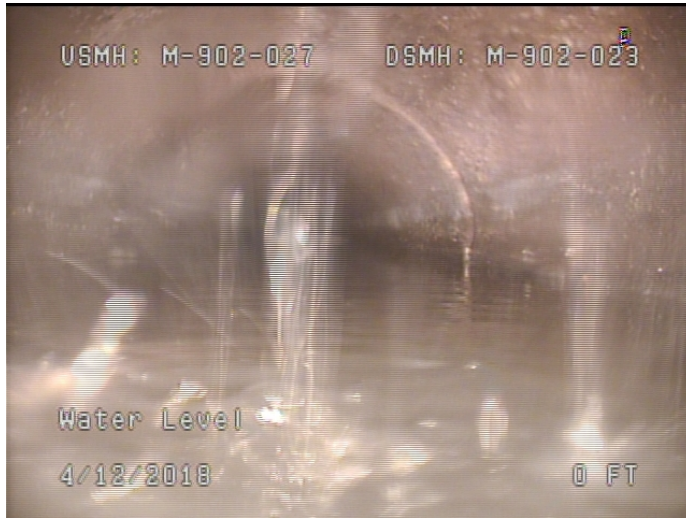
Code: **MWL**
Description: **Water Level**

Distance (ft): **.0**
Structural Grade: **0**
O&M Grade: **0**
Clock Start/From:
Clock To:
1st Value:
2nd Value:
Value Percent: **30.000**
Continuous Index:
Within 8" of Joint: **NO**
Remarks:

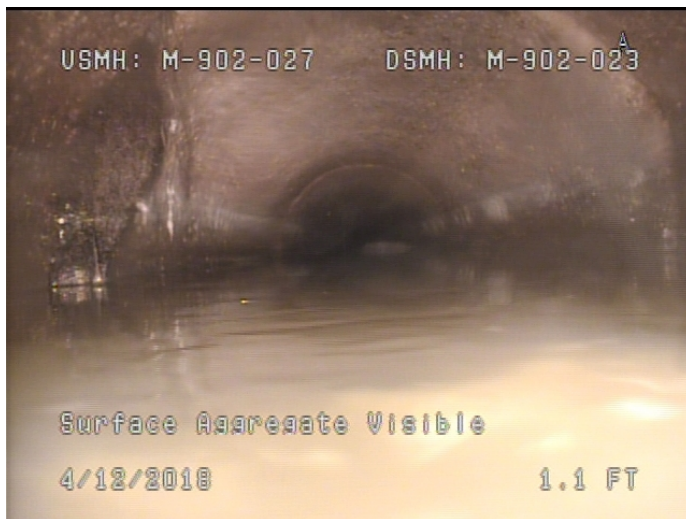
Code: **SAV**
Description: **Surface Aggregate Visible**

Distance (ft): **1.1**
Structural Grade: **3**
O&M Grade: **0**
Clock Start/From: **8**
Clock To: **4**
1st Value:
2nd Value:
Value Percent:
Continuous Index: **S01**
Within 8" of Joint: **NO**
Remarks:

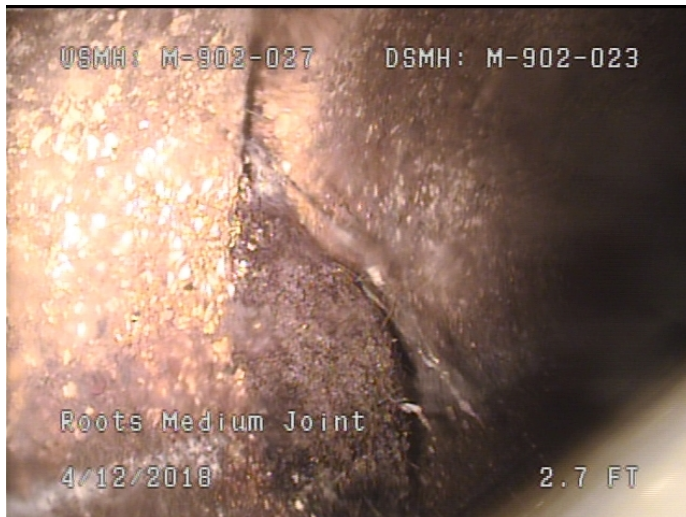
Code:	RMJ
Description:	Roots Medium Joint
Distance (ft):	2.7
Structural Grade:	0
O&M Grade:	3
Clock Start/From:	10
Clock To:	
1st Value:	
2nd Value:	
Value Percent:	10.000
Continuous Index:	
Within 8" of Joint:	YES
Remarks:

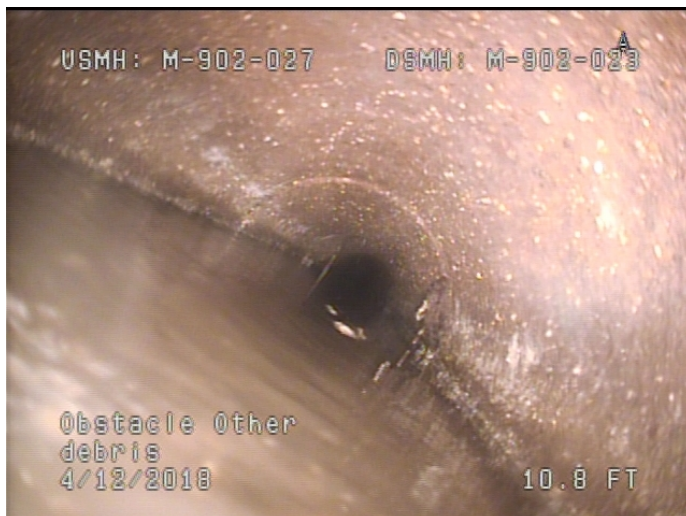
Code:	OBZ
Description:	Obstacle Other
Distance (ft):	10.8
Structural Grade:	0
O&M Grade:	4
Clock Start/From:	4
Clock To:	8
1st Value:	
2nd Value:	
Value Percent:	25.000
Continuous Index:	
Within 8" of Joint:	NO
Remarks:	debris

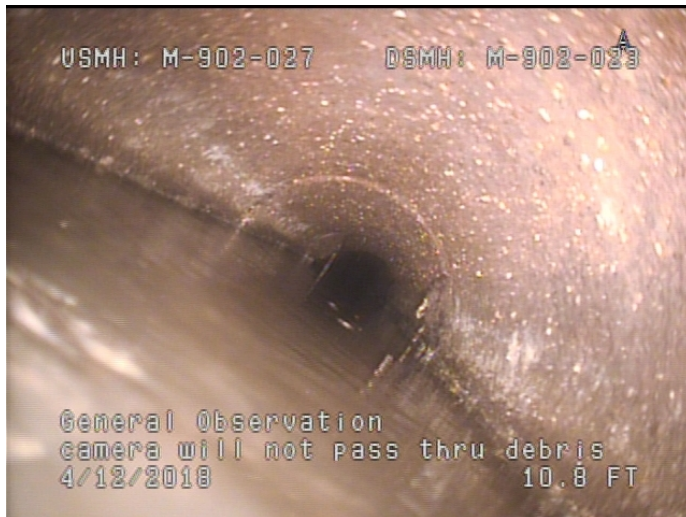
Code:	MGO
Description:	General Observation
Distance (ft):	10.8
Structural Grade:	0
O&M Grade:	0
Clock Start/From:	
Clock To:	
1st Value:	
2nd Value:	
Value Percent:	
Continuous Index:	
Within 8" of Joint:	NO
Remarks:	camera will not pass thru debris

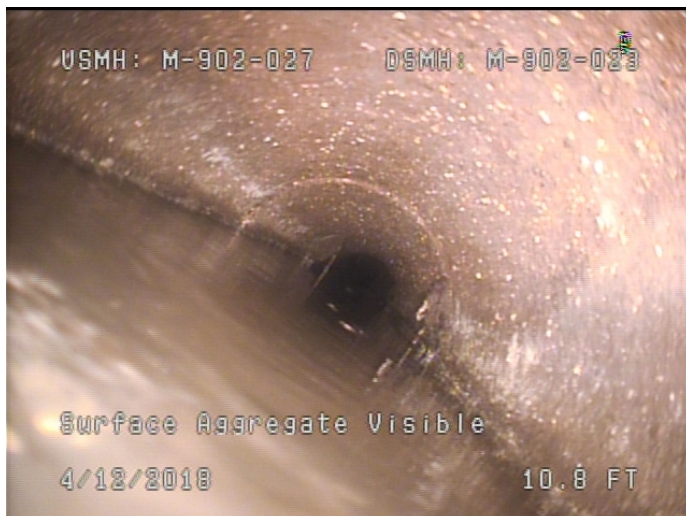
Code:	SAV
Description:	Surface Aggregate Visible
Distance (ft):	10.8
Structural Grade:	3
O&M Grade:	0
Clock Start/From:	8
Clock To:	4
1st Value:	
2nd Value:	
Value Percent:	
Continuous Index:	F01
Within 8" of Joint:	NO
Remarks:

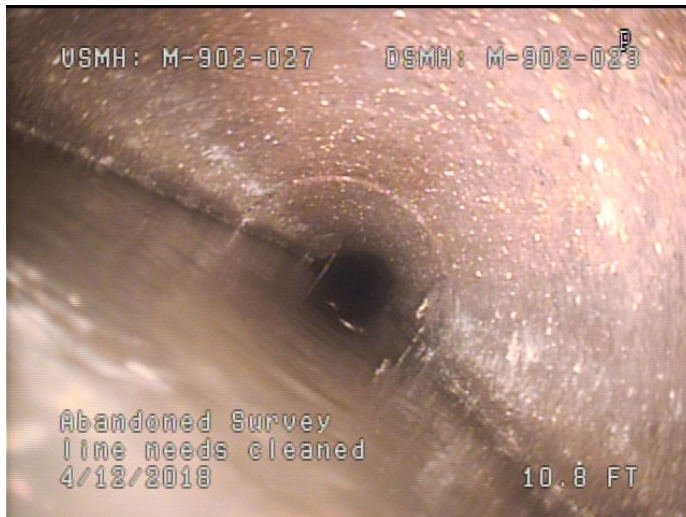
Code:	MSA
Description:	Abandoned Survey
Distance (ft):	10.8
Structural Grade:	0
O&M Grade:	0
Clock Start/From:	
Clock To:	
1st Value:	
2nd Value:	
Value Percent:	
Continuous Index:	
Within 8" of Joint:	NO
Remarks:	line needs cleaned
