Profile/Photo Observation Report

Date:	07/31/2023	Weather:		Coding:	PACP 7.0
Pipe Length (ft):	282.0	Owner:	City of Hobart	Pre Clean:	Heavy Cleaning
P.O.#:	YES502259	Surveyor:	S. Bucklin	PSR:	P-902-027-023
Customer:	City of Hobart	Clean Date:	05/19/2023	Shape:	C

Street:	East 34th Avenue	Flow Control:	Not Controlled
City:	Hobart, IN	Year Renewed:	
Location:	Easement/Right of Way	Tape/Media #:	
Purpose:	Routine Assessment	Dia/Height:	18"
Use:	Sanitary Sewage Pipe	Material:	RCP
Drain Area:		Lining:	None
Category:	NA		
Comment:			
Location Details:		Direction of Survey:	Downstream
US MH:	M-902-027	DS MH:	M-902-023
		Total Length Surveyed (ft):	280.4

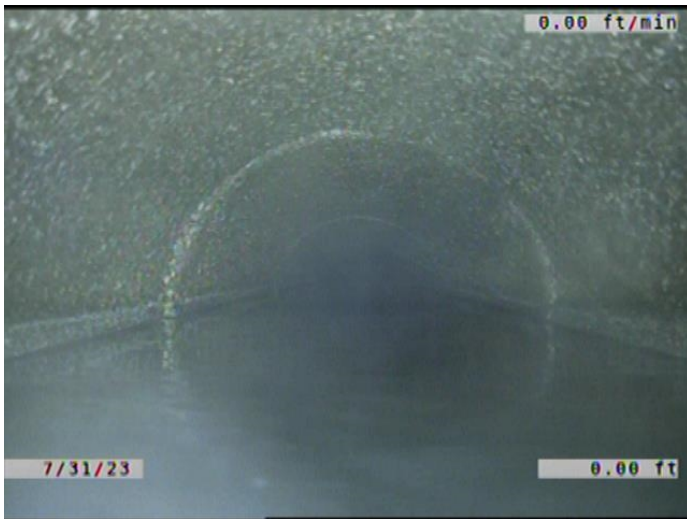
Code: **MWL**
Description: **Miscellaneous Water Level**

Distance (ft): **.0**
Structural Grade: **0**
O&M Grade: **0**
Clock Start/From:
Clock To:
1st Value:
2nd Value:
Value Percent: **50.000**
Continuous Index:
Within 8" of Joint: **NO**
Remarks:

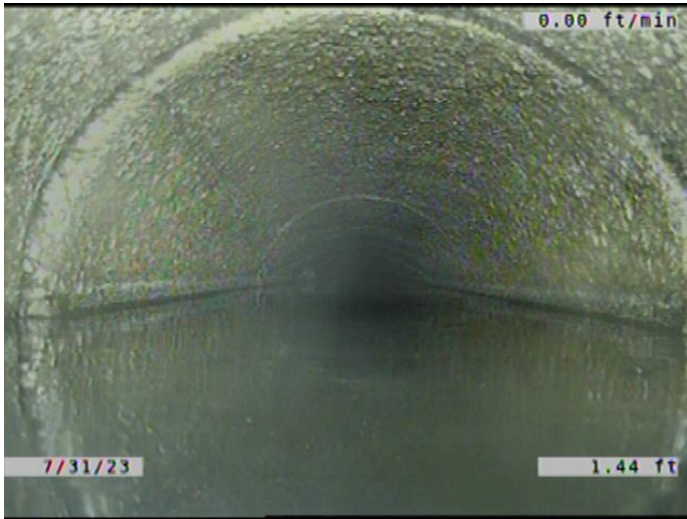
Code: **MWL**
Description: **Miscellaneous Water Level**

Distance (ft): **1.4**
Structural Grade: **0**
O&M Grade: **0**
Clock Start/From:
Clock To:
1st Value:
2nd Value:
Value Percent: **60.000**
Continuous Index:
Within 8" of Joint: **NO**
Remarks:

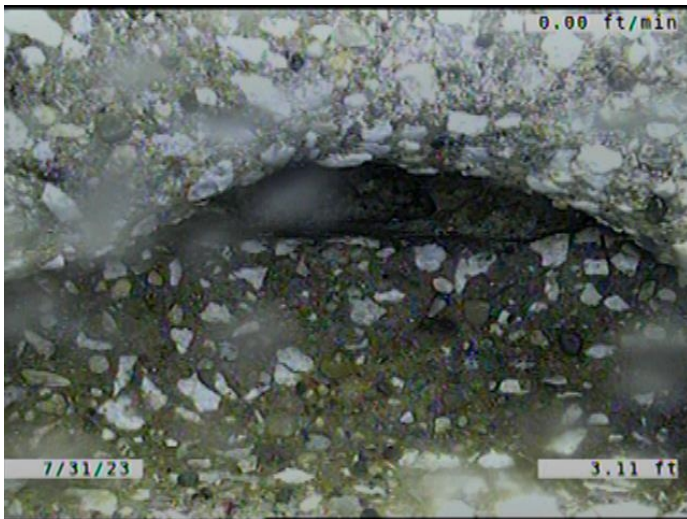
Code: **SMW**
Description: **Surface Damage Missing Wall**

Distance (ft): **3.1**
Structural Grade: **5**
O&M Grade: **0**
Clock Start/From: **9**
Clock To: **3**
1st Value:
2nd Value:
Value Percent:
Continuous Index: **S01**
Within 8" of Joint: **YES**
Remarks: **SOIL VISIBLE. AT JOINTS.**

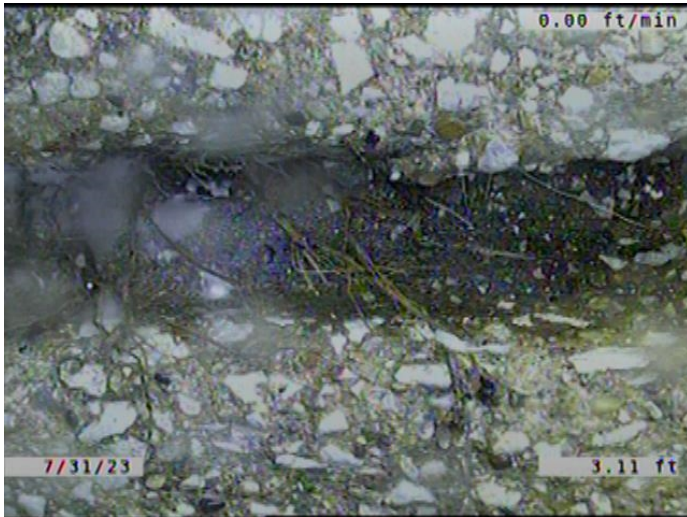
Code: **RFJ**
Description: **Roots Fine Joint**

Distance (ft): **3.1**
Structural Grade: **0**
O&M Grade: **1**
Clock Start/From: **9**
Clock To: **11**
1st Value:
2nd Value:
Value Percent:
Continuous Index:
Within 8" of Joint: **YES**
Remarks:

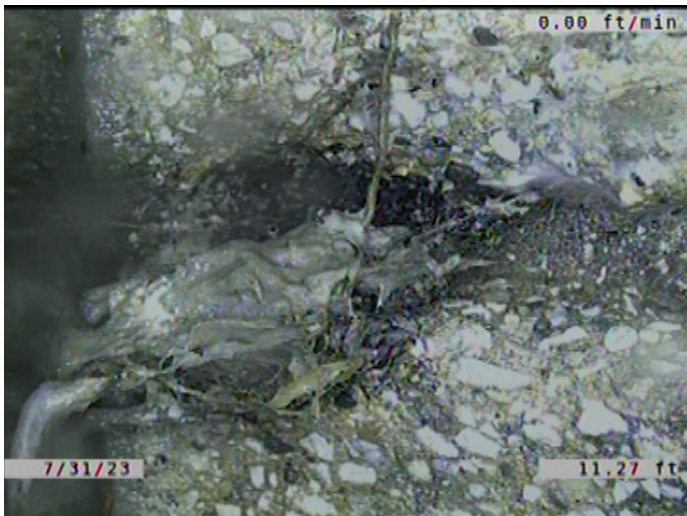
Code: **RFJ**
Description: **Roots Fine Joint**

Distance (ft): **11.3**
Structural Grade: **0**
O&M Grade: **1**
Clock Start/From: **9**
Clock To: **3**
1st Value:
2nd Value:
Value Percent:
Continuous Index: **S02**
Within 8" of Joint: **YES**
Remarks:

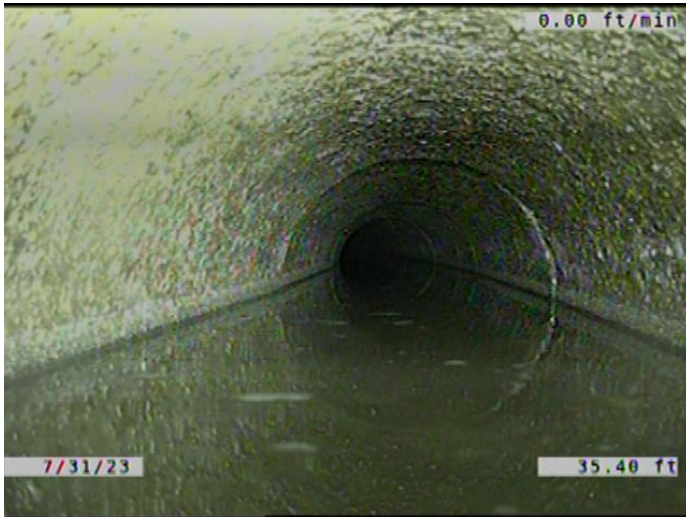
Code: **LR**
Description: **Line Right**

Distance (ft): **35.4**
Structural Grade: **0**
O&M Grade: **1**
Clock Start/From:
Clock To:
1st Value:
2nd Value:
Value Percent: **5.000**
Continuous Index:
Within 8" of Joint: **NO**
Remarks:

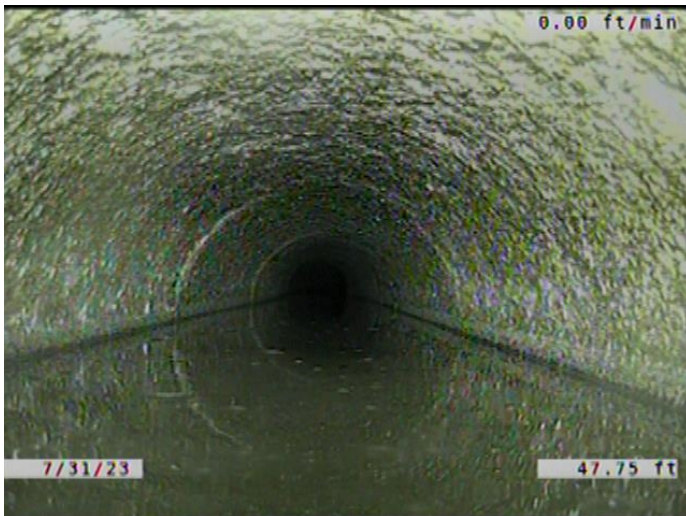
Code: **LL**
Description: **Line Left**

Distance (ft): **47.7**
Structural Grade: **0**
O&M Grade: **1**
Clock Start/From:
Clock To:
1st Value:
2nd Value:
Value Percent: **5.000**
Continuous Index:
Within 8" of Joint: **NO**
Remarks:

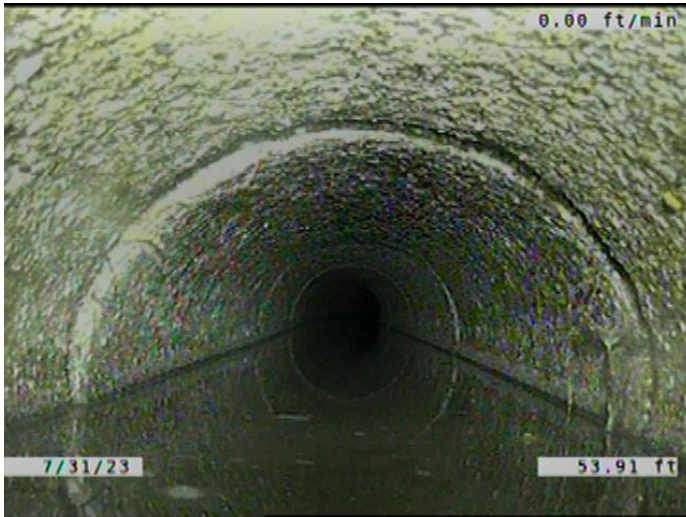
Code: **MWL**
Description: **Miscellaneous Water Level**

Distance (ft): **53.9**
Structural Grade: **0**
O&M Grade: **0**
Clock Start/From:
Clock To:
1st Value:
2nd Value:
Value Percent: **45.000**
Continuous Index:
Within 8" of Joint: **NO**
Remarks:

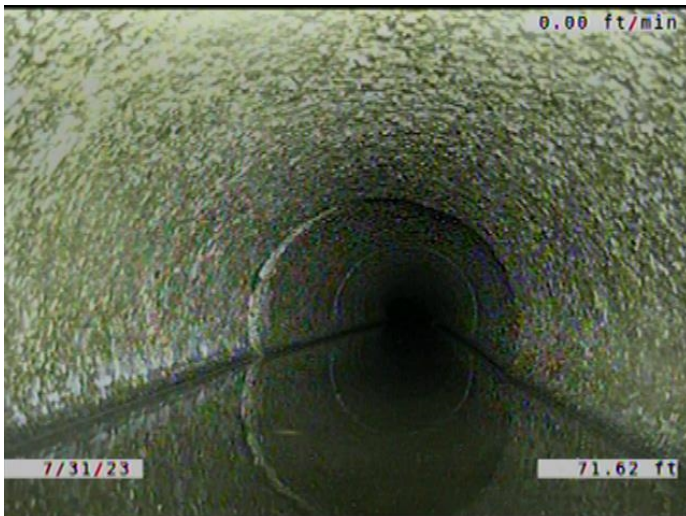
Code: **LR**
Description: **Line Right**

Distance (ft): **71.6**
Structural Grade: **0**
O&M Grade: **1**
Clock Start/From:
Clock To:
1st Value:
2nd Value:
Value Percent: **5.000**
Continuous Index:
Within 8" of Joint: **NO**
Remarks:

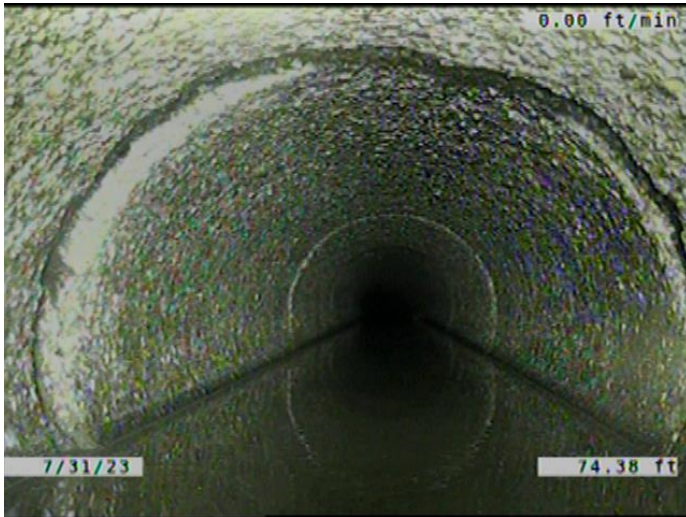
Code: **MWL**
 Description: **Miscellaneous Water Level**

Distance (ft): **74.4**
 Structural Grade: **0**
 O&M Grade: **0**
 Clock Start/From:
 Clock To:
 1st Value:
 2nd Value:
 Value Percent: **20.000**
 Continuous Index:
 Within 8" of Joint: **NO**
 Remarks:

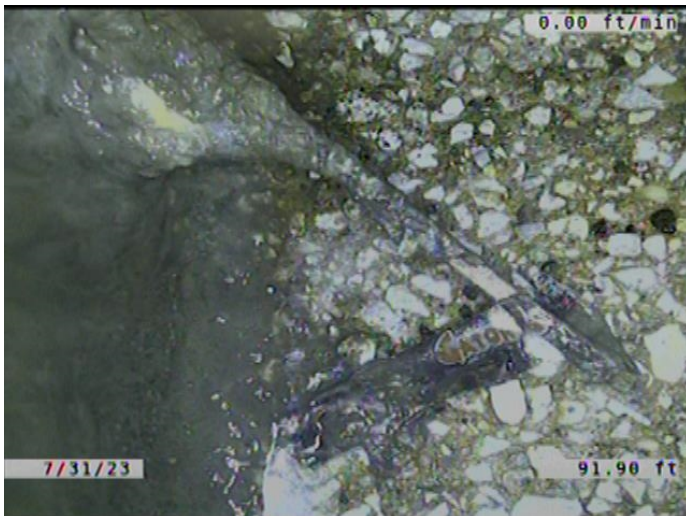
Code: **OBZ**
 Description: **Obstruction Other**

Distance (ft): **91.9**
 Structural Grade: **0**
 O&M Grade: **2**
 Clock Start/From: **4**
 Clock To: **6**
 1st Value:
 2nd Value:
 Value Percent: **5.000**
 Continuous Index:
 Within 8" of Joint: **YES**
 Remarks: **STICK**

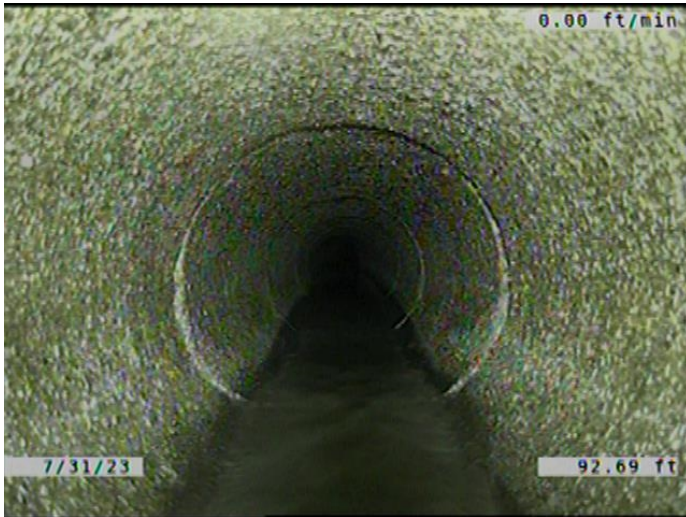
Code: **MWL**
Description: **Miscellaneous Water Level**

Distance (ft): **92.7**
Structural Grade: **0**
O&M Grade: **0**
Clock Start/From:
Clock To:
1st Value:
2nd Value:
Value Percent: **10.000**
Continuous Index:
Within 8" of Joint: **NO**
Remarks:

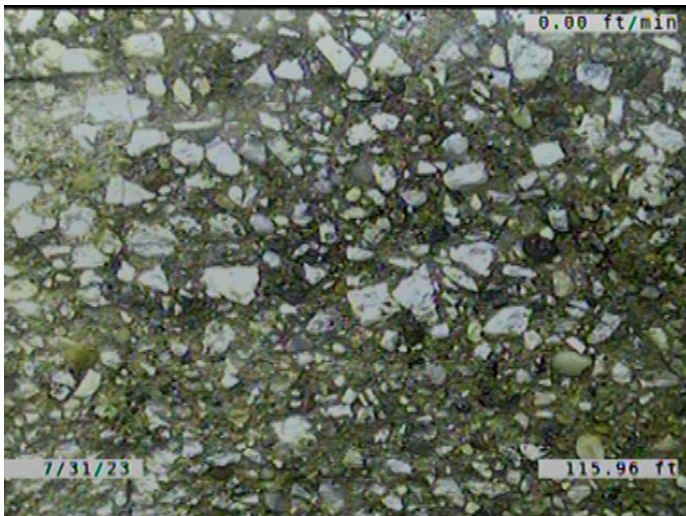
Code: **SAM**
Description: **Surface Damage Aggregate Missing**

Distance (ft): **116.0**
Structural Grade: **4**
O&M Grade: **0**
Clock Start/From: **12**
Clock To: **3**
1st Value:
2nd Value:
Value Percent:
Continuous Index:
Within 8" of Joint: **YES**
Remarks:

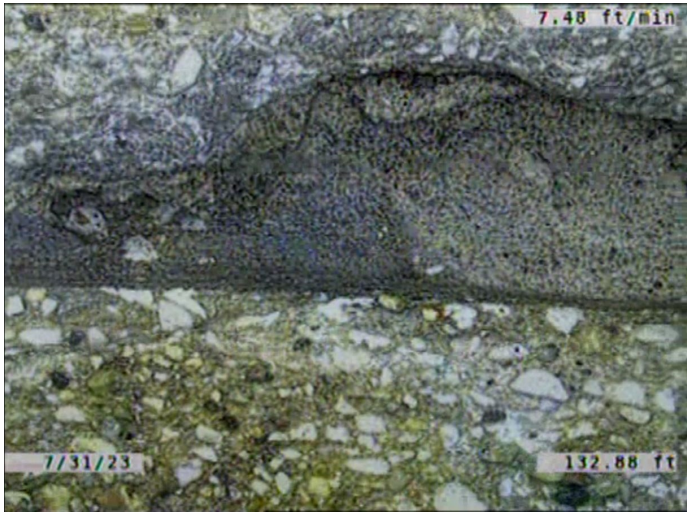
Code: **SMW**
Description: **Surface Damage Missing Wall**

Distance (ft): **132.8**
Structural Grade: **5**
O&M Grade: **0**
Clock Start/From: **9**
Clock To: **3**
1st Value:
2nd Value:
Value Percent:
Continuous Index: **F01**
Within 8" of Joint: **YES**
Remarks: **SOIL VISIBLE. AT JOINTS.**

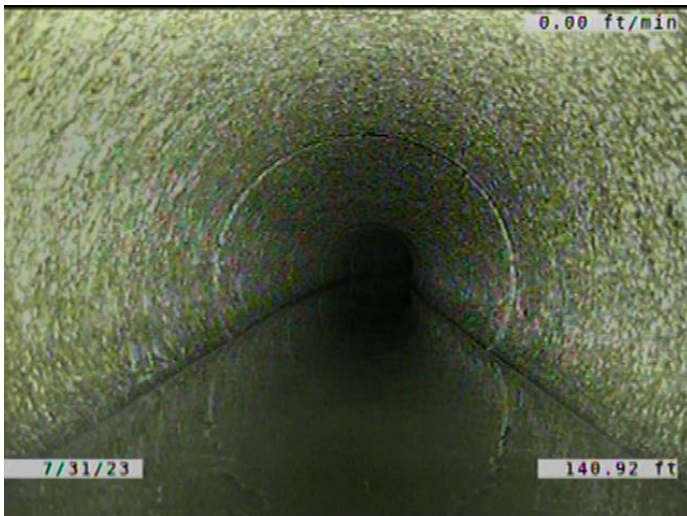
Code: **RFJ**
Description: **Roots Fine Joint**

Distance (ft): **140.9**
Structural Grade: **0**
O&M Grade: **1**
Clock Start/From: **9**
Clock To: **3**
1st Value:
2nd Value:
Value Percent:
Continuous Index: **F02**
Within 8" of Joint: **YES**
Remarks:

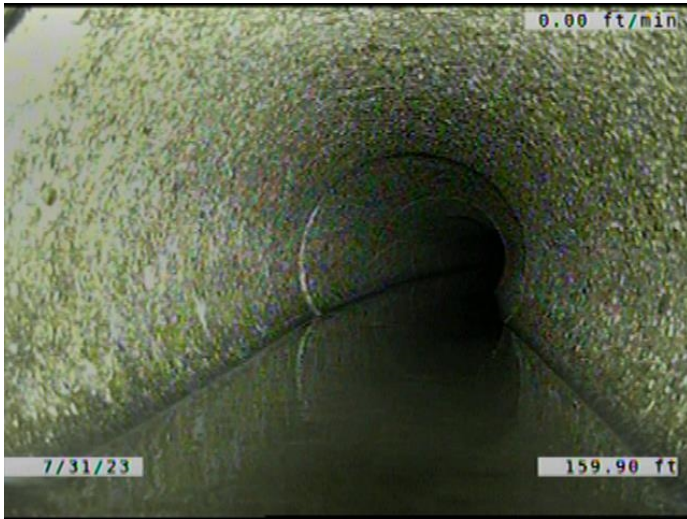
Code: **LR**
Description: **Line Right**

Distance (ft): **159.9**
Structural Grade: **0**
O&M Grade: **2**
Clock Start/From:
Clock To:
1st Value:
2nd Value:
Value Percent: **15.000**
Continuous Index:
Within 8" of Joint: **NO**
Remarks:

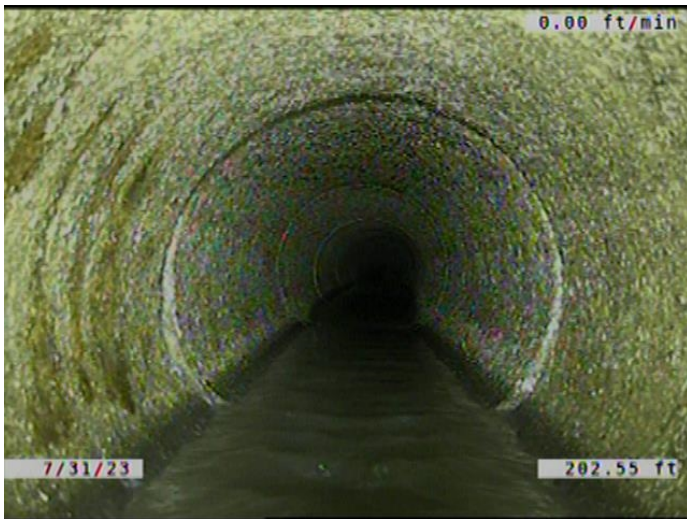
Code: **SRP**
Description: **Surface Damage Reinforcement Projecting**

Distance (ft): **202.5**
Structural Grade: **5**
O&M Grade: **0**
Clock Start/From: **8**
Clock To: **10**
1st Value:
2nd Value:
Value Percent:
Continuous Index:
Within 8" of Joint: **YES**
Remarks:

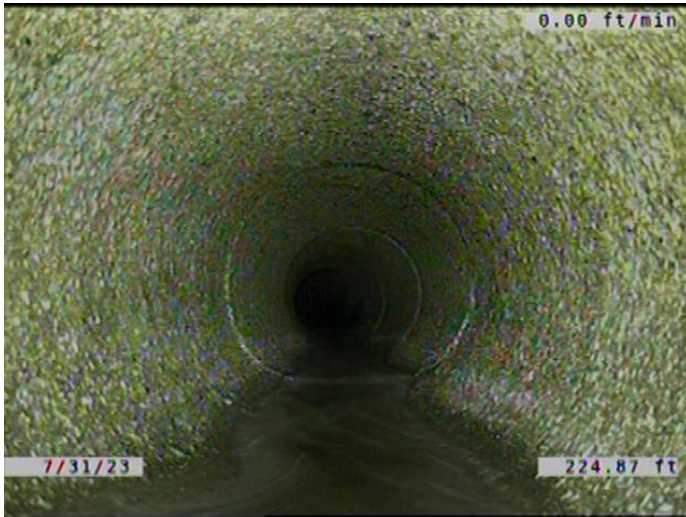
Code: **LD**
Description: **Line Down**

Distance (ft): **224.9**
Structural Grade: **0**
O&M Grade: **1**
Clock Start/From:
Clock To:
1st Value:
2nd Value:
Value Percent: **10.000**
Continuous Index:
Within 8" of Joint: **NO**
Remarks:

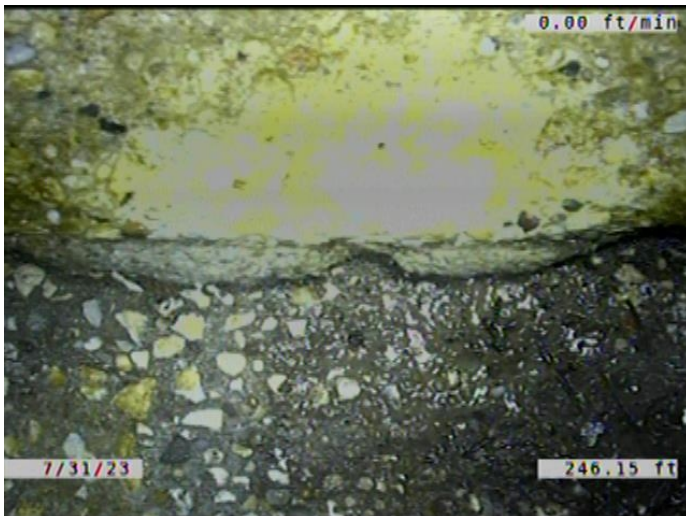
Code: **MSC**
Description: **Miscellaneous Shape/Size Change**

Distance (ft): **246.1**
Structural Grade: **0**
O&M Grade: **0**
Clock Start/From:
Clock To:
1st Value: **21.000**
2nd Value:
Value Percent:
Continuous Index:
Within 8" of Joint: **NO**
Remarks:

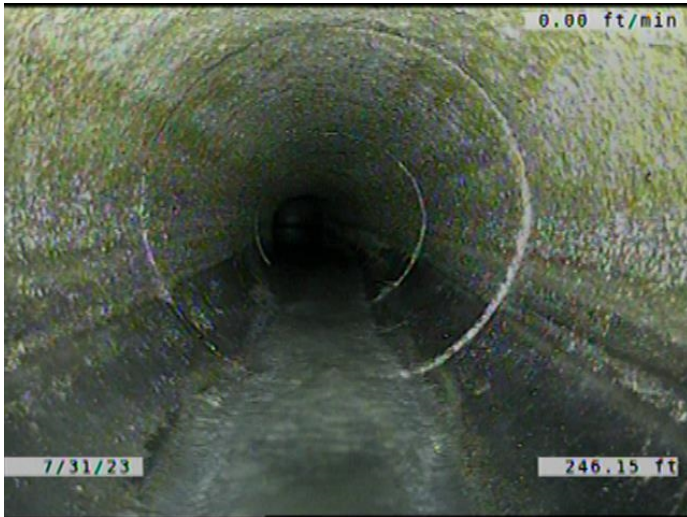
Code:	MGO
Description:	Miscellaneous General Observation
Distance (ft):	246.1
Structural Grade:	0
O&M Grade:	0
Clock Start/From:	
Clock To:	
1st Value:	
2nd Value:	
Value Percent:	
Continuous Index:	
Within 8" of Joint:	NO
Remarks:	18" RCP TO 21" RCP

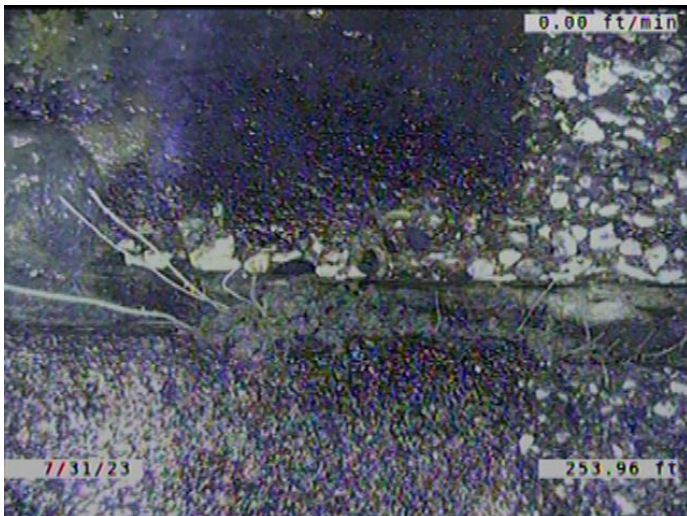
Code:	RFJ
Description:	Roots Fine Joint
Distance (ft):	254.0
Structural Grade:	0
O&M Grade:	1
Clock Start/From:	12
Clock To:	5
1st Value:	
2nd Value:	
Value Percent:	
Continuous Index:	
Within 8" of Joint:	YES
Remarks:

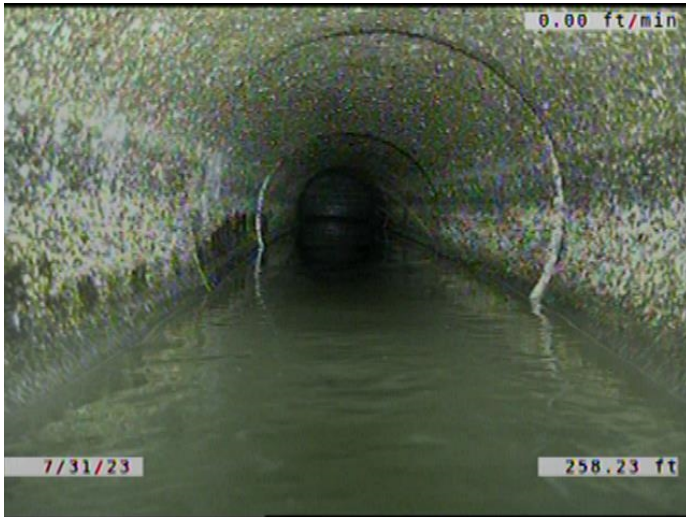
Code:	MWL
Description:	Miscellaneous Water Level
Distance (ft):	258.2
Structural Grade:	0
O&M Grade:	0
Clock Start/From:	
Clock To:	
1st Value:	
2nd Value:	
Value Percent:	25.000
Continuous Index:	
Within 8" of Joint:	NO
Remarks:

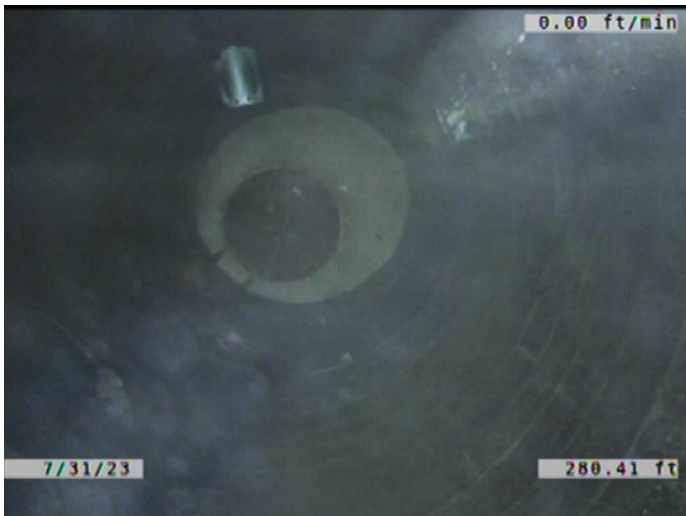
Code:	AMH
Description:	Manhole
Distance (ft):	280.4
Structural Grade:	0
O&M Grade:	0
Clock Start/From:	
Clock To:	
1st Value:	
2nd Value:	
Value Percent:	
Continuous Index:	
Within 8" of Joint:	NO
Remarks:	M-902-023
