Profile/Photo Observation Report

Street:	randolph pl	Flow Control:	Not Controlled
City:	Hobart, IN	Year Renewed:	
Location:	Other	Tape/Media #:	
Purpose:	Not Known	Dia/Height:	10"
Use:	Sanitary	Material:	PVC
Drain Area:	NA	Lining:	
Category:	NA		
Comment:

Location Details:		Direction of Survey:	Downstream
US MH:	M-902-030	DS MH:	M-902-029
		Total Length Surveyed (ft):	3.2

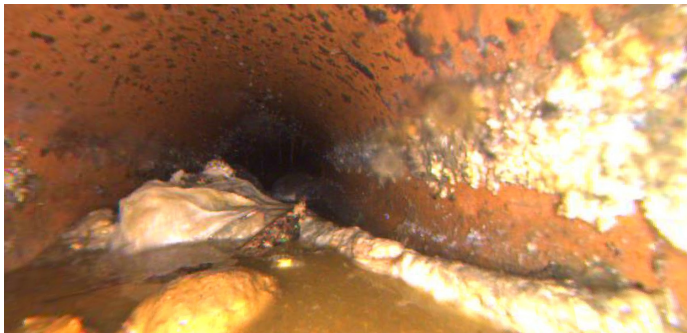
Code: **AMH**
Description: **Manhole**

Distance (ft): **.0**
Structural Grade: **0**
O&M Grade: **0**
Clock Start/From:
Clock To:
1st Value:
2nd Value:
Value Percent:
Continuous Index:
Within 8" of Joint: **NO**
Remarks: **M-902-030**

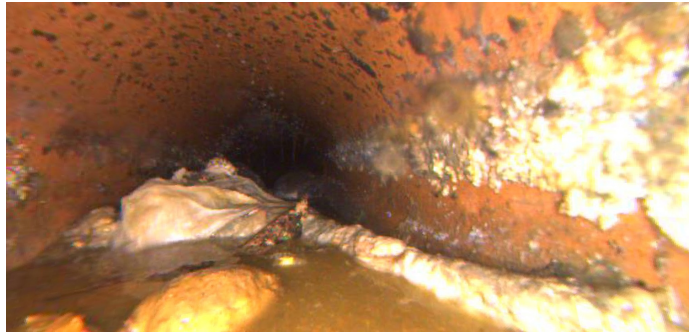
Code: **MWL**
Description: **Water Level**

Distance (ft): **.0**
Structural Grade: **0**
O&M Grade: **0**
Clock Start/From:
Clock To:
1st Value:
2nd Value:
Value Percent: **40.000**
Continuous Index:
Within 8" of Joint: **NO**
Remarks:

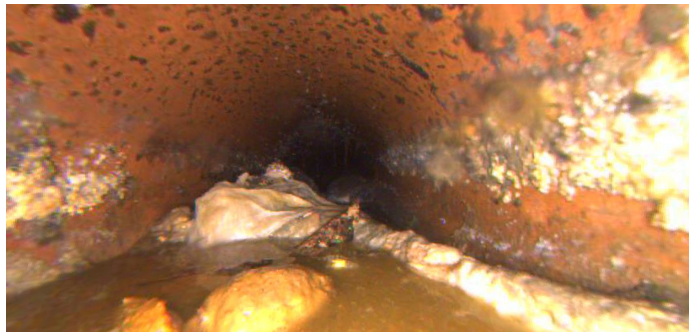
Code: **DAGS**
Description: **Deposits Attached Grease**

Distance (ft): **.0**
Structural Grade: **0**
O&M Grade: **2**
Clock Start/From: **8**
Clock To: **4**
1st Value:
2nd Value:
Value Percent: **5.000**
Continuous Index:
Within 8" of Joint: **NO**
Remarks:

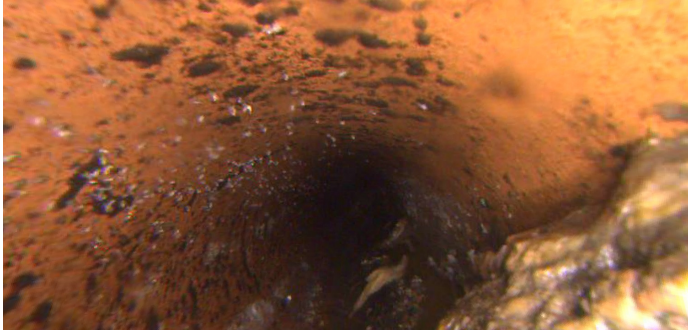
Code:	MSA
Description:	Abandoned Survey
Distance (ft):	3.2
Structural Grade:	0
O&M Grade:	0
Clock Start/From:	
Clock To:	
1st Value:	
2nd Value:	
Value Percent:	
Continuous Index:	
Within 8" of Joint:	NO
Remarks:	OVERTURNED
