## Profile/Photo Observation Report

Street:	<b>N HOBART RD</b>	Flow Control:	<b>Not Controlled</b>
City:	<b>Hobart, IN</b>	Year Renewed:	
Location:	<b>Other</b>	Tape/Media #:	
Purpose:	<b>Not Known</b>	Dia/Height:	<b>12"</b>
Use:	<b>Sanitary</b>	Material:	<b>VCP</b>
Drain Area:	<b>NA</b>	Lining:	
Category:	<b>NA</b>		
Comment:

Location Details:		Direction of Survey:	<b>Downstream</b>
US MH:	<b>M-902-031</b>	DS MH:	<b>M-902-020</b>
		Total Length Surveyed (ft):	<b>18.8</b>

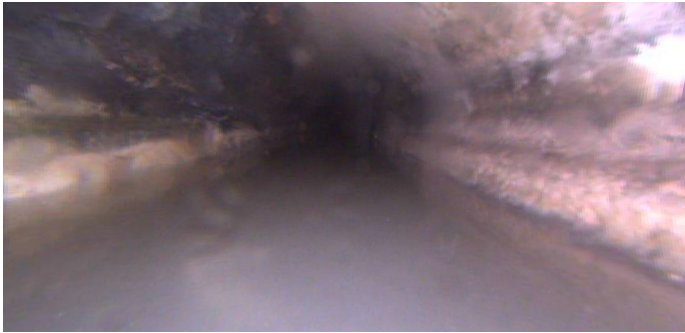
Code:	<b>AMH</b>
Description:	<b>Manhole</b>

Distance (ft):	<b>.0</b>
Structural Grade:	<b>0</b>
O&M Grade:	<b>0</b>
Clock Start/From:	
Clock To:	
1st Value:	
2nd Value:	
Value Percent:	
Continuous Index:	
Within 8" of Joint:	<b>NO</b>
Remarks:	<b>M-902-031</b>

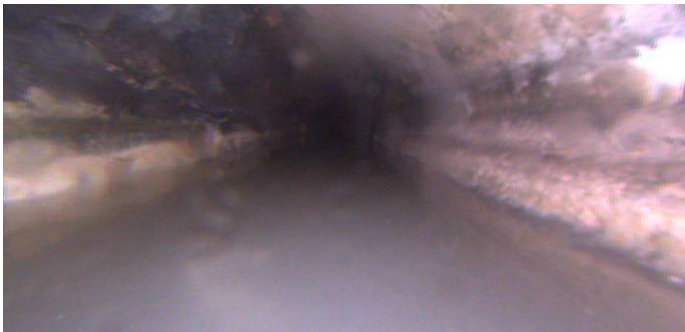
Code:	<b>MWL</b>
Description:	<b>Water Level</b>

Distance (ft):	<b>.0</b>
Structural Grade:	<b>0</b>
O&M Grade:	<b>0</b>
Clock Start/From:	
Clock To:	
1st Value:	
2nd Value:	
Value Percent:	<b>5.000</b>
Continuous Index:	
Within 8" of Joint:	<b>NO</b>
Remarks:

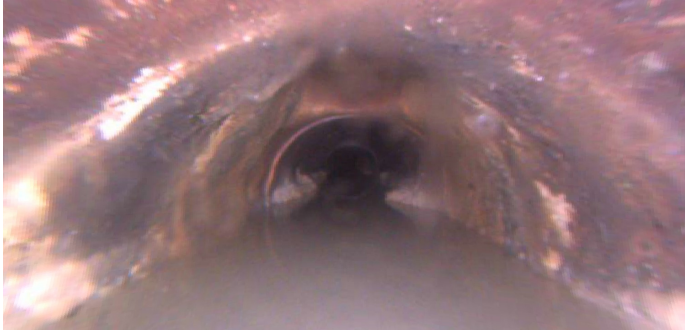
Code: **TF**  
Description: **Tap Factory**

Distance (ft): **7.1**  
Structural Grade: **0**  
O&M Grade: **0**  
Clock Start/From: **12**  
Clock To:  
1st Value: **4.000**  
2nd Value:  
Value Percent:  
Continuous Index:  
Within 8" of Joint:  
Remarks:

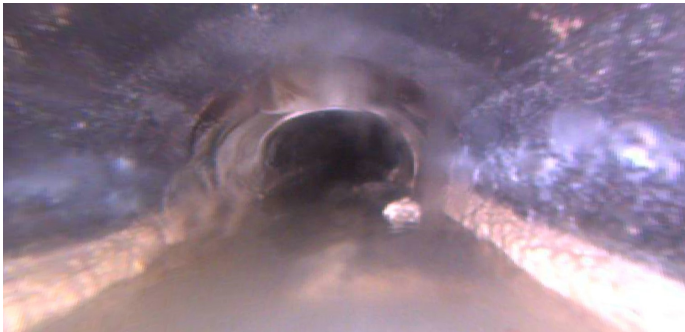
Code: **TF**  
Description: **Tap Factory**

Distance (ft): **10.6**  
Structural Grade: **0**  
O&M Grade: **0**  
Clock Start/From: **12**  
Clock To:  
1st Value: **4.000**  
2nd Value:  
Value Percent:  
Continuous Index:  
Within 8" of Joint:  
Remarks:

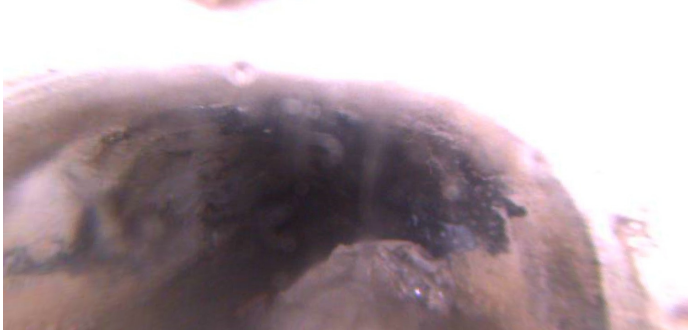
Code: **D**  
Description: **Deformed**

Distance (ft): **11.9**  
Structural Grade: **4**  
O&M Grade: **0**  
Clock Start/From:  
Clock To:  
1st Value:  
2nd Value:  
Value Percent: **5.000**  
Continuous Index:  
Within 8" of Joint: **NO**  
Remarks:

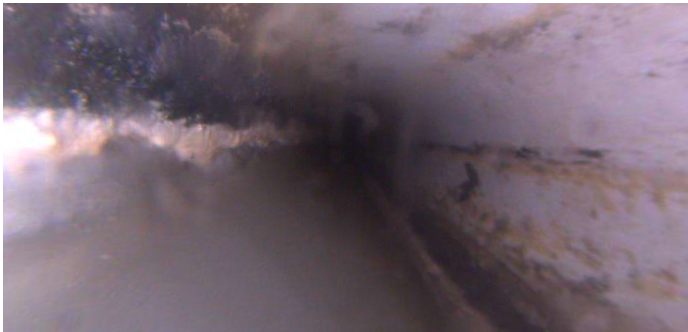
Code: **DAGS**  
Description: **Deposits Attached Grease**

Distance (ft): **18.8**  
Structural Grade: **0**  
O&M Grade: **2**  
Clock Start/From: **8**  
Clock To: **4**  
1st Value:  
2nd Value:  
Value Percent: **5.000**  
Continuous Index: **F01**  
Within 8" of Joint: **NO**  
Remarks:

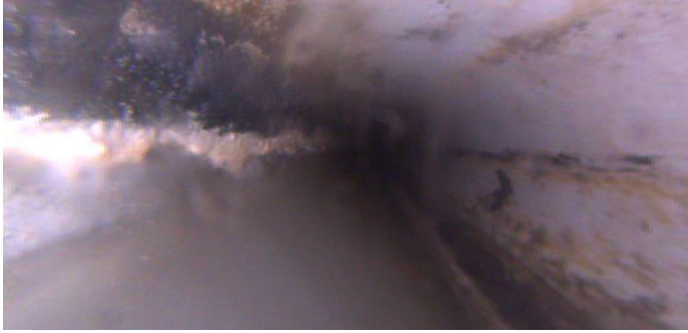
Code:	<b>MSA</b>
Description:	<b>Abandoned Survey</b>
Distance (ft):	<b>18.8</b>
Structural Grade:	<b>0</b>
O&M Grade:	<b>0</b>
Clock Start/From:	
Clock To:	
1st Value:	
2nd Value:	
Value Percent:	
Continuous Index:	
Within 8" of Joint:	<b>NO</b>
Remarks:	<b>camera stopped</b>
