Profile/Photo Observation Report

Date:	03/21/2018	Weather:		Coding:	PACP 6.0
Pipe Length (ft):	222.9	Owner:	NA	Pre Clean:	Not Known
P.O.#:		Surveyor:	Selasie Honu	PSR:	P-902-020-031
Customer:		Clean Date:	01/01/1900	Shape:	C

Street:	37th ave	Flow Control:	Not Controlled
City:	Hobart, IN	Year Renewed:	
Location:	Other	Tape/Media #:	
Purpose:	Not Known	Dia/Height:	12"
Use:	Sanitary	Material:	VCP
Drain Area:	NA	Lining:	
Category:	NA		
Comment:

Location Details:		Direction of Survey:	Downstream
US MH:	M-902-031	DS MH:	M-902-020
		Total Length Surveyed (ft):	18.8

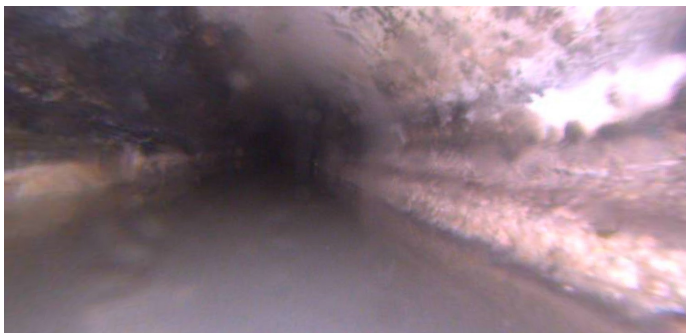
Code: **DAGS**
Description: **Deposits Attached Grease**

Distance (ft): **.0**
Structural Grade: **0**
O&M Grade: **2**
Clock Start/From: **8**
Clock To: **4**
1st Value:
2nd Value:
Value Percent: **5.000**
Continuous Index: **S01**
Within 8" of Joint: **NO**
Remarks:

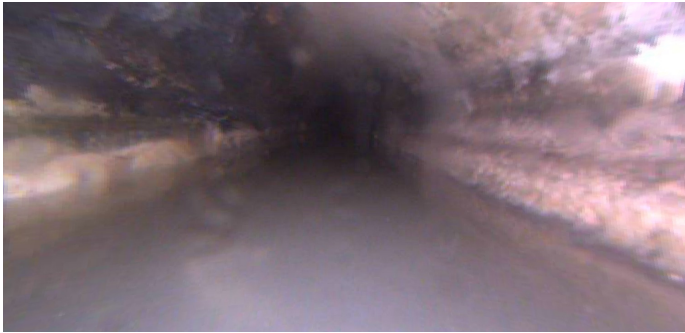
Code:	AMH
Description:	Manhole

Distance (ft):	.0
Structural Grade:	0
O&M Grade:	0
Clock Start/From:	
Clock To:	
1st Value:	
2nd Value:	
Value Percent:	
Continuous Index:	
Within 8" of Joint:	NO
Remarks:	M-902-031

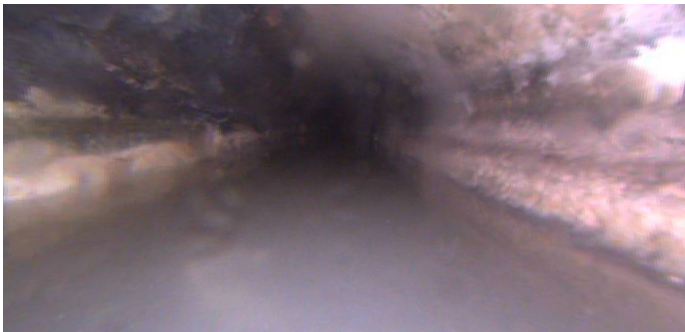
Code:	MWL
Description:	Water Level

Distance (ft):	.0
Structural Grade:	0
O&M Grade:	0
Clock Start/From:	
Clock To:	
1st Value:	
2nd Value:	
Value Percent:	5.000
Continuous Index:	
Within 8" of Joint:	NO
Remarks:

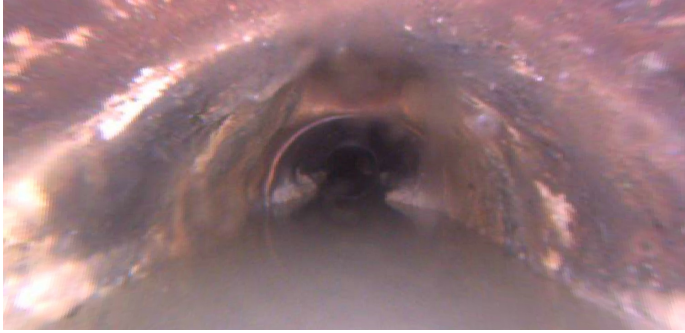
Code: **TF**
Description: **Tap Factory**

Distance (ft): **7.1**
Structural Grade: **0**
O&M Grade: **0**
Clock Start/From: **12**
Clock To:
1st Value: **4.000**
2nd Value:
Value Percent:
Continuous Index:
Within 8" of Joint:
Remarks:

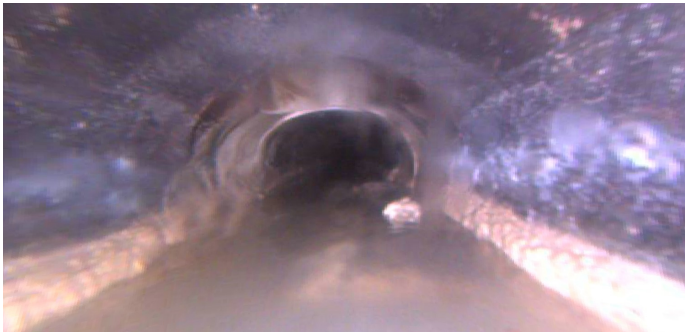
Code: **TF**
Description: **Tap Factory**

Distance (ft): **10.6**
Structural Grade: **0**
O&M Grade: **0**
Clock Start/From: **12**
Clock To:
1st Value: **4.000**
2nd Value:
Value Percent:
Continuous Index:
Within 8" of Joint:
Remarks:

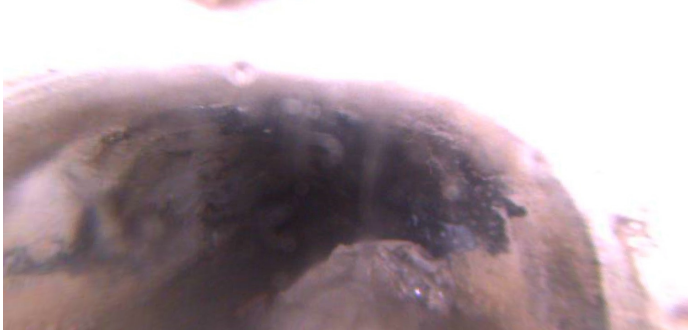
Code: **D**
Description: **Deformed**

Distance (ft): **11.9**
Structural Grade: **4**
O&M Grade: **0**
Clock Start/From:
Clock To:
1st Value:
2nd Value:
Value Percent: **5.000**
Continuous Index:
Within 8" of Joint: **NO**
Remarks:

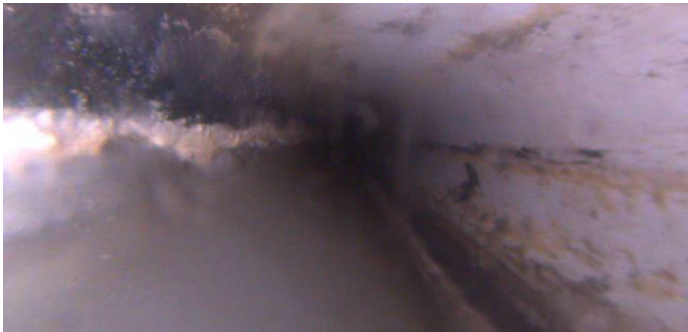
Code: **DAGS**
Description: **Deposits Attached Grease**

Distance (ft): **18.8**
Structural Grade: **0**
O&M Grade: **2**
Clock Start/From: **8**
Clock To: **4**
1st Value:
2nd Value:
Value Percent: **5.000**
Continuous Index: **F01**
Within 8" of Joint: **NO**
Remarks:

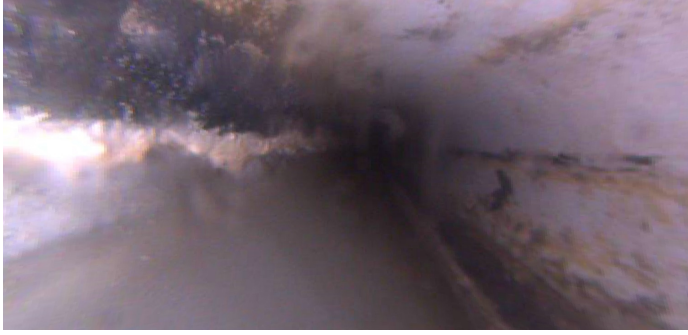
Code:	MSA
Description:	Abandoned Survey
Distance (ft):	18.8
Structural Grade:	0
O&M Grade:	0
Clock Start/From:	
Clock To:	
1st Value:	
2nd Value:	
Value Percent:	
Continuous Index:	
Within 8" of Joint:	NO
Remarks:	camera stopped
