# Profile/Photo Observation Report

Date:	07/24/2023	Weather:		Coding:	PACP 7.0
Pipe Length (ft):	204.0	Owner:	City of Hobart	Pre Clean:	Heavy Cleaning
P.O.#:	YES502259	Surveyor:	S. Bucklin	PSR:	P-902-018-032
Customer:	City of Hobart	Clean Date:	06/02/2023	Shape:	C

Street:	East 34th Court	Flow Control:	Not Controlled
City:	Hobart, IN	Year Renewed:	
Location:	Easement/Right of Way	Tape/Media #:	
Purpose:	Routine Assessment	Dia/Height:	10"
Use:	Sanitary Sewage Pipe	Material:	VCP
Drain Area:		Lining:	None
Category:	NA		
Comment:			
Location Details:		Direction of Survey:	Downstream
US MH:	M-902-032	DS MH:	M-902-018
		Total Length Surveyed (ft):	213.2

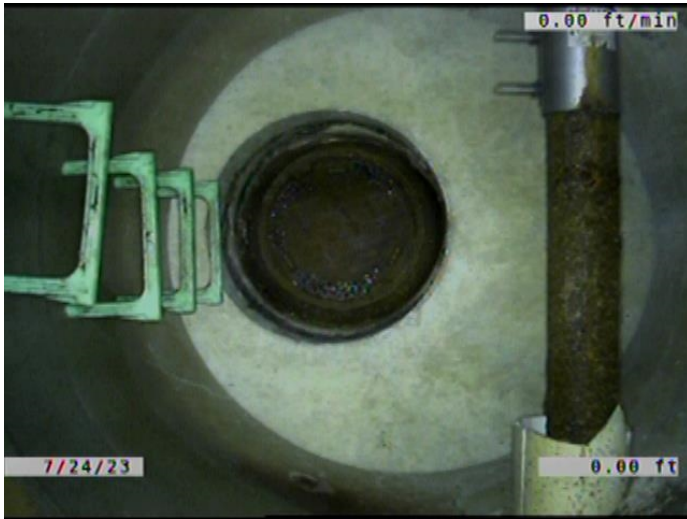
Code: **AMH**  
Description: **Manhole**

Distance (ft): **.0**  
Structural Grade: **0**  
O&M Grade: **0**  
Clock Start/From:  
Clock To:  
1st Value:  
2nd Value:  
Value Percent:  
Continuous Index:  
Within 8" of Joint: **NO**  
Remarks: **M-902-032**

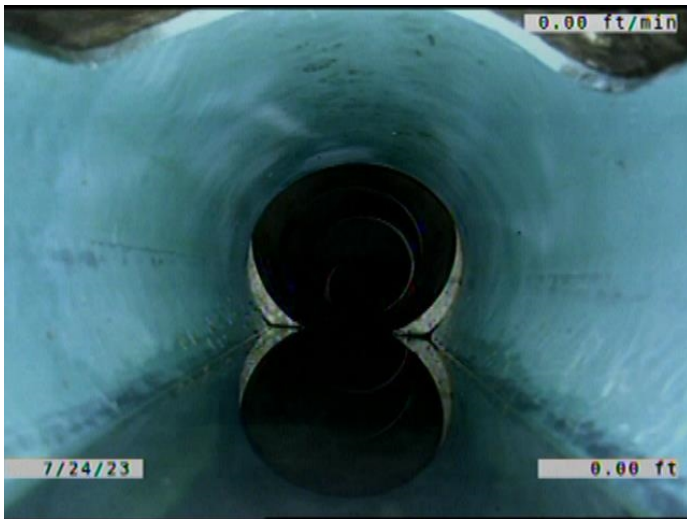
Code: **MWL**  
Description: **Miscellaneous Water Level**

Distance (ft): **.0**  
Structural Grade: **0**  
O&M Grade: **0**  
Clock Start/From:  
Clock To:  
1st Value:  
2nd Value:  
Value Percent: **10.000**  
Continuous Index:  
Within 8" of Joint: **NO**  
Remarks:

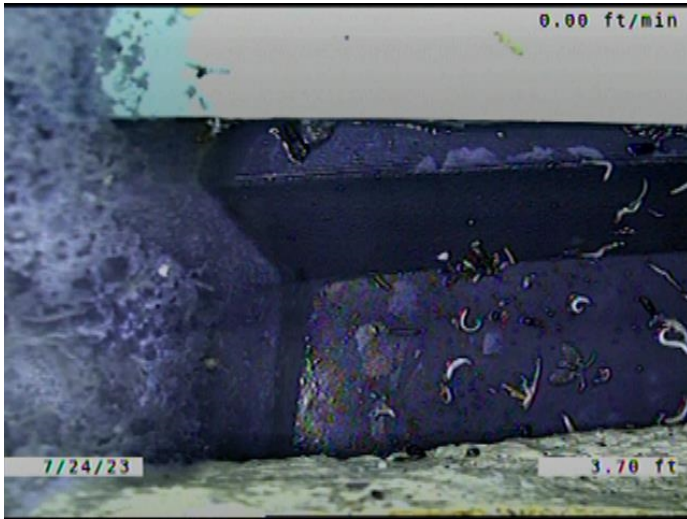
Code: **JAM**  
Description: **Joint Angular Medium**

Distance (ft): **3.7**  
Structural Grade: **3**  
O&M Grade: **0**  
Clock Start/From:  
Clock To:  
1st Value:  
2nd Value:  
Value Percent:  
Continuous Index:  
Within 8" of Joint: **NO**  
Remarks:

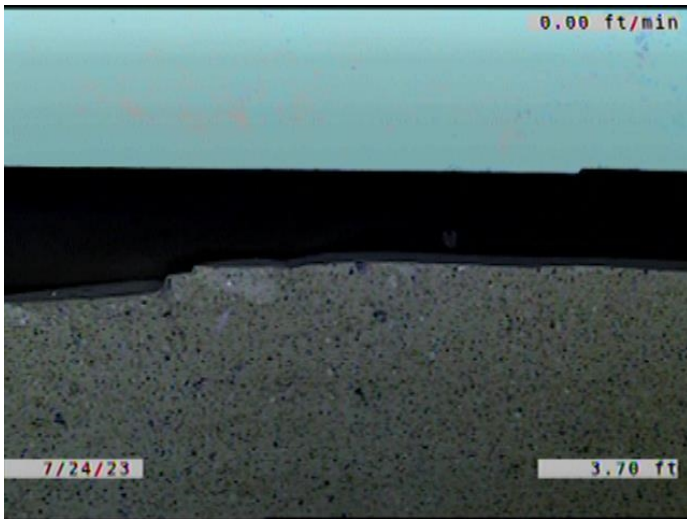
Code: **MMC**  
Description: **Miscellaneous Material Change**

Distance (ft): **3.7**  
Structural Grade: **0**  
O&M Grade: **0**  
Clock Start/From:  
Clock To:  
1st Value:  
2nd Value:  
Value Percent:  
Continuous Index:  
Within 8" of Joint: **NO**  
Remarks: **PVC TO VCP**

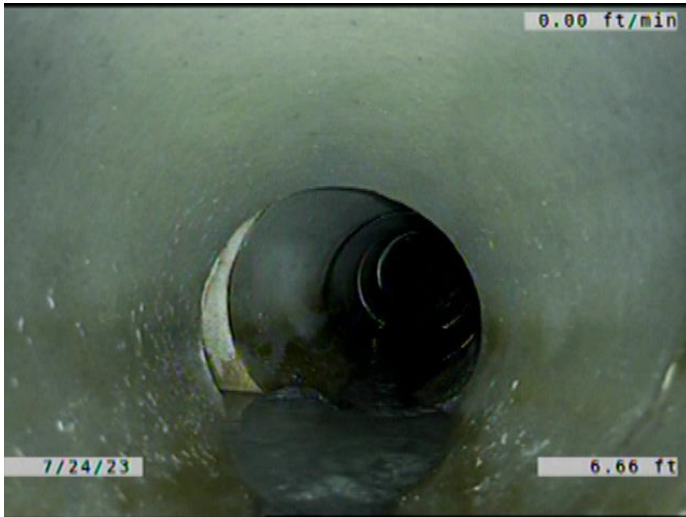
Code: **LD**  
Description: **Line Down**

Distance (ft): **6.7**  
Structural Grade: **0**  
O&M Grade: **2**  
Clock Start/From:  
Clock To:  
1st Value:  
2nd Value:  
Value Percent: **15.000**  
Continuous Index:  
Within 8" of Joint: **NO**  
Remarks:

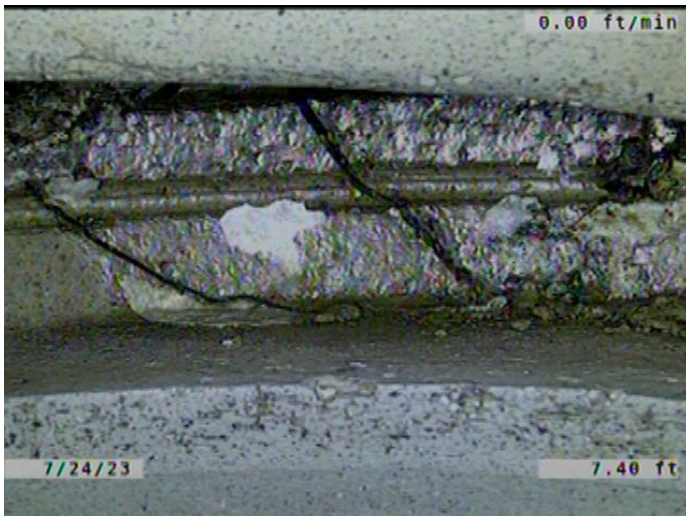
Code: **B**  
Description: **Broken**

Distance (ft): **7.4**  
Structural Grade: **4**  
O&M Grade: **0**  
Clock Start/From: **12**  
Clock To: **5**  
1st Value:  
2nd Value:  
Value Percent:  
Continuous Index:  
Within 8" of Joint: **YES**  
Remarks:

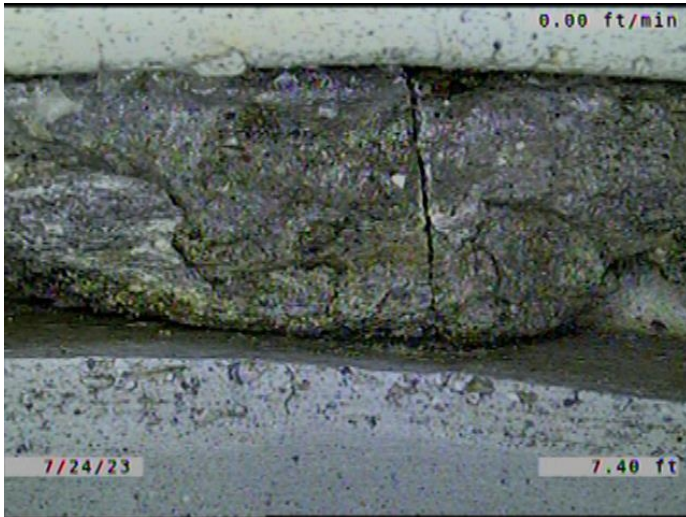
Code: **DAE**  
 Description: **Deposits Attached Encrustation**

Distance (ft): **7.4**  
 Structural Grade: **0**  
 O&M Grade: **2**  
 Clock Start/From: **7**  
 Clock To: **5**  
 1st Value:  
 2nd Value:  
 Value Percent: **5.000**  
 Continuous Index:  
 Within 8" of Joint: **YES**  
 Remarks:

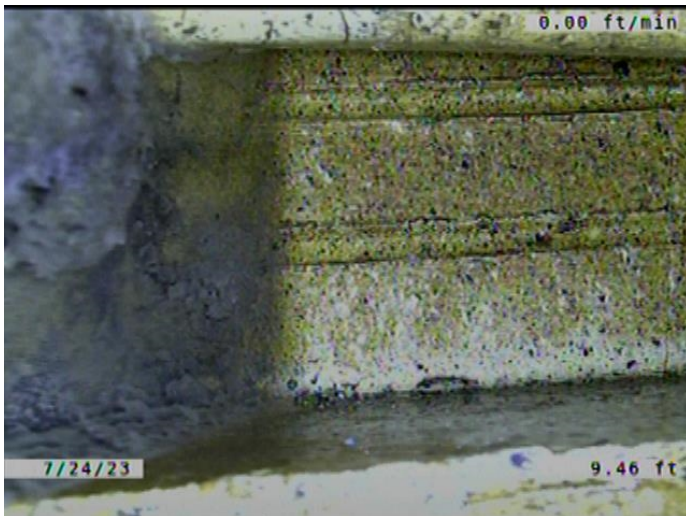
Code: **JAL**  
 Description: **Joint Angular Large**

Distance (ft): **9.5**  
 Structural Grade: **4**  
 O&M Grade: **0**  
 Clock Start/From:  
 Clock To:  
 1st Value:  
 2nd Value:  
 Value Percent:  
 Continuous Index:  
 Within 8" of Joint: **NO**  
 Remarks:

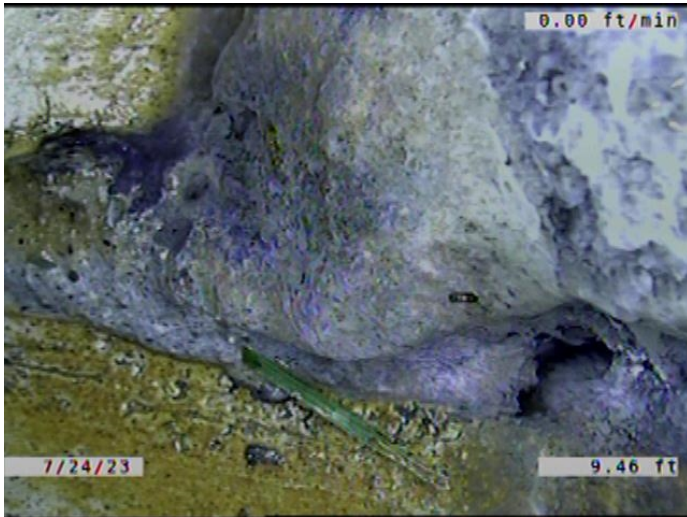
Code: **DAE**  
Description: **Deposits Attached Encrustation**

Distance (ft): **9.5**  
Structural Grade: **0**  
O&M Grade: **2**  
Clock Start/From: **3**  
Clock To: **9**  
1st Value:  
2nd Value:  
Value Percent: **5.000**  
Continuous Index: **S01**  
Within 8" of Joint: **YES**  
Remarks:

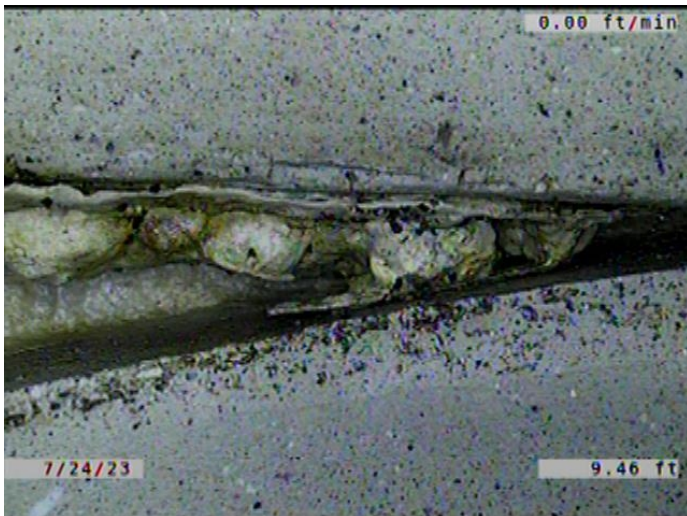
Code: **DAE**  
Description: **Deposits Attached Encrustation**

Distance (ft): **9.5**  
Structural Grade: **0**  
O&M Grade: **2**  
Clock Start/From: **9**  
Clock To: **12**  
1st Value:  
2nd Value:  
Value Percent: **5.000**  
Continuous Index:  
Within 8" of Joint: **YES**  
Remarks:

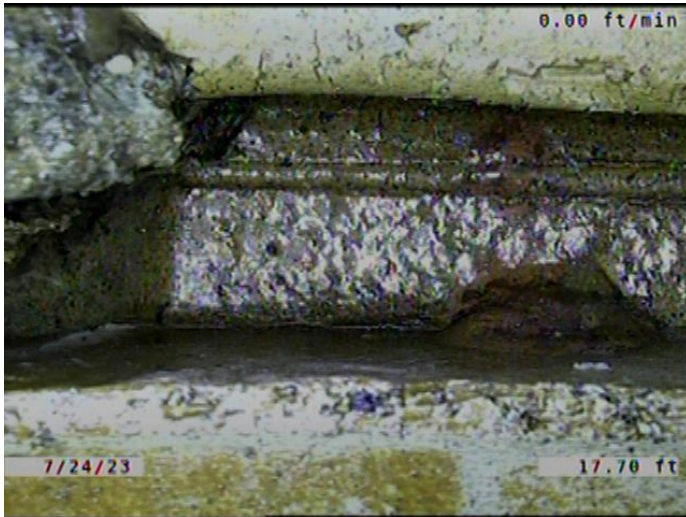
Code: **JAM**  
 Description: **Joint Angular Medium**

Distance (ft): **17.7**  
 Structural Grade: **3**  
 O&M Grade: **0**  
 Clock Start/From:  
 Clock To:  
 1st Value:  
 2nd Value:  
 Value Percent:  
 Continuous Index:  
 Within 8" of Joint: **NO**  
 Remarks:

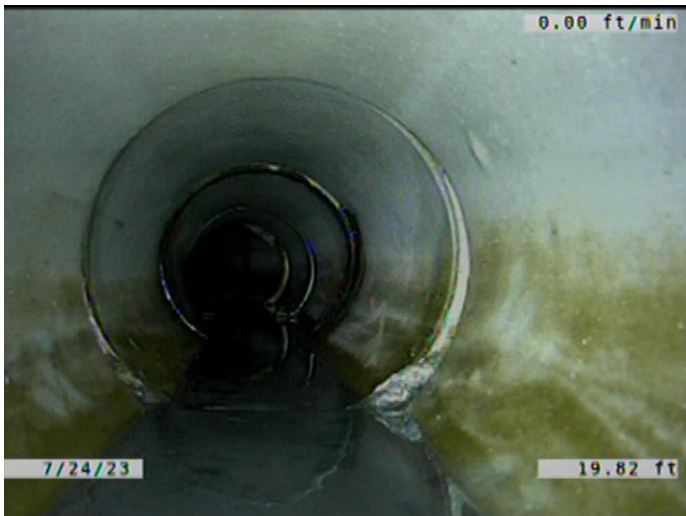
Code: **LL**  
 Description: **Line Left**

Distance (ft): **19.8**  
 Structural Grade: **0**  
 O&M Grade: **4**  
 Clock Start/From:  
 Clock To:  
 1st Value:  
 2nd Value:  
 Value Percent: **35.000**  
 Continuous Index: **S03**  
 Within 8" of Joint: **NO**  
 Remarks:

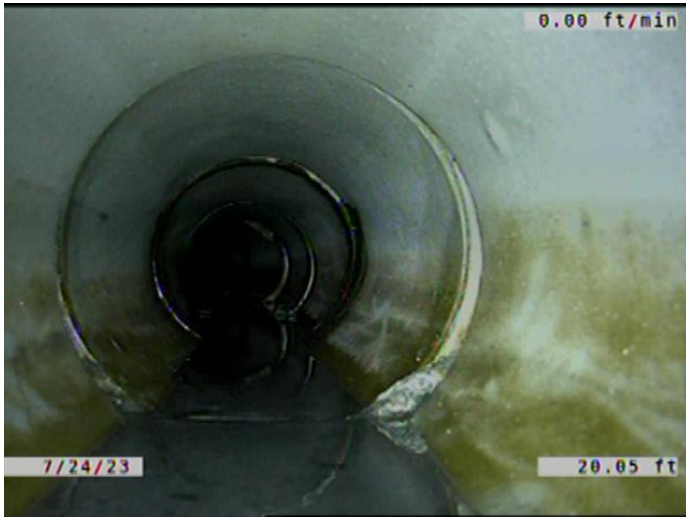
Code: **DSF**  
Description: **Deposits Settled Fine**

Distance (ft): **20.1**  
Structural Grade: **0**  
O&M Grade: **2**  
Clock Start/From: **5**  
Clock To: **7**  
1st Value:  
2nd Value:  
Value Percent: **5.000**  
Continuous Index: **S04**  
Within 8" of Joint: **YES**  
Remarks:

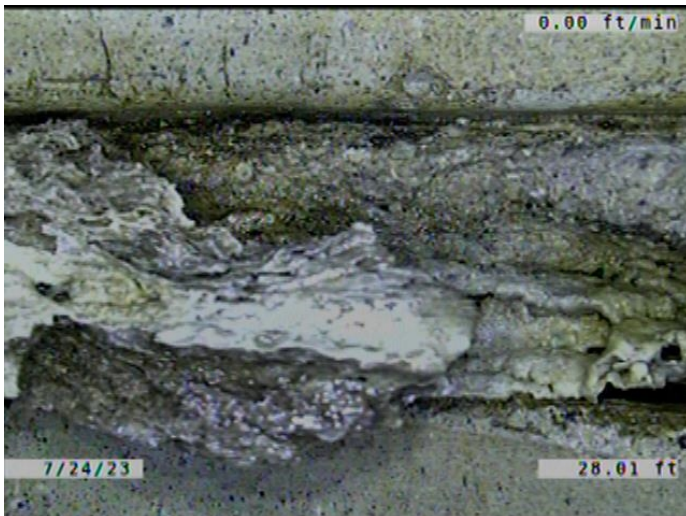
Code: **DAE**  
Description: **Deposits Attached Encrustation**

Distance (ft): **28.0**  
Structural Grade: **0**  
O&M Grade: **2**  
Clock Start/From: **8**  
Clock To: **4**  
1st Value:  
2nd Value:  
Value Percent: **5.000**  
Continuous Index:  
Within 8" of Joint: **YES**  
Remarks:

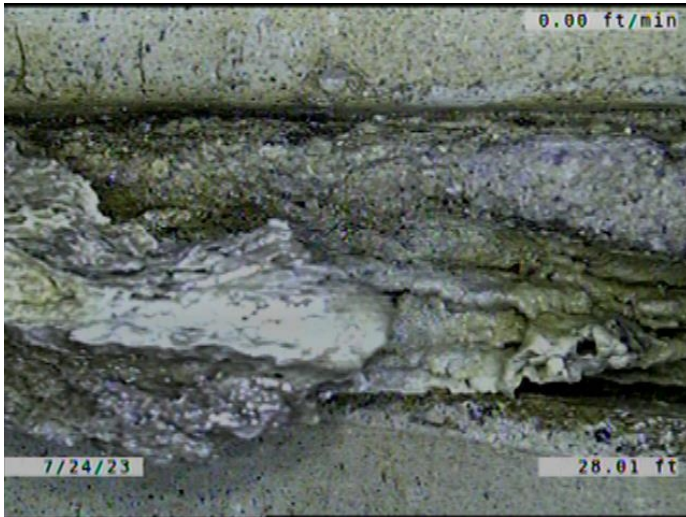
Code: **IWJ**  
 Description: **Infiltration Weeper Joint**

Distance (ft): **28.0**  
 Structural Grade: **0**  
 O&M Grade: **2**  
 Clock Start/From: **2**  
 Clock To:  
 1st Value:  
 2nd Value:  
 Value Percent:  
 Continuous Index:  
 Within 8" of Joint: **YES**  
 Remarks:

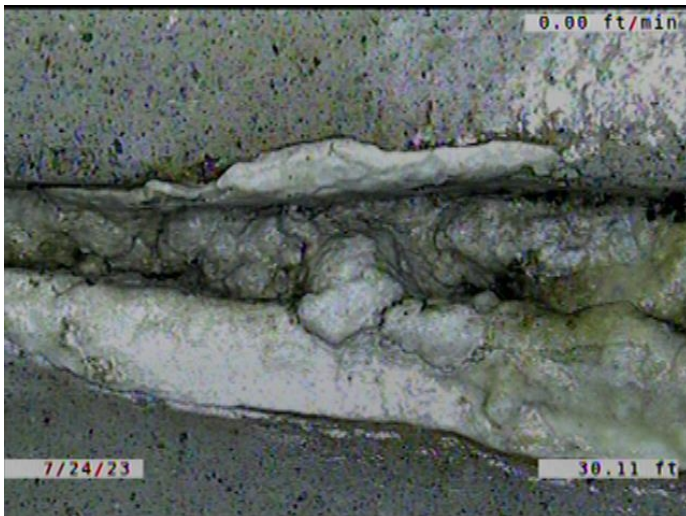
Code: **DAE**  
 Description: **Deposits Attached Encrustation**

Distance (ft): **30.1**  
 Structural Grade: **0**  
 O&M Grade: **2**  
 Clock Start/From: **12**  
 Clock To: **12**  
 1st Value:  
 2nd Value:  
 Value Percent: **5.000**  
 Continuous Index:  
 Within 8" of Joint: **YES**  
 Remarks:

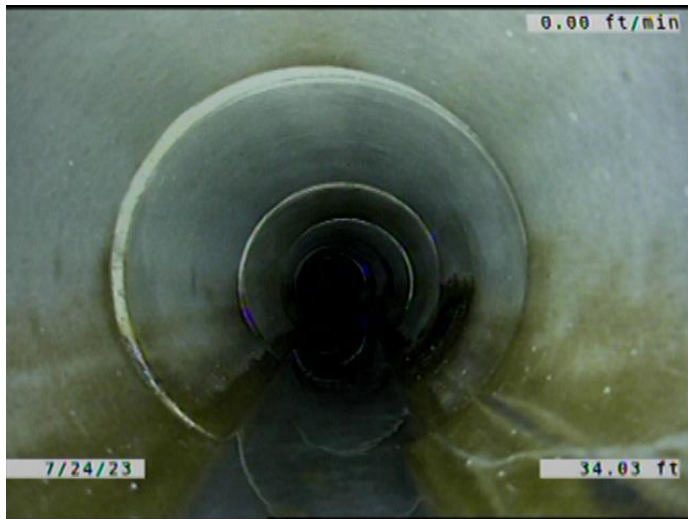
Code: **LL**  
Description: **Line Left**

Distance (ft): **34.0**  
Structural Grade: **0**  
O&M Grade: **4**  
Clock Start/From:  
Clock To:  
1st Value:  
2nd Value:  
Value Percent: **35.000**  
Continuous Index: **F03**  
Within 8" of Joint: **NO**  
Remarks:

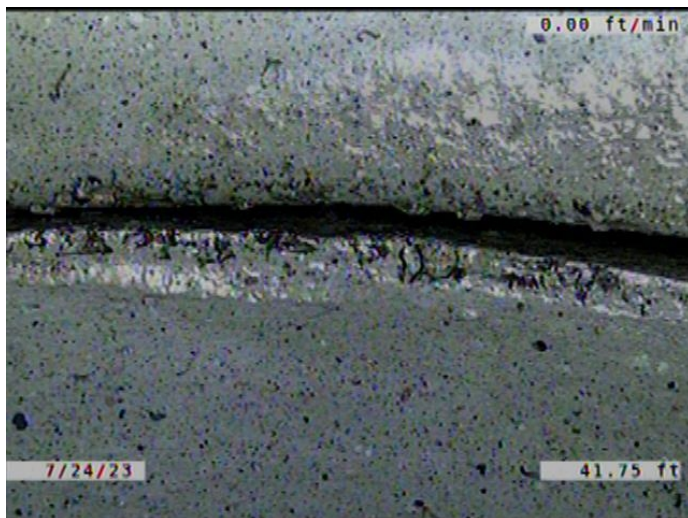
Code: **IWJ**  
Description: **Infiltration Weeper Joint**

Distance (ft): **41.8**  
Structural Grade: **0**  
O&M Grade: **2**  
Clock Start/From: **12**  
Clock To: **4**  
1st Value:  
2nd Value:  
Value Percent:  
Continuous Index: **S06**  
Within 8" of Joint: **YES**  
Remarks:

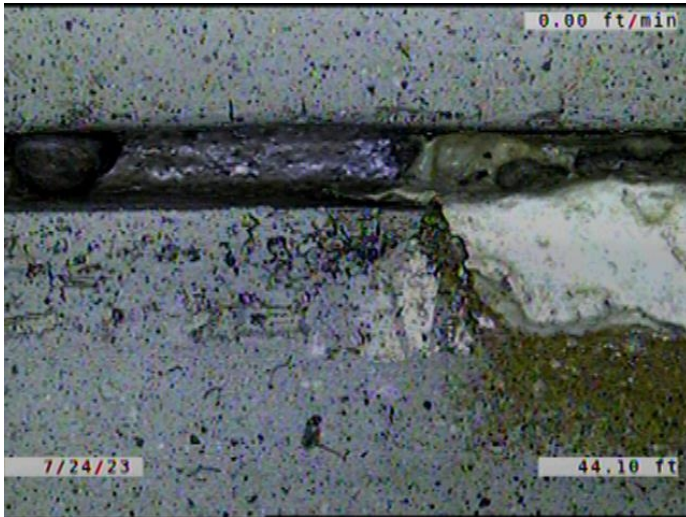
Code: **DAE**  
Description: **Deposits Attached Encrustation**

Distance (ft): **44.1**  
Structural Grade: **0**  
O&M Grade: **2**  
Clock Start/From: **12**  
Clock To: **4**  
1st Value:  
2nd Value:  
Value Percent: **5.000**  
Continuous Index: **S05**  
Within 8" of Joint: **YES**  
Remarks:

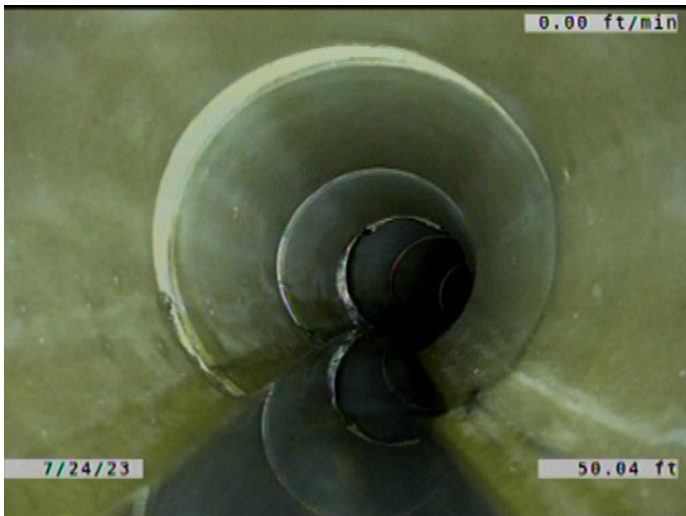
Code: **DAE**  
Description: **Deposits Attached Encrustation**

Distance (ft): **50.0**  
Structural Grade: **0**  
O&M Grade: **2**  
Clock Start/From: **12**  
Clock To: **4**  
1st Value:  
2nd Value:  
Value Percent: **5.000**  
Continuous Index: **F05**  
Within 8" of Joint: **YES**  
Remarks:

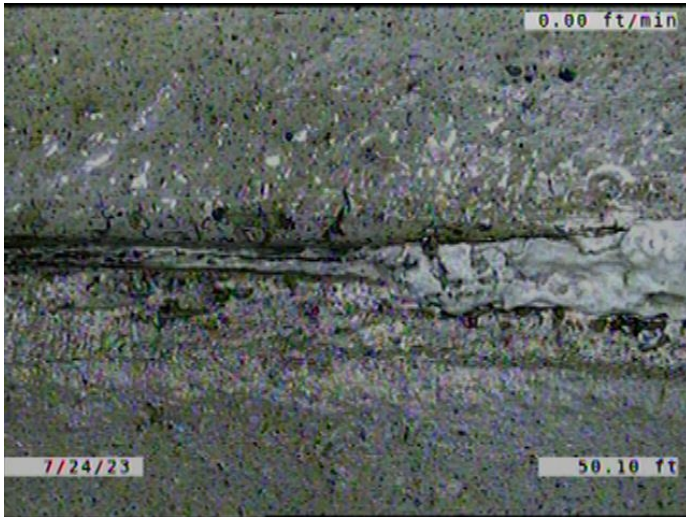
Code: **DAE**  
Description: **Deposits Attached Encrustation**

Distance (ft): **50.1**  
Structural Grade: **0**  
O&M Grade: **2**  
Clock Start/From: **12**  
Clock To: **12**  
1st Value:  
2nd Value:  
Value Percent: **5.000**  
Continuous Index: **S07**  
Within 8" of Joint: **YES**  
Remarks:

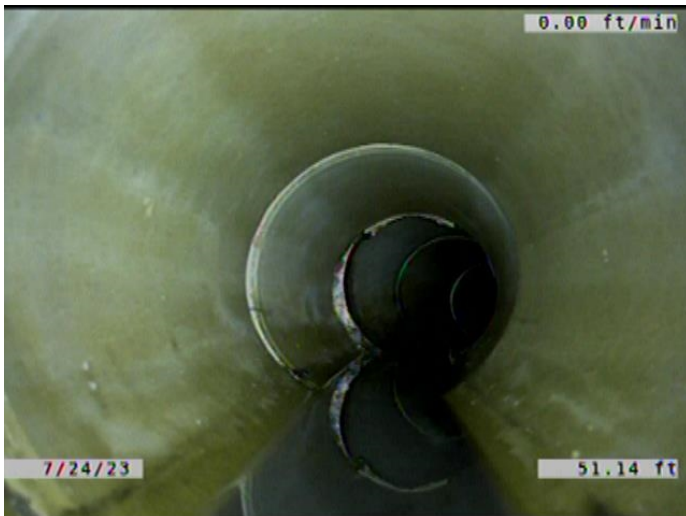
Code: **LR**  
Description: **Line Right**

Distance (ft): **51.1**  
Structural Grade: **0**  
O&M Grade: **4**  
Clock Start/From:  
Clock To:  
1st Value:  
2nd Value:  
Value Percent: **35.000**  
Continuous Index: **S08**  
Within 8" of Joint: **NO**  
Remarks:

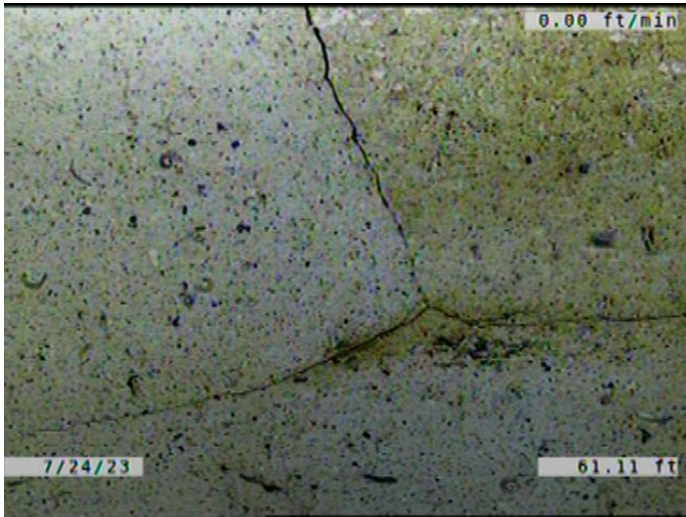
Code: **B**  
Description: **Broken**

Distance (ft): **61.1**  
Structural Grade: **4**  
O&M Grade: **0**  
Clock Start/From: **8**  
Clock To: **4**  
1st Value:  
2nd Value:  
Value Percent:  
Continuous Index:  
Within 8" of Joint: **YES**  
Remarks:

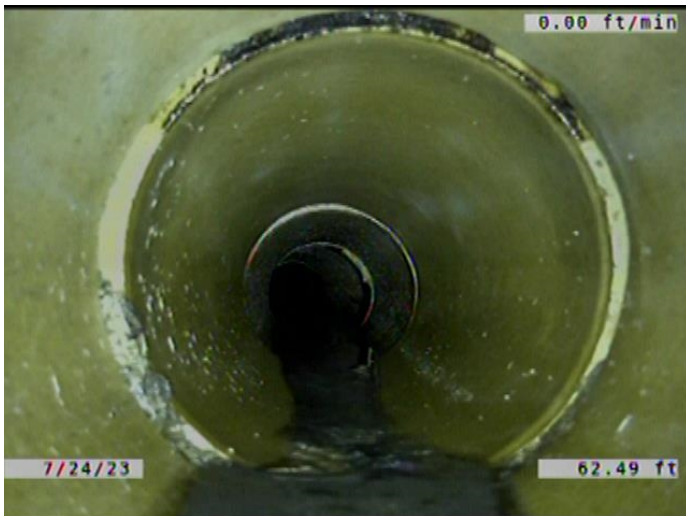
Code: **LR**  
Description: **Line Right**

Distance (ft): **62.5**  
Structural Grade: **0**  
O&M Grade: **4**  
Clock Start/From:  
Clock To:  
1st Value:  
2nd Value:  
Value Percent: **35.000**  
Continuous Index: **F08**  
Within 8" of Joint: **NO**  
Remarks:

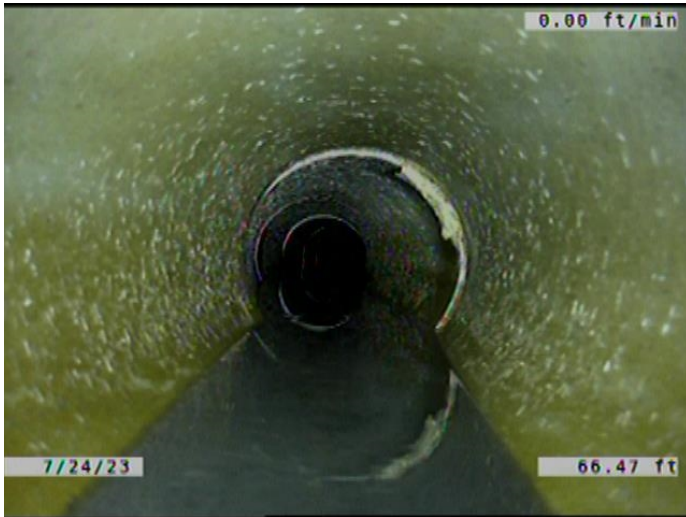
Code: **MWLS**  
 Description: **Miscellaneous Water Level Sag**

Distance (ft): **66.5**  
 Structural Grade: **3**  
 O&M Grade: **0**  
 Clock Start/From:  
 Clock To:  
 1st Value:  
 2nd Value:  
 Value Percent: **35.000**  
 Continuous Index: **S09**  
 Within 8" of Joint: **NO**  
 Remarks:

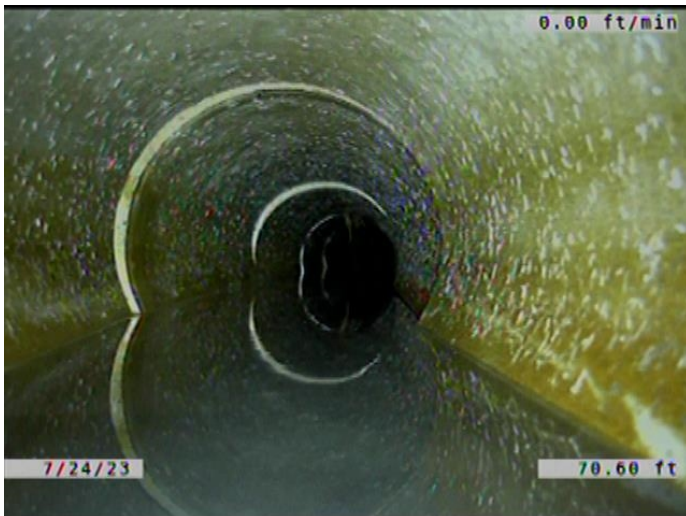
Code: **LL**  
 Description: **Line Left**

Distance (ft): **70.6**  
 Structural Grade: **0**  
 O&M Grade: **1**  
 Clock Start/From:  
 Clock To:  
 1st Value:  
 2nd Value:  
 Value Percent: **5.000**  
 Continuous Index:  
 Within 8" of Joint: **NO**  
 Remarks:

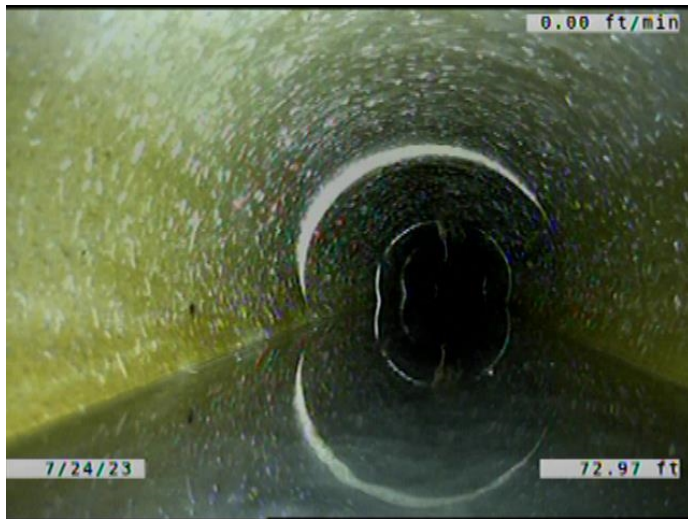
Code: **LR**  
Description: **Line Right**

Distance (ft): **73.0**  
Structural Grade: **0**  
O&M Grade: **1**  
Clock Start/From:  
Clock To:  
1st Value:  
2nd Value:  
Value Percent: **5.000**  
Continuous Index:  
Within 8" of Joint: **NO**  
Remarks:

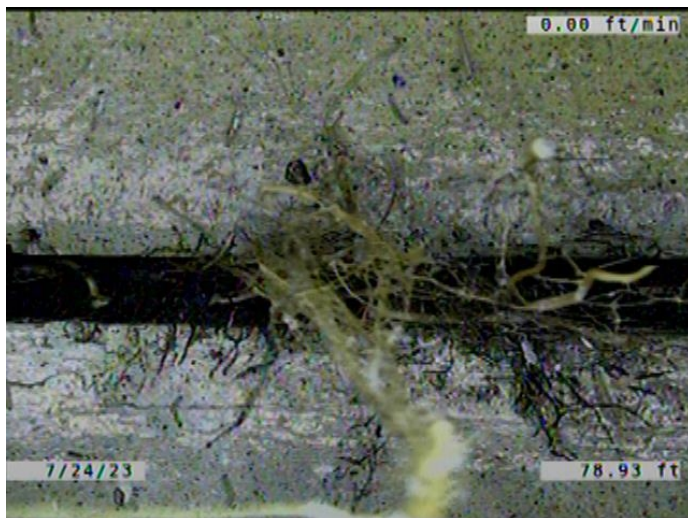
Code: **RFJ**  
Description: **Roots Fine Joint**

Distance (ft): **78.9**  
Structural Grade: **0**  
O&M Grade: **1**  
Clock Start/From: **9**  
Clock To: **3**  
1st Value:  
2nd Value:  
Value Percent:  
Continuous Index:  
Within 8" of Joint: **YES**  
Remarks:

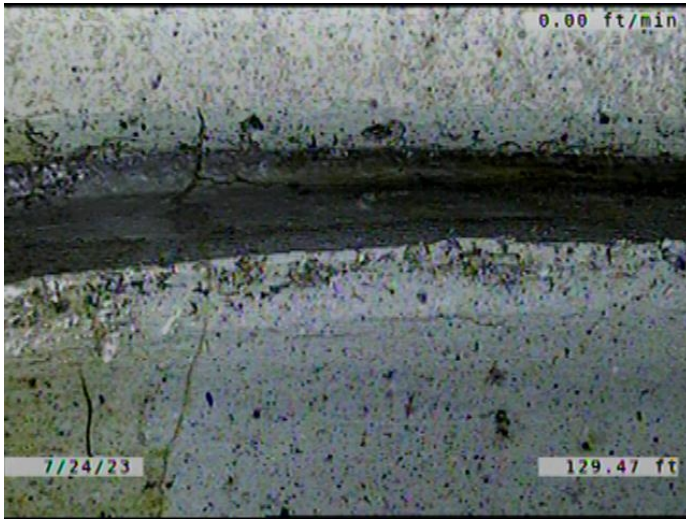
Code: **CM**  
Description: **Crack Multiple**

Distance (ft): **129.5**  
Structural Grade: **3**  
O&M Grade: **0**  
Clock Start/From: **8**  
Clock To: **10**  
1st Value:  
2nd Value:  
Value Percent:  
Continuous Index:  
Within 8" of Joint: **YES**  
Remarks:

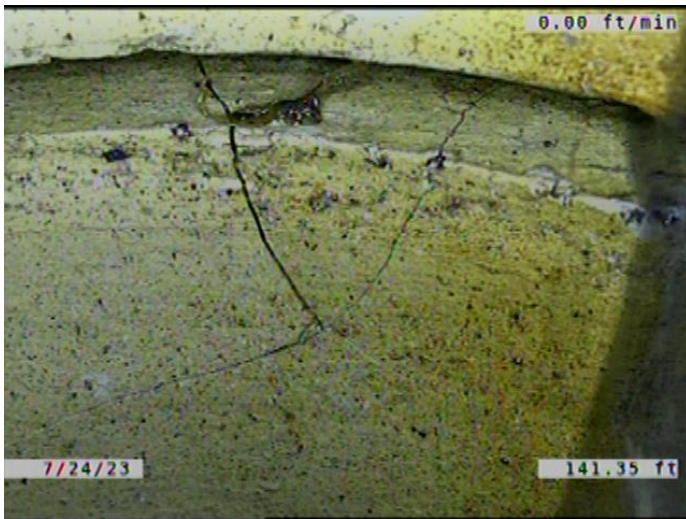
Code: **FM**  
Description: **Fracture Multiple**

Distance (ft): **141.4**  
Structural Grade: **4**  
O&M Grade: **0**  
Clock Start/From: **8**  
Clock To: **4**  
1st Value:  
2nd Value:  
Value Percent:  
Continuous Index:  
Within 8" of Joint: **YES**  
Remarks:

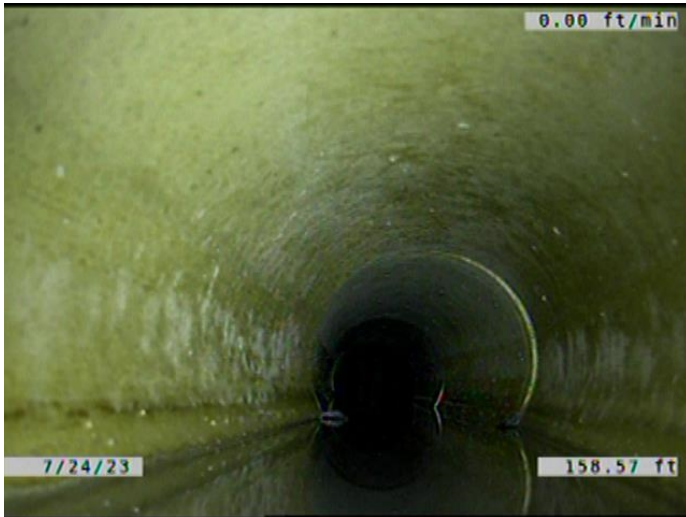
Code: **LR**  
Description: **Line Right**

Distance (ft): **158.6**  
Structural Grade: **0**  
O&M Grade: **1**  
Clock Start/From:  
Clock To:  
1st Value:  
2nd Value:  
Value Percent: **5.000**  
Continuous Index:  
Within 8" of Joint: **NO**  
Remarks:

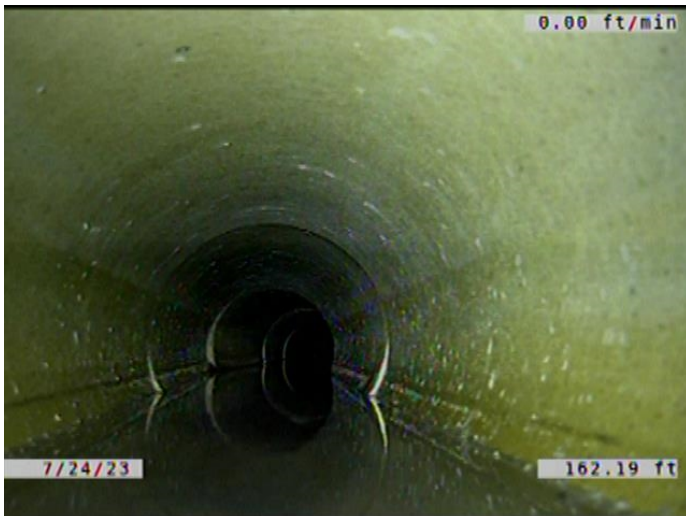
Code: **LL**  
Description: **Line Left**

Distance (ft): **162.2**  
Structural Grade: **0**  
O&M Grade: **1**  
Clock Start/From:  
Clock To:  
1st Value:  
2nd Value:  
Value Percent: **5.000**  
Continuous Index:  
Within 8" of Joint: **NO**  
Remarks:

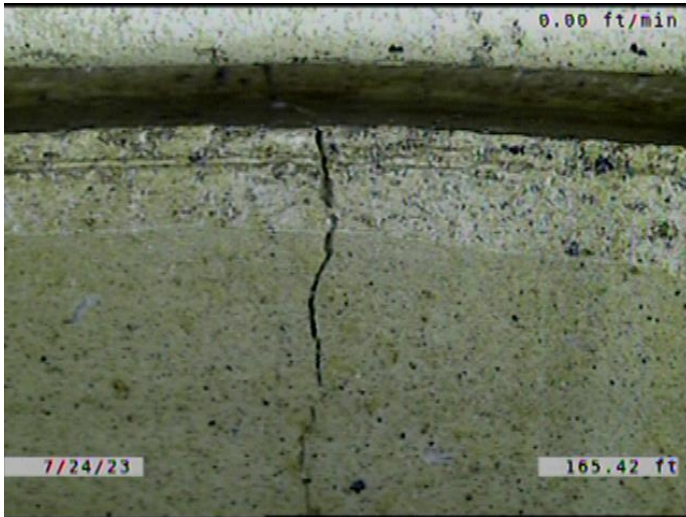
Code: **FM**  
Description: **Fracture Multiple**

Distance (ft): **165.4**  
Structural Grade: **4**  
O&M Grade: **0**  
Clock Start/From: **10**  
Clock To: **4**  
1st Value:  
2nd Value:  
Value Percent:  
Continuous Index:  
Within 8" of Joint: **YES**  
Remarks:

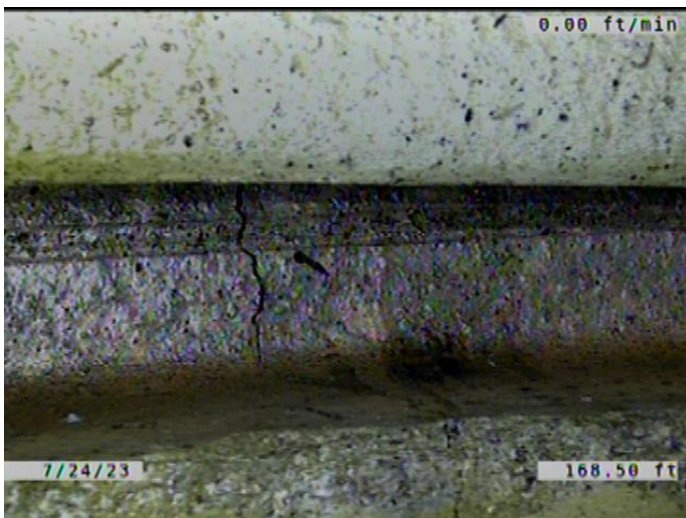
Code: **JAM**  
Description: **Joint Angular Medium**

Distance (ft): **168.5**  
Structural Grade: **3**  
O&M Grade: **0**  
Clock Start/From:  
Clock To:  
1st Value:  
2nd Value:  
Value Percent:  
Continuous Index:  
Within 8" of Joint: **NO**  
Remarks:

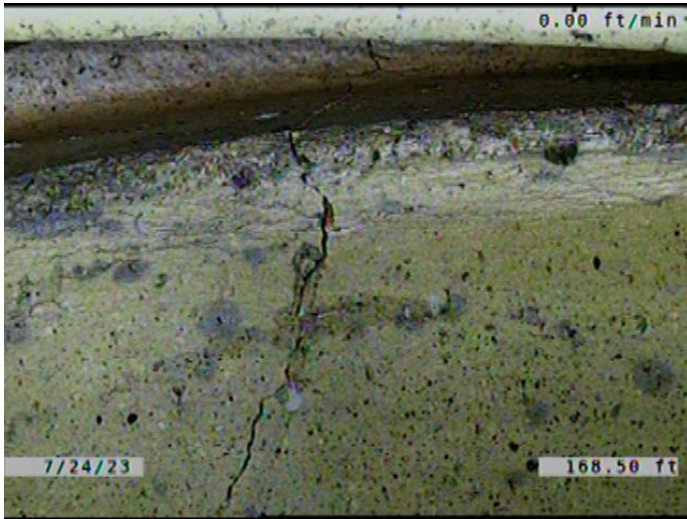
Code: **CM**  
Description: **Crack Multiple**

Distance (ft): **168.5**  
Structural Grade: **3**  
O&M Grade: **0**  
Clock Start/From: **8**  
Clock To: **4**  
1st Value:  
2nd Value:  
Value Percent:  
Continuous Index:  
Within 8" of Joint: **YES**  
Remarks:

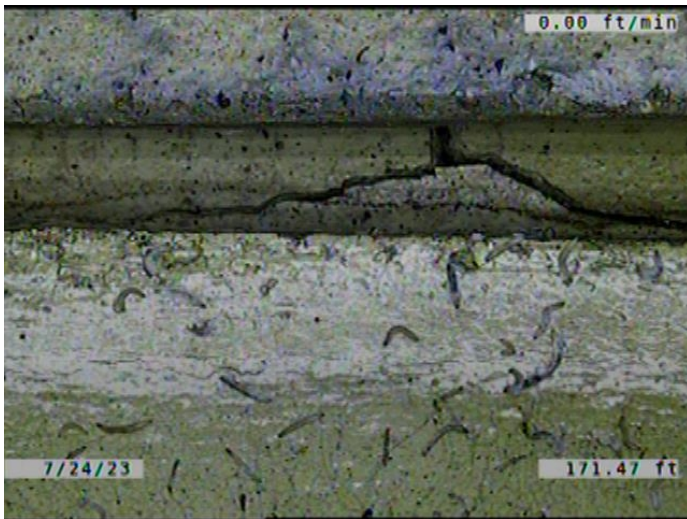
Code: **B**  
Description: **Broken**

Distance (ft): **171.5**  
Structural Grade: **4**  
O&M Grade: **0**  
Clock Start/From: **8**  
Clock To: **4**  
1st Value:  
2nd Value:  
Value Percent:  
Continuous Index:  
Within 8" of Joint: **YES**  
Remarks:

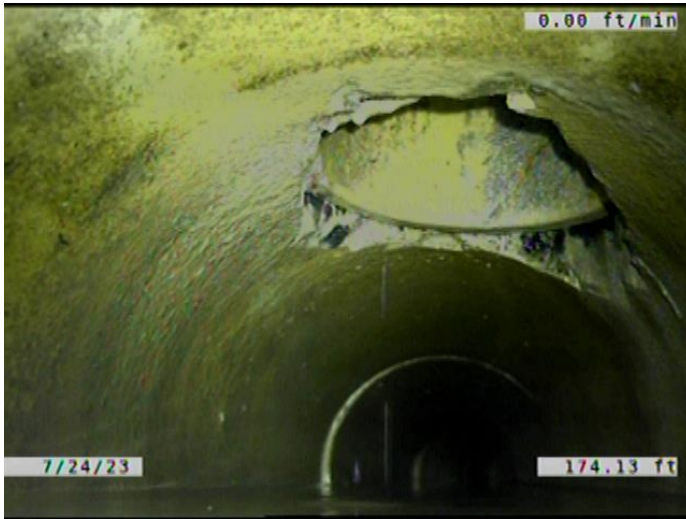
Code: **LR**  
Description: **Line Right**

Distance (ft): **174.1**  
Structural Grade: **0**  
O&M Grade: **2**  
Clock Start/From:  
Clock To:  
1st Value:  
2nd Value:  
Value Percent: **15.000**  
Continuous Index:  
Within 8" of Joint: **NO**  
Remarks:

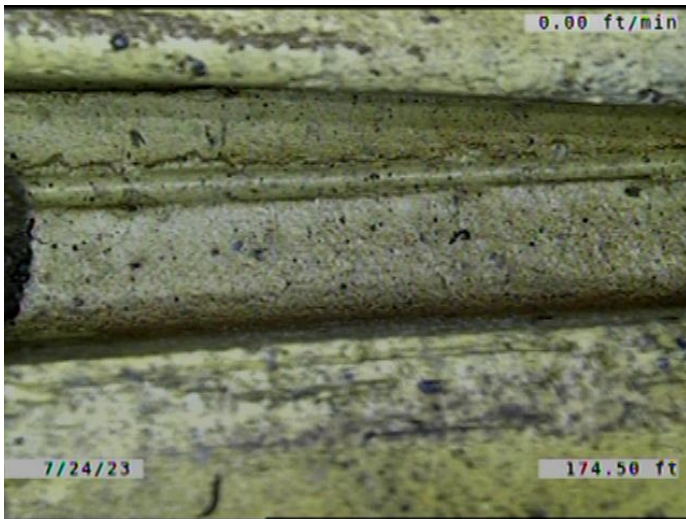
Code: **JAM**  
Description: **Joint Angular Medium**

Distance (ft): **174.5**  
Structural Grade: **3**  
O&M Grade: **0**  
Clock Start/From:  
Clock To:  
1st Value:  
2nd Value:  
Value Percent:  
Continuous Index:  
Within 8" of Joint: **NO**  
Remarks:

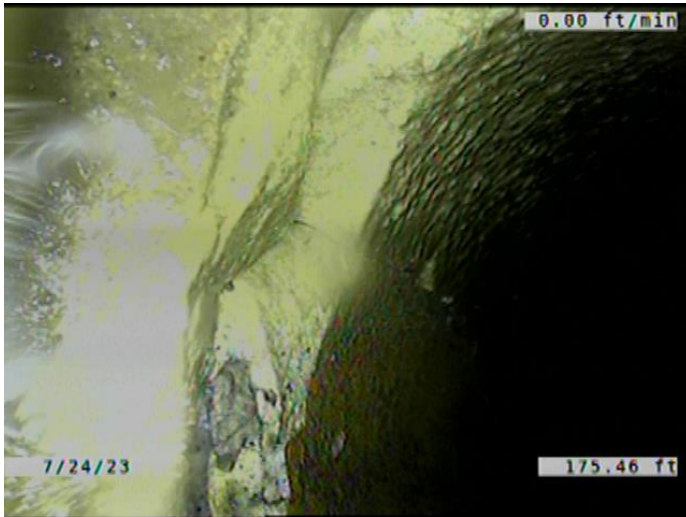
Code: **SSS**  
Description: **Surface Damage Surface Spalling**

Distance (ft): **175.5**  
Structural Grade: **2**  
O&M Grade: **0**  
Clock Start/From: **10**  
Clock To: **2**  
1st Value:  
2nd Value:  
Value Percent:  
Continuous Index:  
Within 8" of Joint: **YES**  
Remarks:

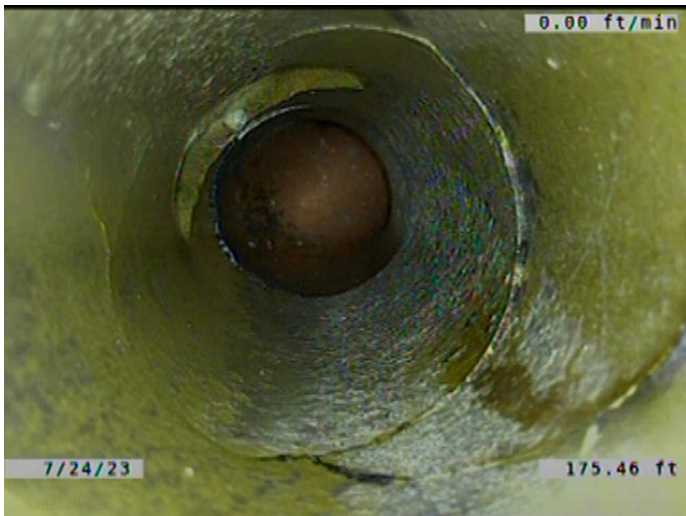
Code: **TBD**  
Description: **Tap Break-in/Hammer Defective**

Distance (ft): **175.5**  
Structural Grade: **0**  
O&M Grade: **3**  
Clock Start/From: **12**  
Clock To:  
1st Value: **6.000**  
2nd Value:  
Value Percent:  
Continuous Index:  
Within 8" of Joint: **YES**  
Remarks: **CONSTANTLY RUNNING WATER.  
SERVICE BROKEN. LOOKS TO BE A C**

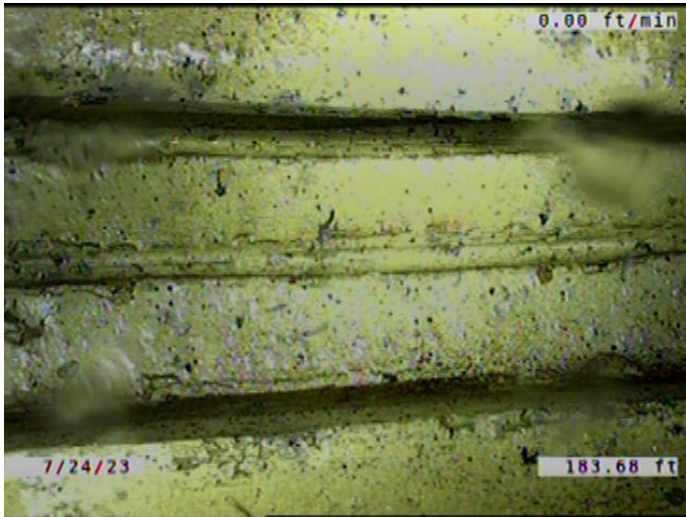
Code: **JAM**  
Description: **Joint Angular Medium**

Distance (ft): **183.7**  
Structural Grade: **3**  
O&M Grade: **0**  
Clock Start/From:  
Clock To:  
1st Value:  
2nd Value:  
Value Percent:  
Continuous Index:  
Within 8" of Joint: **NO**  
Remarks:

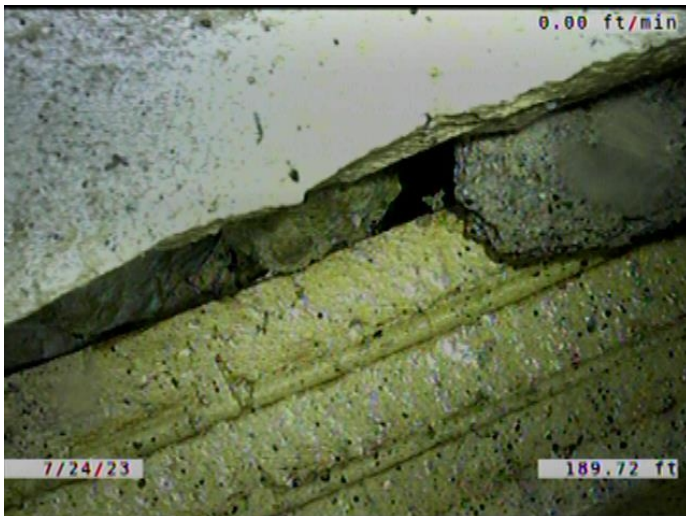
Code: **BVV**  
Description: **Broken Void Visible**

Distance (ft): **189.7**  
Structural Grade: **5**  
O&M Grade: **0**  
Clock Start/From: **8**  
Clock To: **4**  
1st Value:  
2nd Value:  
Value Percent:  
Continuous Index:  
Within 8" of Joint: **YES**  
Remarks: **SOIL VISIBLE TOO.**

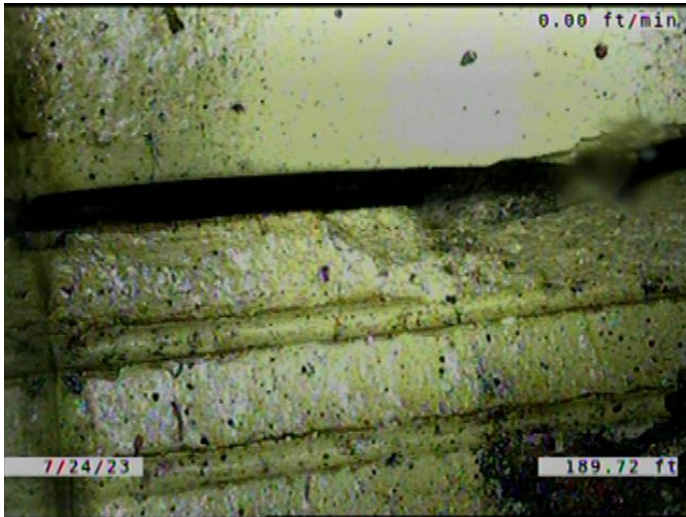
Code: **JAL**  
Description: **Joint Angular Large**

Distance (ft): **189.7**  
Structural Grade: **4**  
O&M Grade: **0**  
Clock Start/From:  
Clock To:  
1st Value:  
2nd Value:  
Value Percent:  
Continuous Index:  
Within 8" of Joint: **NO**  
Remarks:

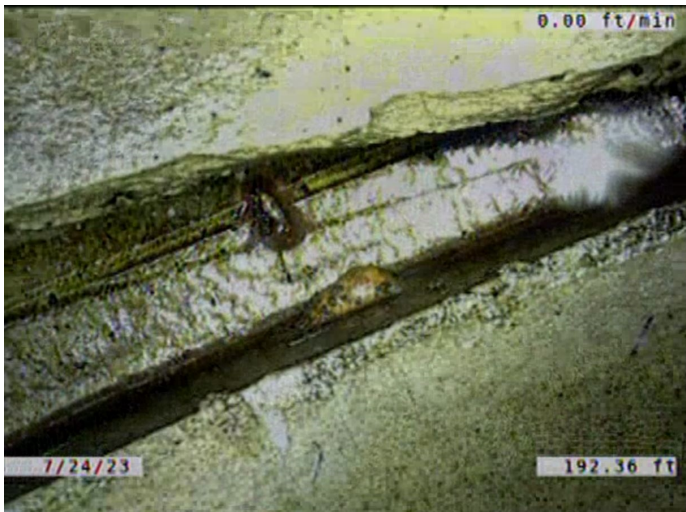
Code: **SMW**  
Description: **Surface Damage Missing Wall**

Distance (ft): **192.6**  
Structural Grade: **5**  
O&M Grade: **0**  
Clock Start/From: **10**  
Clock To: **4**  
1st Value:  
2nd Value:  
Value Percent:  
Continuous Index:  
Within 8" of Joint: **NO**  
Remarks:

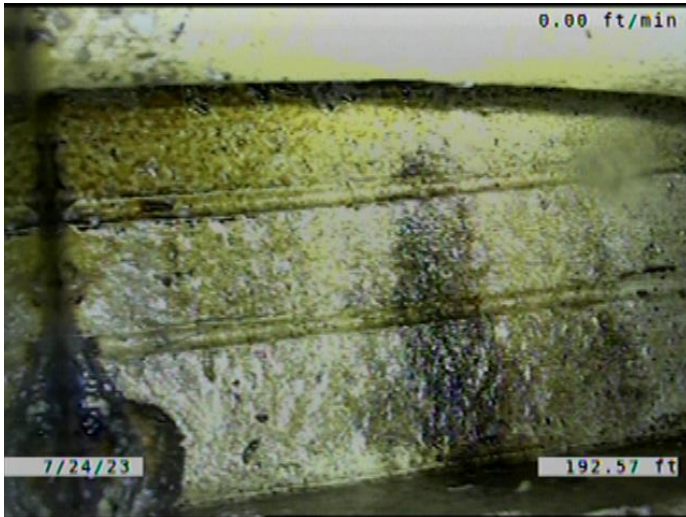
Code: **JAL**  
Description: **Joint Angular Large**

Distance (ft): **192.6**  
Structural Grade: **4**  
O&M Grade: **0**  
Clock Start/From:  
Clock To:  
1st Value:  
2nd Value:  
Value Percent:  
Continuous Index:  
Within 8" of Joint: **NO**  
Remarks:

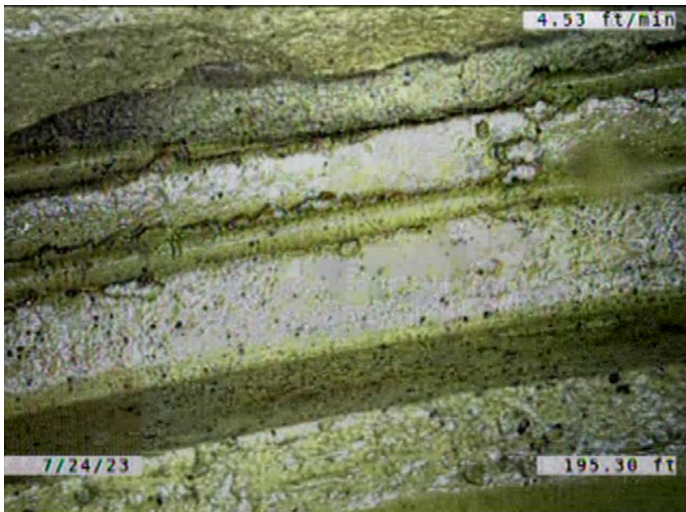
Code: **SMW**  
Description: **Surface Damage Missing Wall**

Distance (ft): **195.3**  
Structural Grade: **5**  
O&M Grade: **0**  
Clock Start/From: **10**  
Clock To: **4**  
1st Value:  
2nd Value:  
Value Percent:  
Continuous Index:  
Within 8" of Joint: **YES**  
Remarks:

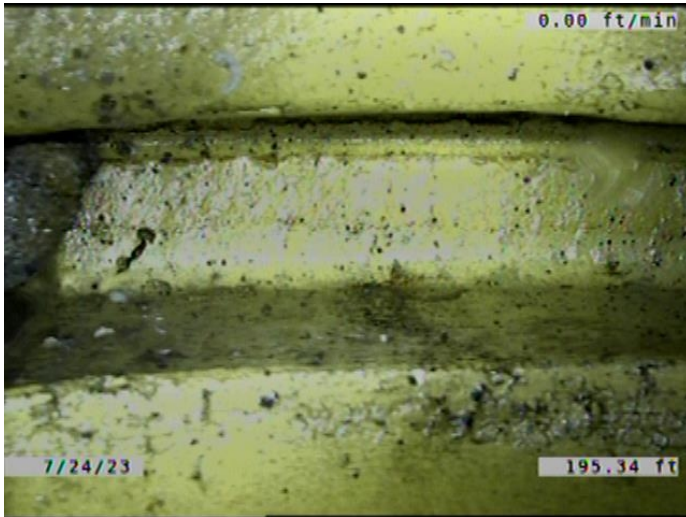
Code: **JAM**  
Description: **Joint Angular Medium**

Distance (ft): **195.3**  
Structural Grade: **3**  
O&M Grade: **0**  
Clock Start/From:  
Clock To:  
1st Value:  
2nd Value:  
Value Percent:  
Continuous Index: **S11**  
Within 8" of Joint: **NO**  
Remarks:

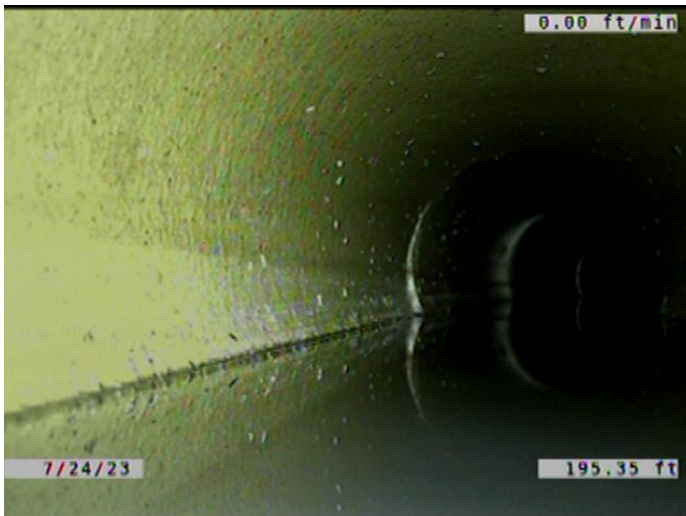
Code: **LR**  
Description: **Line Right**

Distance (ft): **195.4**  
Structural Grade: **0**  
O&M Grade: **4**  
Clock Start/From:  
Clock To:  
1st Value:  
2nd Value:  
Value Percent: **35.000**  
Continuous Index: **S10**  
Within 8" of Joint: **NO**  
Remarks:

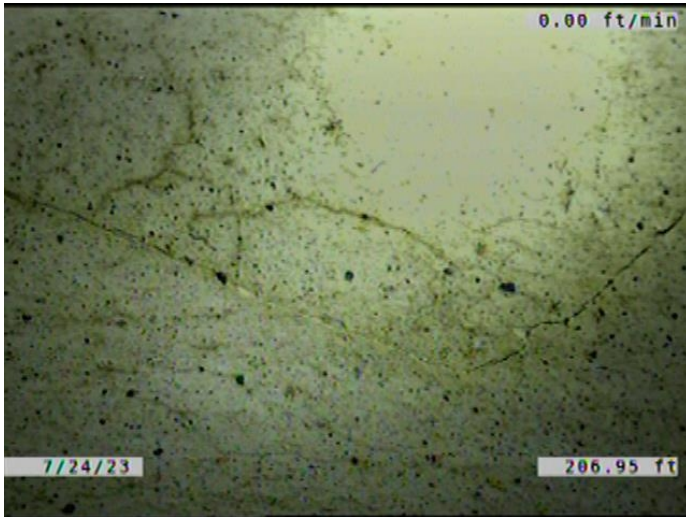
Code: **CM**  
Description: **Crack Multiple**

Distance (ft): **206.9**  
Structural Grade: **3**  
O&M Grade: **0**  
Clock Start/From: **11**  
Clock To: **4**  
1st Value:  
2nd Value:  
Value Percent:  
Continuous Index:  
Within 8" of Joint: **YES**  
Remarks:

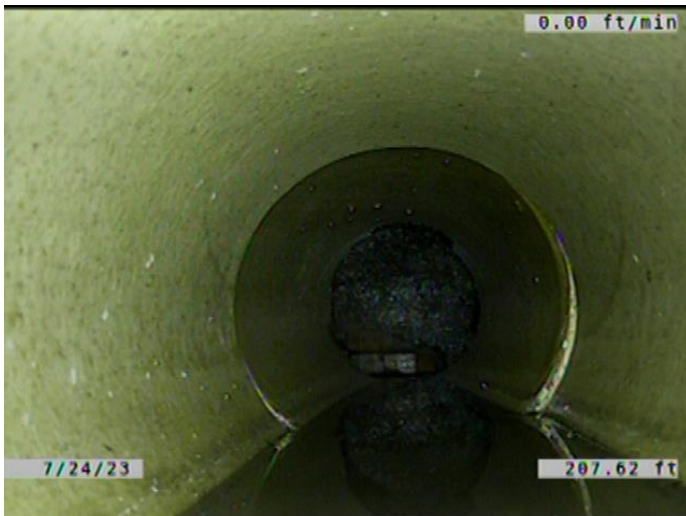
Code: **LR**  
Description: **Line Right**

Distance (ft): **207.6**  
Structural Grade: **0**  
O&M Grade: **4**  
Clock Start/From:  
Clock To:  
1st Value:  
2nd Value:  
Value Percent: **35.000**  
Continuous Index: **F10**  
Within 8" of Joint: **NO**  
Remarks:

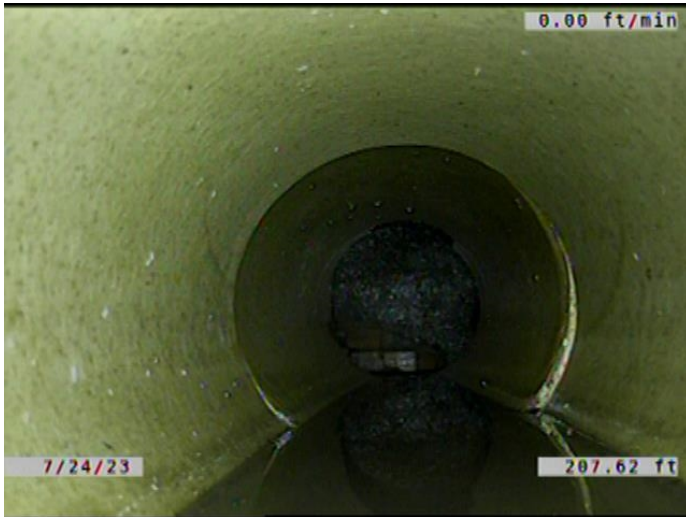
Code: **JAM**  
Description: **Joint Angular Medium**

Distance (ft): **207.6**  
Structural Grade: **3**  
O&M Grade: **0**  
Clock Start/From:  
Clock To:  
1st Value:  
2nd Value:  
Value Percent:  
Continuous Index: **F11**  
Within 8" of Joint: **NO**  
Remarks:

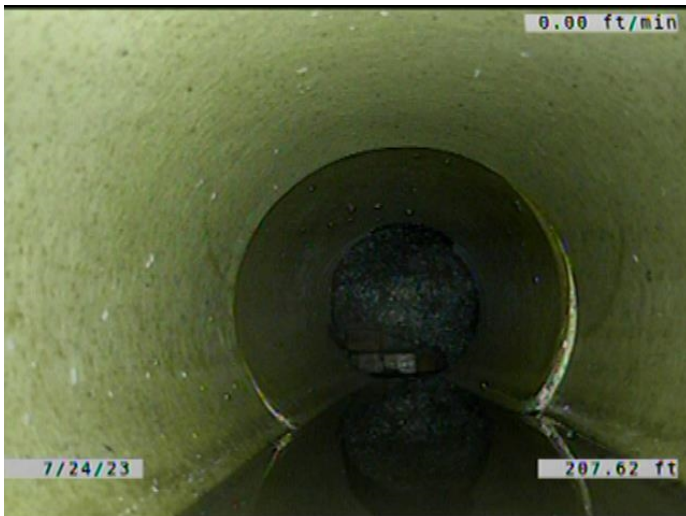
Code: **IWJ**  
Description: **Infiltration Weeper Joint**

Distance (ft): **207.6**  
Structural Grade: **0**  
O&M Grade: **2**  
Clock Start/From: **12**  
Clock To: **4**  
1st Value:  
2nd Value:  
Value Percent:  
Continuous Index: **F06**  
Within 8" of Joint: **YES**  
Remarks:
