# Profile/Photo Observation Report

Date:	07/24/2023	Weather:		Coding:	PACP 7.0
Pipe Length (ft):	204.0	Owner:	City of Hobart	Pre Clean:	Heavy Cleaning
P.O.#:	YES502259	Surveyor:	S. Bucklin	PSR:	P-902-018-032
Customer:	City of Hobart	Clean Date:	06/02/2023	Shape:	C

Street:	East 34th Court	Flow Control:	Not Controlled
City:	Hobart, IN	Year Renewed:	
Location:	Easement/Right of Way	Tape/Media #:	
Purpose:	Routine Assessment	Dia/Height:	10"
Use:	Sanitary Sewage Pipe	Material:	VCP
Drain Area:		Lining:	None
Category:	NA		
Comment:			
Location Details:		Direction of Survey:	Downstream
US MH:	M-902-032	DS MH:	M-902-018
		Total Length Surveyed (ft):	213.2

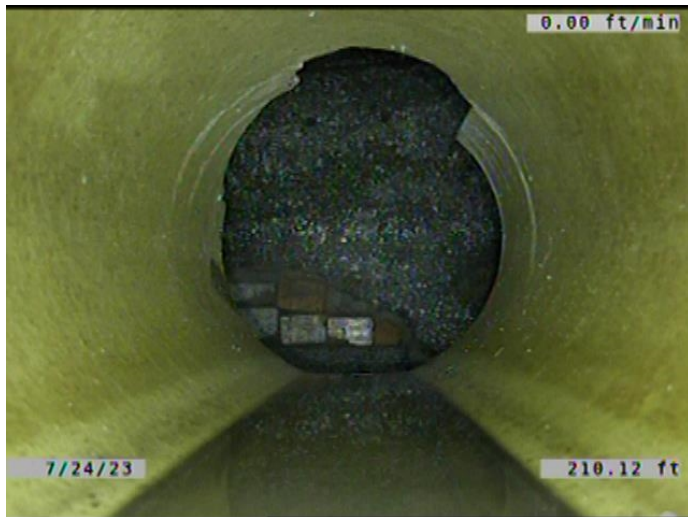
Code: **DAE**  
Description: **Deposits Attached Encrustation**

Distance (ft): **210.1**  
Structural Grade: **0**  
O&M Grade: **2**  
Clock Start/From: **3**  
Clock To: **9**  
1st Value:  
2nd Value:  
Value Percent: **5.000**  
Continuous Index: **F01**  
Within 8" of Joint: **YES**  
Remarks:

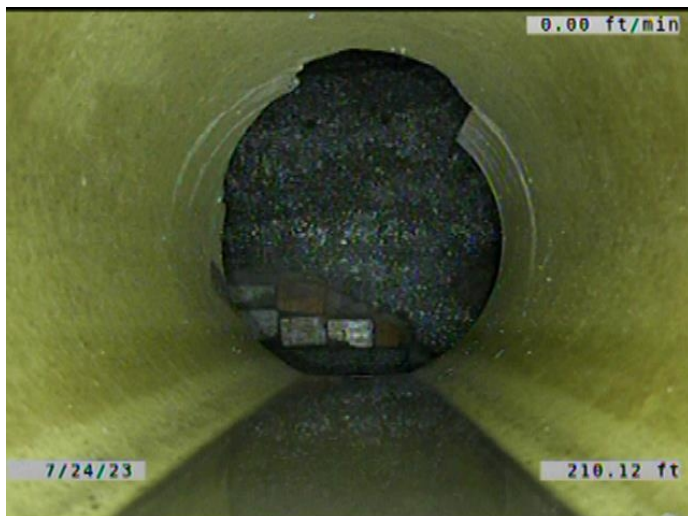
Code: **DSF**  
Description: **Deposits Settled Fine**

Distance (ft): **210.1**  
Structural Grade: **0**  
O&M Grade: **2**  
Clock Start/From: **5**  
Clock To: **7**  
1st Value:  
2nd Value:  
Value Percent: **5.000**  
Continuous Index: **F04**  
Within 8" of Joint: **YES**  
Remarks:

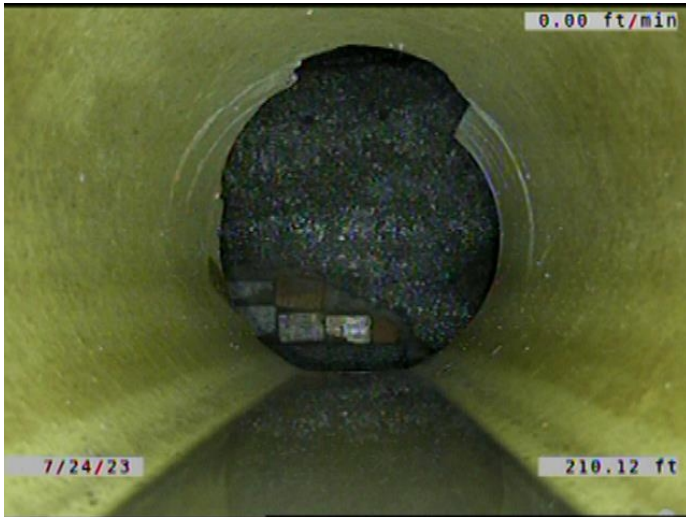
Code: **DAE**  
Description: **Deposits Attached Encrustation**

Distance (ft): **210.1**  
Structural Grade: **0**  
O&M Grade: **2**  
Clock Start/From: **12**  
Clock To: **12**  
1st Value:  
2nd Value:  
Value Percent: **5.000**  
Continuous Index: **F07**  
Within 8" of Joint: **YES**  
Remarks:

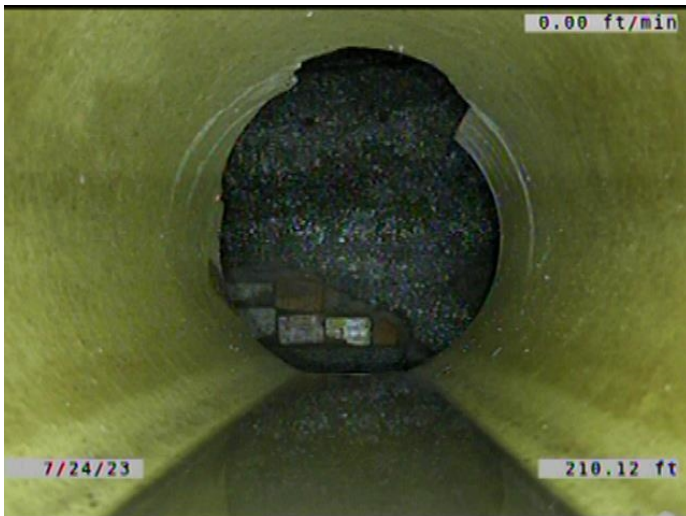
Code: **MWLS**  
Description: **Miscellaneous Water Level Sag**

Distance (ft): **210.1**  
Structural Grade: **3**  
O&M Grade: **0**  
Clock Start/From:  
Clock To:  
1st Value:  
2nd Value:  
Value Percent: **35.000**  
Continuous Index: **F09**  
Within 8" of Joint: **NO**  
Remarks:

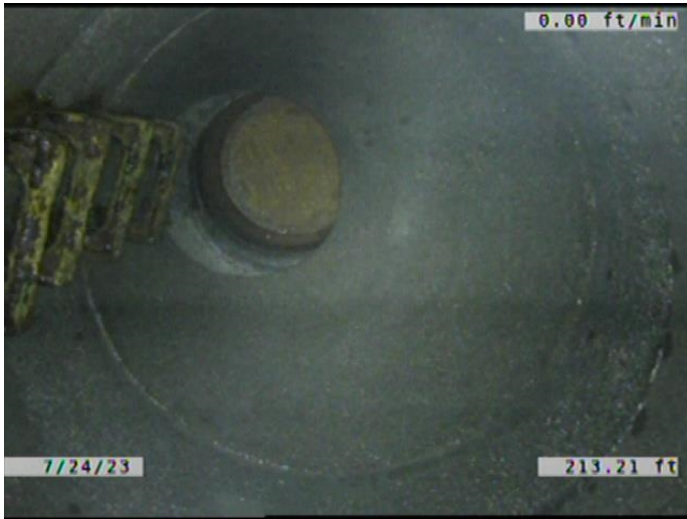
Code:	AMH
Description:	Manhole
Distance (ft):	213.2
Structural Grade:	0
O&M Grade:	0
Clock Start/From:	
Clock To:	
1st Value:	
2nd Value:	
Value Percent:	
Continuous Index:	
Within 8" of Joint:	NO
Remarks:	M-902-018
