Profile/Photo Observation Report

Date:	06/13/2023	Weather:		Coding:	PACP 7.0
Pipe Length (ft):	150.0	Owner:	City of Hobart	Pre Clean:	Heavy Cleaning
P.O.#:	YES502259	Surveyor:	S. Bucklin	PSR:	P-902-032-032A
Customer:	City of Hobart	Clean Date:	05/10/2023	Shape:	C

Street:	North Shelby Street	Flow Control:	Not Controlled
City:	Hobart, IN	Year Renewed:	
Location:	Easement/Right of Way	Tape/Media #:	
Purpose:	Routine Assessment	Dia/Height:	18"
Use:	Sanitary Sewage Pipe	Material:	RCP
Drain Area:		Lining:	None
Category:	NA		
Comment:			
Location Details:		Direction of Survey:	Downstream
US MH:	M-902-032	DS MH:	M-902-032A
		Total Length Surveyed (ft):	151.1

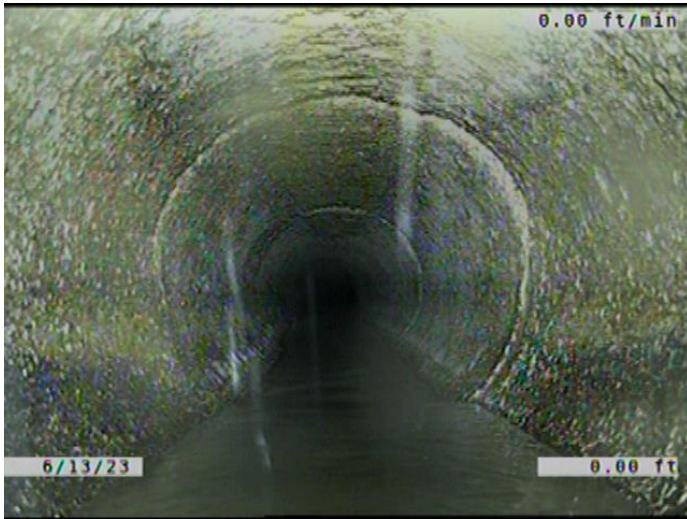
Code: **SAP**
Description: **Surface Damage Aggregate Projecting**

Distance (ft): **.0**
Structural Grade: **3**
O&M Grade: **0**
Clock Start/From: **7**
Clock To: **5**
1st Value:
2nd Value:
Value Percent:
Continuous Index: **S01**
Within 8" of Joint: **YES**
Remarks:

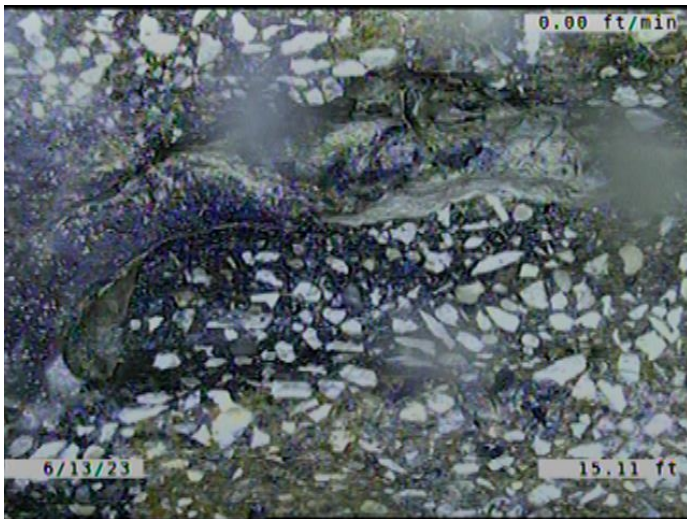
Code: **DAE**
Description: **Deposits Attached Encrustation**

Distance (ft): **15.1**
Structural Grade: **0**
O&M Grade: **2**
Clock Start/From: **7**
Clock To: **5**
1st Value:
2nd Value:
Value Percent: **5.000**
Continuous Index: **S02**
Within 8" of Joint: **YES**
Remarks:

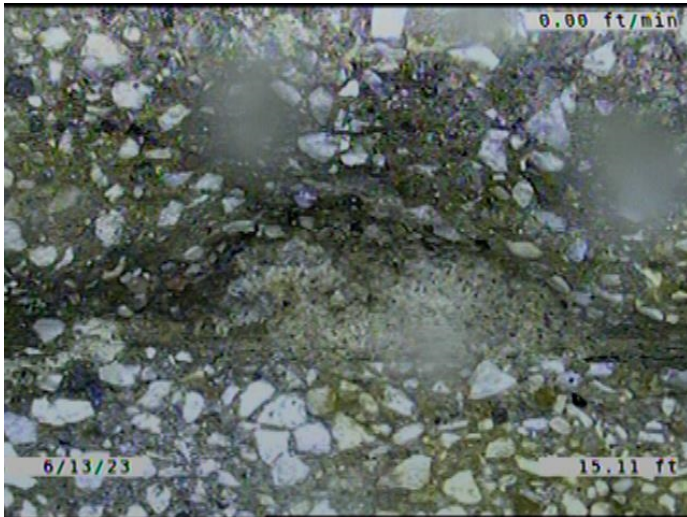
Code:	SMW
Description:	Surface Damage Missing Wall
Distance (ft):	15.1
Structural Grade:	5
O&M Grade:	0
Clock Start/From:	10
Clock To:	
1st Value:	
2nd Value:	
Value Percent:	
Continuous Index:	
Within 8" of Joint:	YES
Remarks:	THE INSIDE OF THE JOINT.

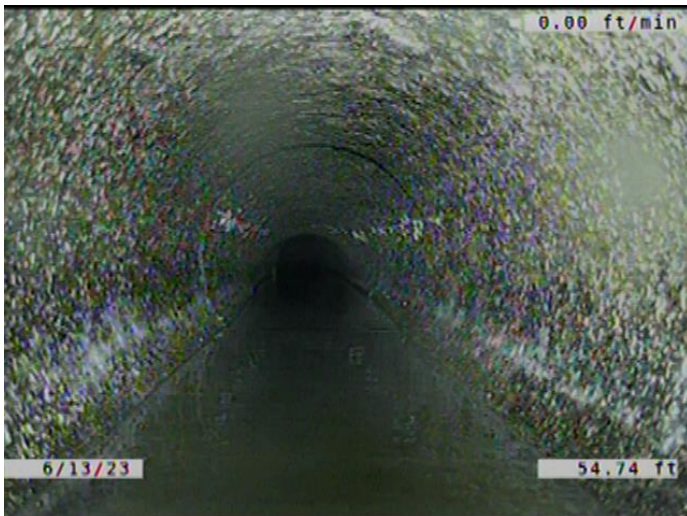
Code:	LL
Description:	Line Left
Distance (ft):	54.7
Structural Grade:	0
O&M Grade:	1
Clock Start/From:	
Clock To:	
1st Value:	
2nd Value:	
Value Percent:	10.000
Continuous Index:	
Within 8" of Joint:	NO
Remarks:

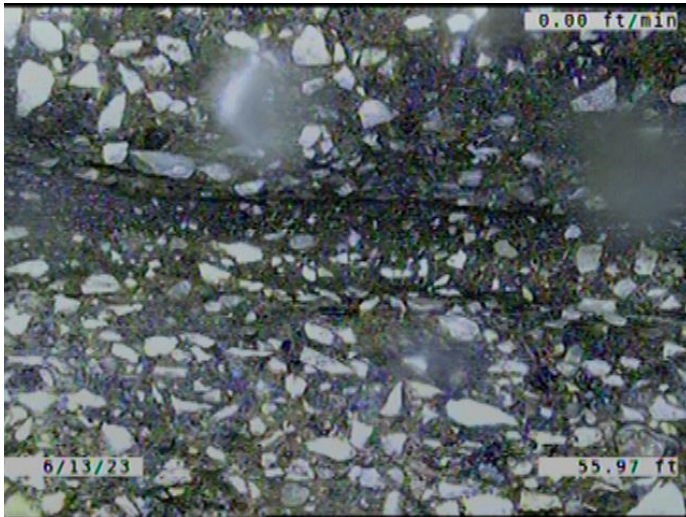
Code: **JAM**
Description: **Joint Angular Medium**

Distance (ft): **56.0**
Structural Grade: **3**
O&M Grade: **0**
Clock Start/From:
Clock To:
1st Value:
2nd Value:
Value Percent:
Continuous Index:
Within 8" of Joint: **NO**
Remarks:

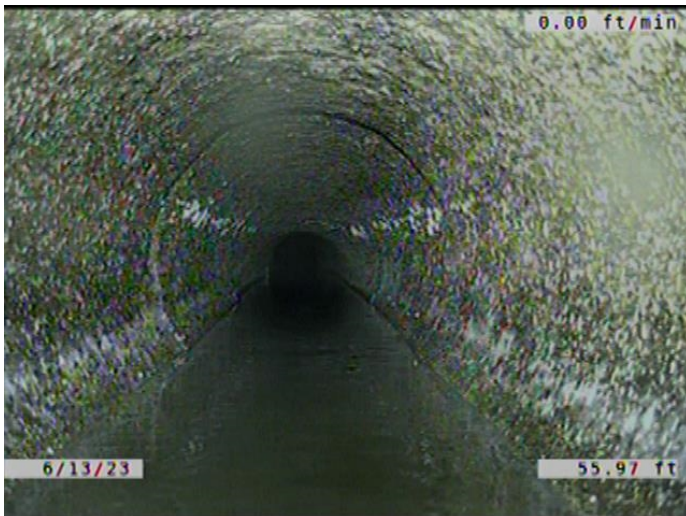
Code: **MWLS**
Description: **Miscellaneous Water Level Sag**

Distance (ft): **56.0**
Structural Grade: **3**
O&M Grade: **0**
Clock Start/From:
Clock To:
1st Value:
2nd Value:
Value Percent: **45.000**
Continuous Index: **S03**
Within 8" of Joint: **NO**
Remarks:

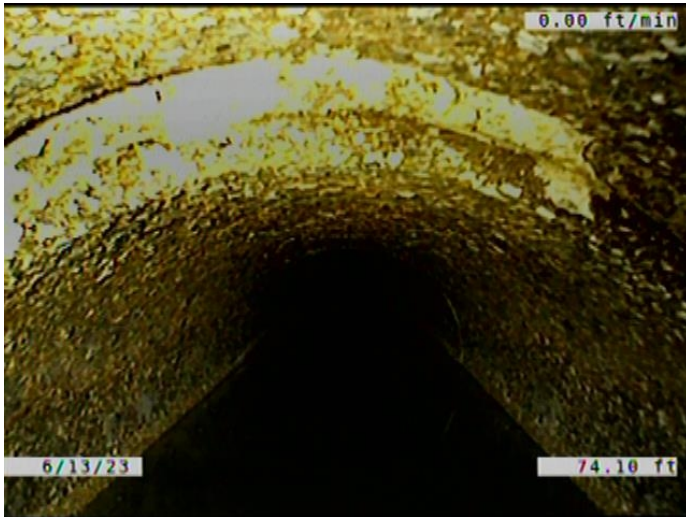
Code: **JOMD**
 Description: **Joint Offset Medium Defective**

Distance (ft): **73.9**
 Structural Grade: **3**
 O&M Grade: **0**
 Clock Start/From:
 Clock To:
 1st Value:
 2nd Value:
 Value Percent:
 Continuous Index:
 Within 8" of Joint: **NO**
 Remarks:

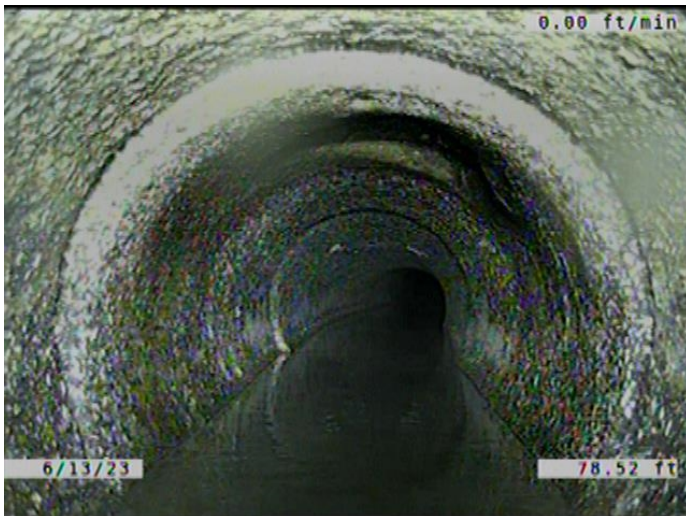
Code: **MWLS**
 Description: **Miscellaneous Water Level Sag**

Distance (ft): **78.5**
 Structural Grade: **3**
 O&M Grade: **0**
 Clock Start/From:
 Clock To:
 1st Value:
 2nd Value:
 Value Percent: **45.000**
 Continuous Index: **F03**
 Within 8" of Joint: **NO**
 Remarks:

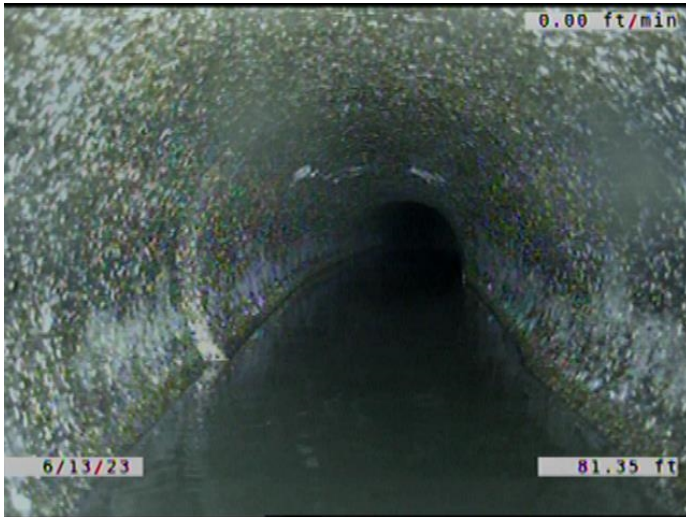
Code: **MWLS**
Description: **Miscellaneous Water Level Sag**

Distance (ft): **81.4**
Structural Grade: **3**
O&M Grade: **0**
Clock Start/From:
Clock To:
1st Value:
2nd Value:
Value Percent: **50.000**
Continuous Index: **S04**
Within 8" of Joint: **NO**
Remarks:

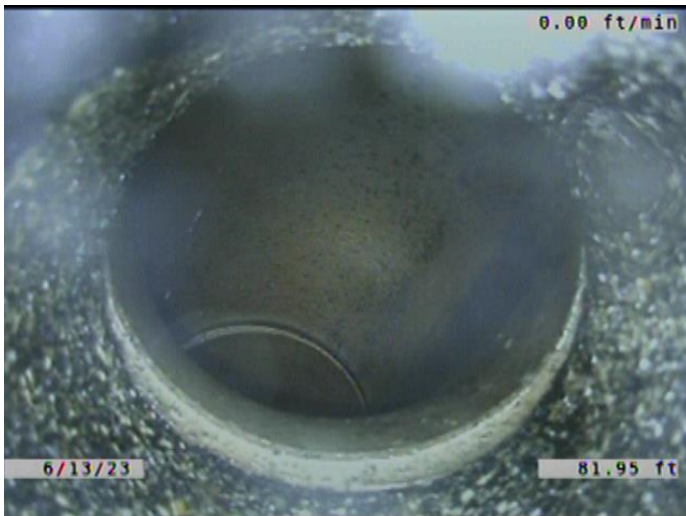
Code: **TF**
Description: **Tap Factory**

Distance (ft): **82.0**
Structural Grade: **0**
O&M Grade: **0**
Clock Start/From: **1**
Clock To:
1st Value: **6.000**
2nd Value:
Value Percent:
Continuous Index:
Within 8" of Joint: **YES**
Remarks: **CONSTANLTY DRIPPING WATER.**

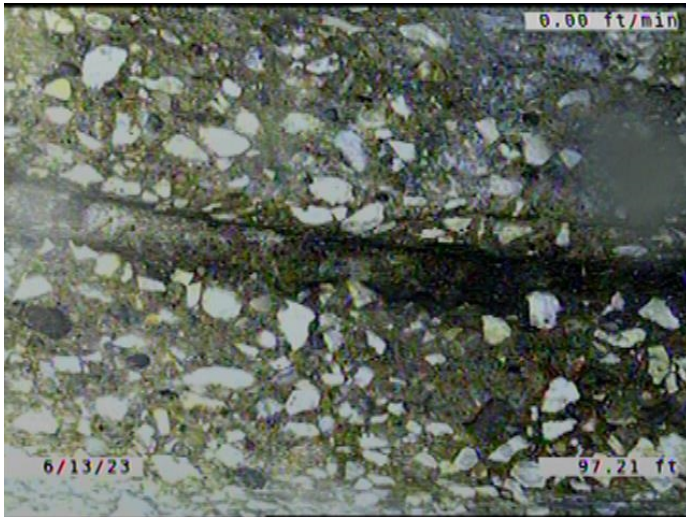
Code: **JOMD**
Description: **Joint Offset Medium Defective**

Distance (ft): **97.2**
Structural Grade: **3**
O&M Grade: **0**
Clock Start/From:
Clock To:
1st Value:
2nd Value:
Value Percent:
Continuous Index:
Within 8" of Joint: **NO**
Remarks:

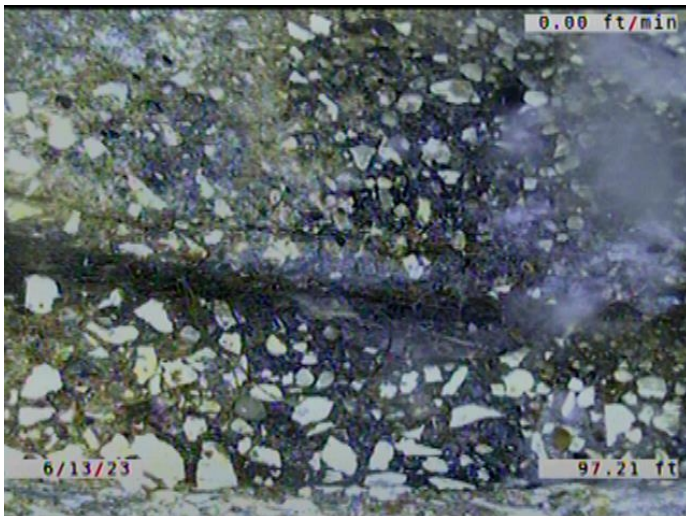
Code: **RFJ**
Description: **Roots Fine Joint**

Distance (ft): **97.2**
Structural Grade: **0**
O&M Grade: **1**
Clock Start/From: **9**
Clock To: **3**
1st Value:
2nd Value:
Value Percent:
Continuous Index: **S05**
Within 8" of Joint: **YES**
Remarks:

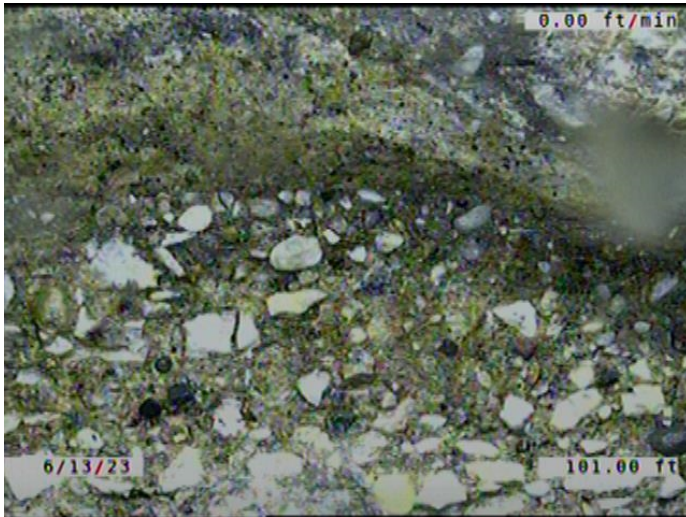
Code: **SMW**
Description: **Surface Damage Missing Wall**

Distance (ft): **101.0**
Structural Grade: **5**
O&M Grade: **0**
Clock Start/From: **11**
Clock To: **1**
1st Value:
2nd Value:
Value Percent:
Continuous Index:
Within 8" of Joint: **YES**
Remarks: **THE INSIDE OF THE JOINT.**

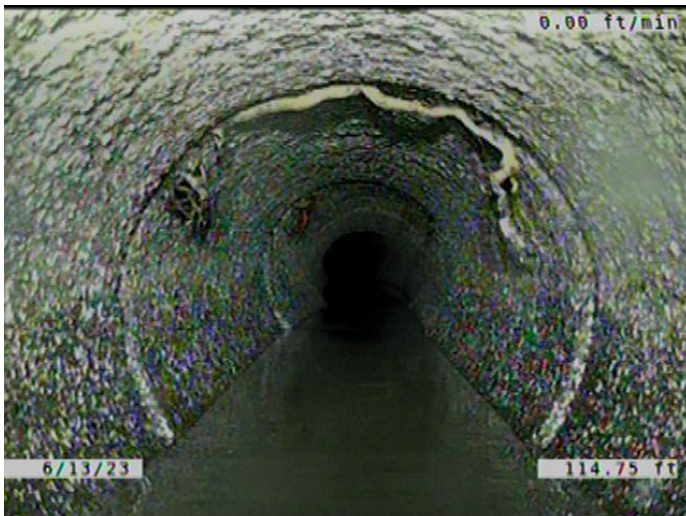
Code: **MWLS**
Description: **Miscellaneous Water Level Sag**

Distance (ft): **114.7**
Structural Grade: **3**
O&M Grade: **0**
Clock Start/From:
Clock To:
1st Value:
2nd Value:
Value Percent: **50.000**
Continuous Index: **F04**
Within 8" of Joint: **NO**
Remarks:

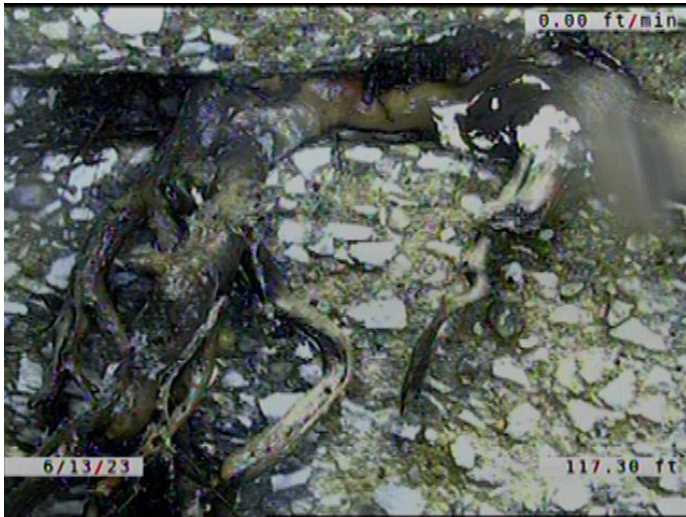
Code: **RTJ**
Description: **Roots Tap Joint**

Distance (ft): **117.3**
Structural Grade: **0**
O&M Grade: **2**
Clock Start/From: **10**
Clock To: **2**
1st Value:
2nd Value:
Value Percent: **5.000**
Continuous Index: **S06**
Within 8" of Joint: **YES**
Remarks:

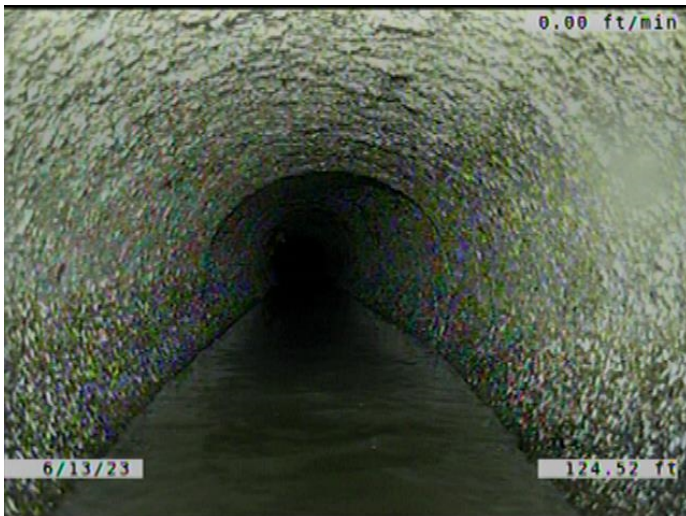
Code: **MWLS**
Description: **Miscellaneous Water Level Sag**

Distance (ft): **124.5**
Structural Grade: **2**
O&M Grade: **0**
Clock Start/From:
Clock To:
1st Value:
2nd Value:
Value Percent: **20.000**
Continuous Index: **S07**
Within 8" of Joint: **NO**
Remarks:

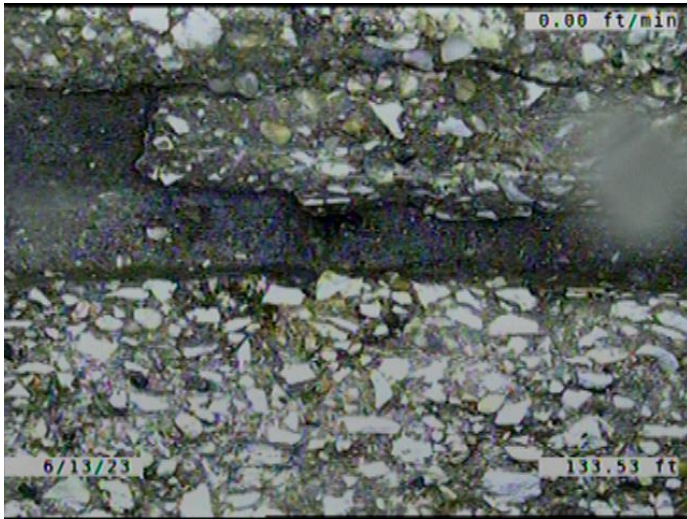
Code: **B**
Description: **Broken**

Distance (ft): **133.5**
Structural Grade: **4**
O&M Grade: **0**
Clock Start/From: **12**
Clock To: **2**
1st Value:
2nd Value:
Value Percent:
Continuous Index:
Within 8" of Joint: **YES**
Remarks:

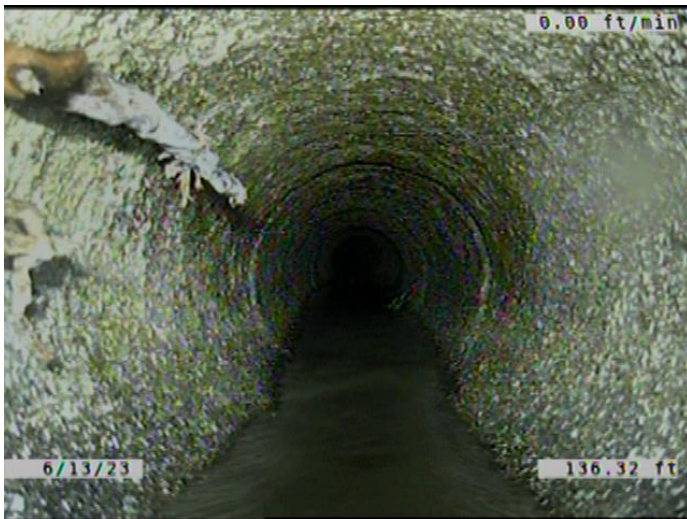
Code: **MWLS**
Description: **Miscellaneous Water Level Sag**

Distance (ft): **136.3**
Structural Grade: **2**
O&M Grade: **0**
Clock Start/From:
Clock To:
1st Value:
2nd Value:
Value Percent: **20.000**
Continuous Index: **F07**
Within 8" of Joint: **NO**
Remarks:

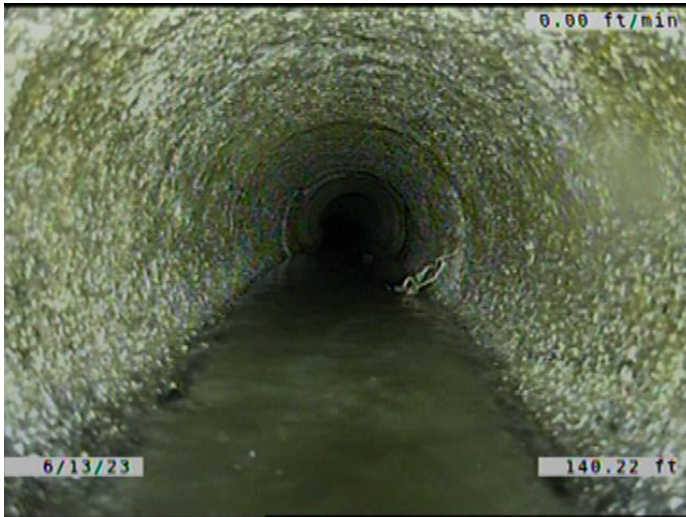
Code:	MWLS
Description:	Miscellaneous Water Level Sag
Distance (ft):	140.2
Structural Grade:	2
O&M Grade:	0
Clock Start/From:	
Clock To:	
1st Value:	
2nd Value:	
Value Percent:	20.000
Continuous Index:	S08
Within 8" of Joint:	NO
Remarks:

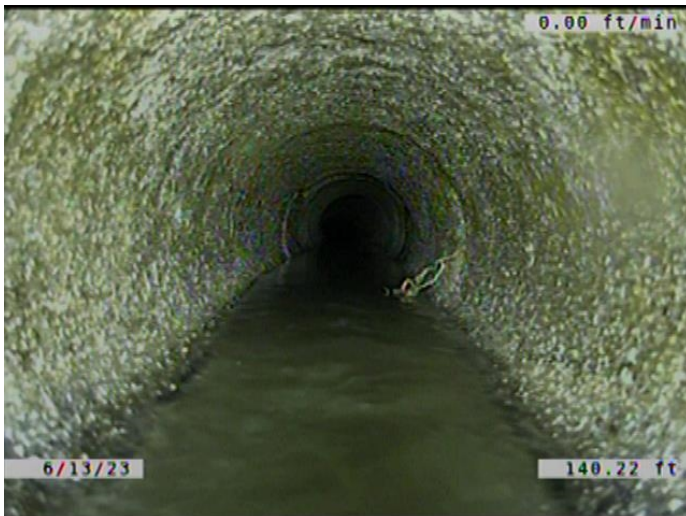
Code:	RTJ
Description:	Roots Tap Joint
Distance (ft):	140.2
Structural Grade:	0
O&M Grade:	2
Clock Start/From:	10
Clock To:	2
1st Value:	
2nd Value:	
Value Percent:	5.000
Continuous Index:	F06
Within 8" of Joint:	YES
Remarks:

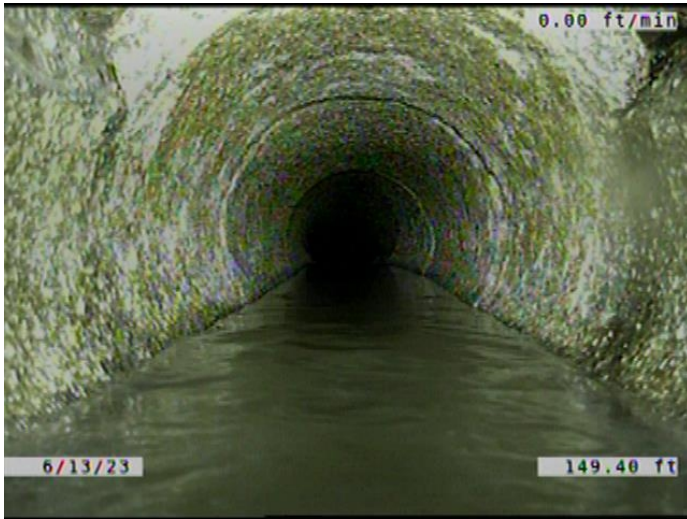
Code: **SAP**
Description: **Surface Damage Aggregate Projecting**

Distance (ft): **149.4**
Structural Grade: **3**
O&M Grade: **0**
Clock Start/From: **7**
Clock To: **5**
1st Value:
2nd Value:
Value Percent:
Continuous Index: **F01**
Within 8" of Joint: **YES**
Remarks:

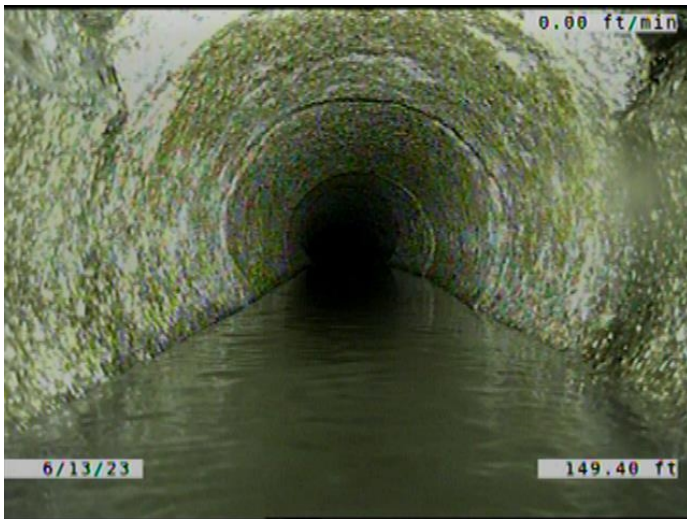
Code: **DAE**
Description: **Deposits Attached Encrustation**

Distance (ft): **149.4**
Structural Grade: **0**
O&M Grade: **2**
Clock Start/From: **7**
Clock To: **5**
1st Value:
2nd Value:
Value Percent: **5.000**
Continuous Index: **F02**
Within 8" of Joint: **YES**
Remarks:

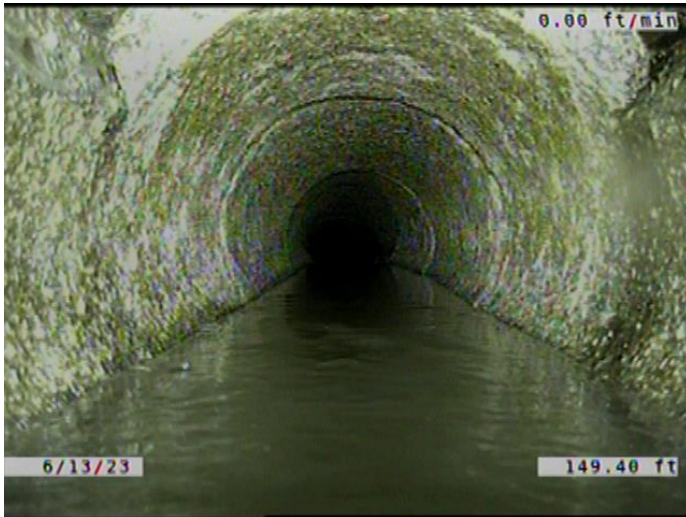
Code: **RFJ**
Description: **Roots Fine Joint**

Distance (ft): **149.4**
Structural Grade: **0**
O&M Grade: **1**
Clock Start/From: **9**
Clock To: **3**
1st Value:
2nd Value:
Value Percent:
Continuous Index: **F05**
Within 8" of Joint: **YES**
Remarks:

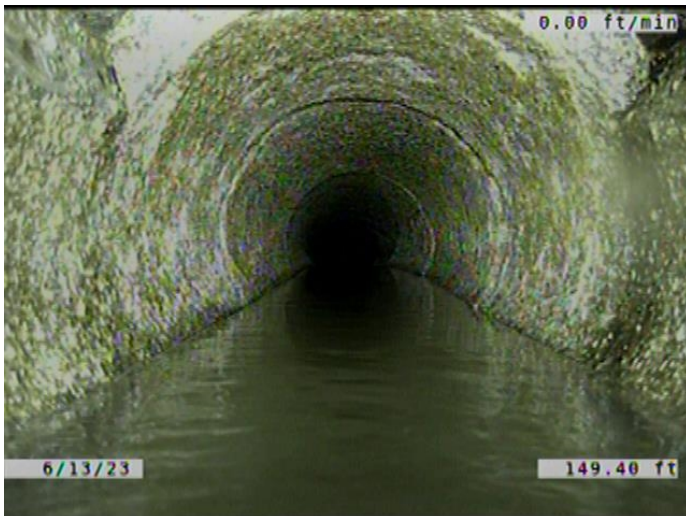
Code: **MWLS**
Description: **Miscellaneous Water Level Sag**

Distance (ft): **149.4**
Structural Grade: **2**
O&M Grade: **0**
Clock Start/From:
Clock To:
1st Value:
2nd Value:
Value Percent: **20.000**
Continuous Index: **F08**
Within 8" of Joint: **NO**
Remarks:
