## Profile/Photo Observation Report

Date:	<b>07/31/2023</b>	Weather:		Coding:	<b>PACP 7.0</b>
Pipe Length (ft):	<b>139.0</b>	Owner:	<b>City of Hobart</b>	Pre Clean:	<b>Heavy Cleaning</b>
P.O.#:	<b>YES502259</b>	Surveyor:	<b>S. Bucklin</b>	PSR:	<b>P-902-032A-027</b>
Customer:	<b>City of Hobart</b>	Clean Date:	<b>05/18/2023</b>	Shape:	<b>C</b>

Street:	<b>East 34th Avenue</b>	Flow Control:	<b>Not Controlled</b>
City:	<b>Hobart, IN</b>	Year Renewed:	
Location:	<b>Local rural streets with light traffic, t</b>	Tape/Media #:	
Purpose:	<b>Routine Assessment</b>	Dia/Height:	<b>18"</b>
Use:	<b>Sanitary Sewage Pipe</b>	Material:	<b>RCP</b>
Drain Area:		Lining:	<b>None</b>
Category:	<b>NA</b>		
Comment:			
Location Details:		Direction of Survey:	<b>Downstream</b>
US MH:	<b>M-902-032A</b>	DS MH:	<b>M-902-027</b>
		Total Length Surveyed (ft):	<b>139.8</b>

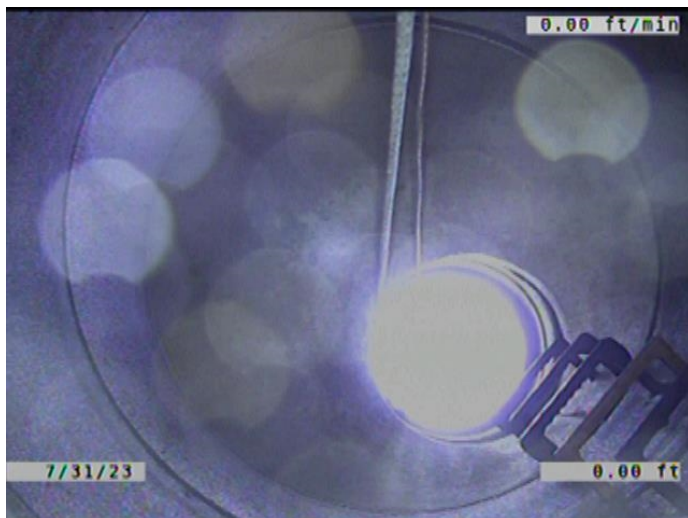
Code: **AMH**  
Description: **Manhole**

Distance (ft): **.0**  
Structural Grade: **0**  
O&M Grade: **0**  
Clock Start/From:  
Clock To:  
1st Value:  
2nd Value:  
Value Percent:  
Continuous Index:  
Within 8" of Joint: **NO**  
Remarks: **M-902-032A**

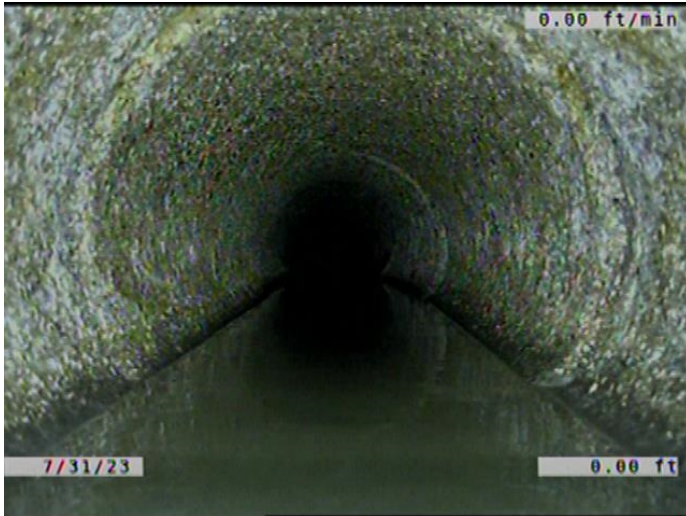
Code: **MWL**  
Description: **Miscellaneous Water Level**

Distance (ft): **.0**  
Structural Grade: **0**  
O&M Grade: **0**  
Clock Start/From:  
Clock To:  
1st Value:  
2nd Value:  
Value Percent: **15.000**  
Continuous Index:  
Within 8" of Joint: **NO**  
Remarks:

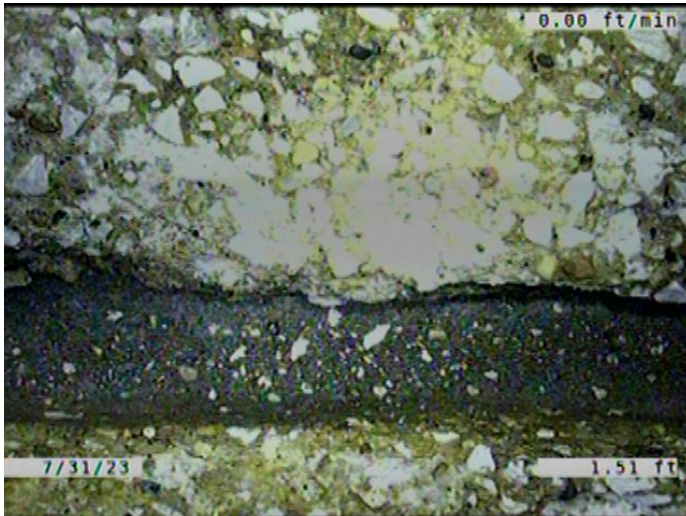
Code: **SMW**  
Description: **Surface Damage Missing Wall**

Distance (ft): **1.5**  
Structural Grade: **5**  
O&M Grade: **0**  
Clock Start/From: **8**  
Clock To: **4**  
1st Value:  
2nd Value:  
Value Percent:  
Continuous Index:  
Within 8" of Joint: **YES**  
Remarks: **THE INSIDE OF THE JOINT.**

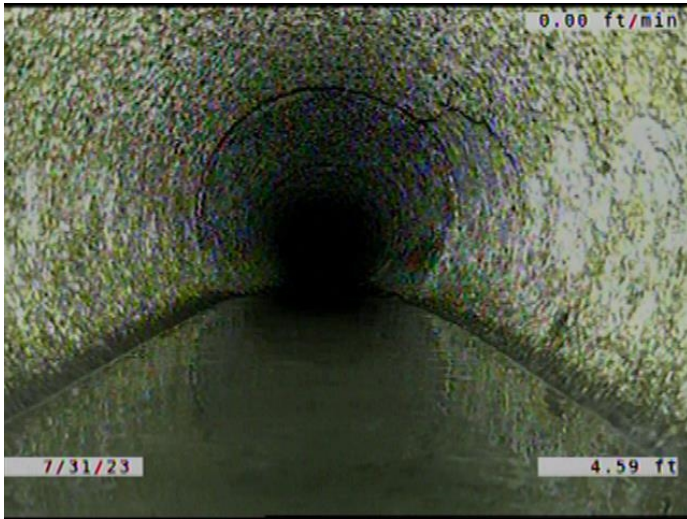
Code: **SAM**  
Description: **Surface Damage Aggregate Missing**

Distance (ft): **4.6**  
Structural Grade: **4**  
O&M Grade: **0**  
Clock Start/From: **1**  
Clock To: **4**  
1st Value:  
2nd Value:  
Value Percent:  
Continuous Index:  
Within 8" of Joint: **YES**  
Remarks:

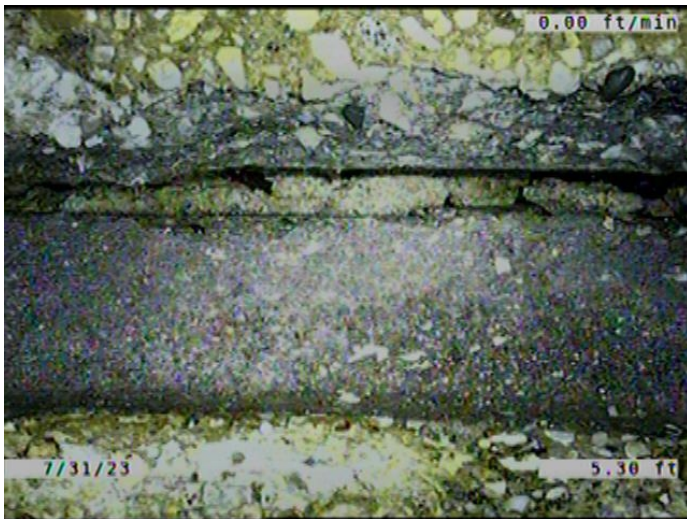
Code: **SMW**  
Description: **Surface Damage Missing Wall**

Distance (ft): **5.3**  
Structural Grade: **5**  
O&M Grade: **0**  
Clock Start/From: **8**  
Clock To: **4**  
1st Value:  
2nd Value:  
Value Percent:  
Continuous Index:  
Within 8" of Joint: **YES**  
Remarks: **SOIL VISIBLE.**

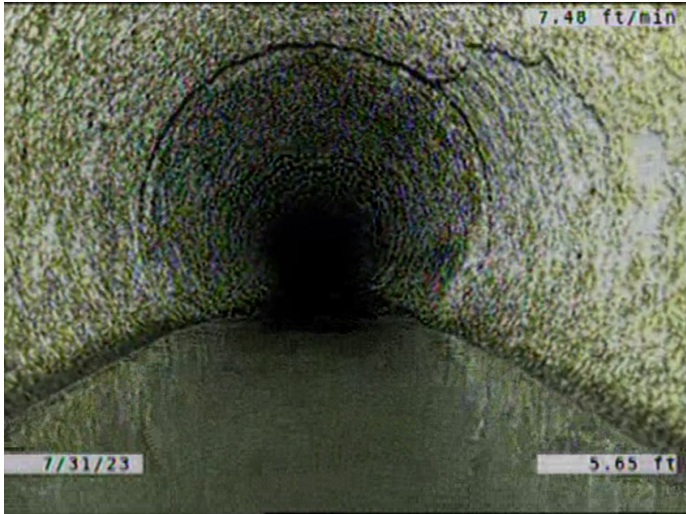
Code: **FS**  
Description: **Fracture Spiral**

Distance (ft): **5.7**  
Structural Grade: **3**  
O&M Grade: **0**  
Clock Start/From: **2**  
Clock To: **3**  
1st Value:  
2nd Value:  
Value Percent:  
Continuous Index:  
Within 8" of Joint: **YES**  
Remarks:

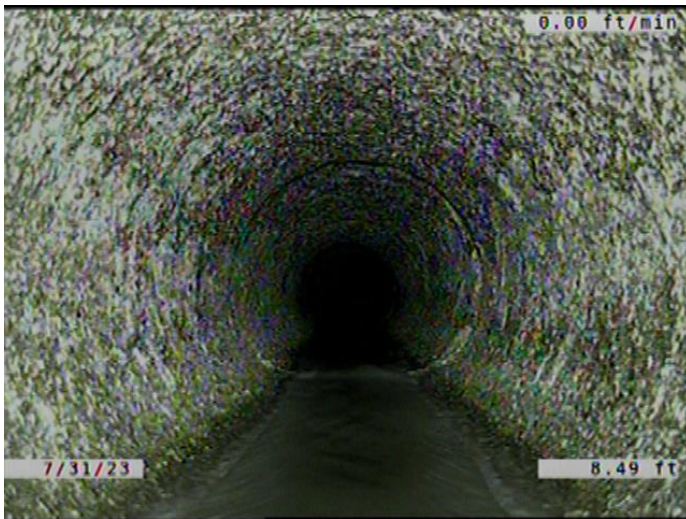
Code: **MWL**  
Description: **Miscellaneous Water Level**

Distance (ft): **8.5**  
Structural Grade: **0**  
O&M Grade: **0**  
Clock Start/From:  
Clock To:  
1st Value:  
2nd Value:  
Value Percent: **5.000**  
Continuous Index:  
Within 8" of Joint: **NO**  
Remarks:

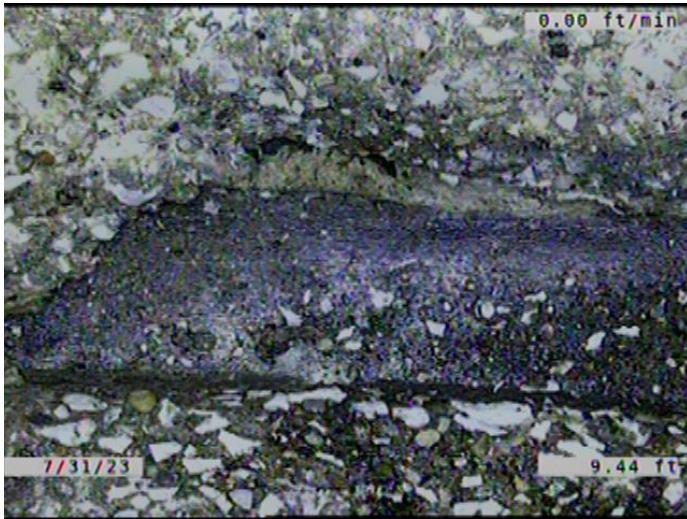
Code: **SMW**  
Description: **Surface Damage Missing Wall**

Distance (ft): **9.4**  
Structural Grade: **5**  
O&M Grade: **0**  
Clock Start/From: **8**  
Clock To: **4**  
1st Value:  
2nd Value:  
Value Percent:  
Continuous Index: **S01**  
Within 8" of Joint: **YES**  
Remarks: **SOIL AND VOID VISIBLE.**

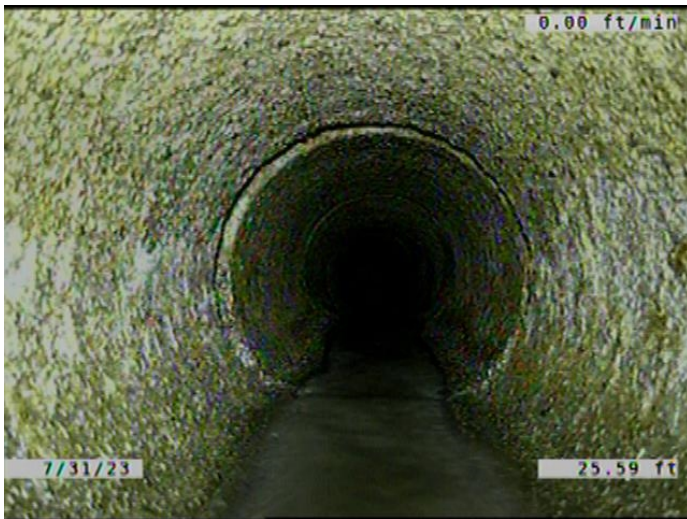
Code: **SAM**  
Description: **Surface Damage Aggregate Missing**

Distance (ft): **25.6**  
Structural Grade: **4**  
O&M Grade: **0**  
Clock Start/From: **9**  
Clock To: **3**  
1st Value:  
2nd Value:  
Value Percent:  
Continuous Index:  
Within 8" of Joint: **YES**  
Remarks:

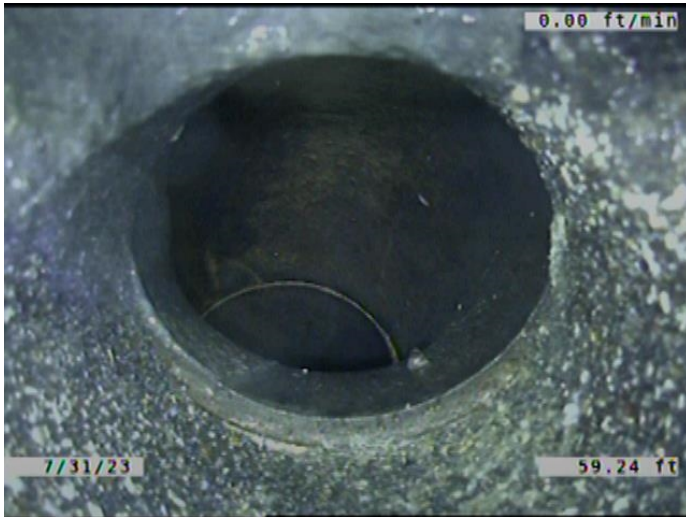
Code: **TF**  
Description: **Tap Factory**

Distance (ft): **59.2**  
Structural Grade: **0**  
O&M Grade: **0**  
Clock Start/From: **12**  
Clock To:  
1st Value: **6.000**  
2nd Value:  
Value Percent:  
Continuous Index:  
Within 8" of Joint: **YES**  
Remarks: **VCP SERVICE.**

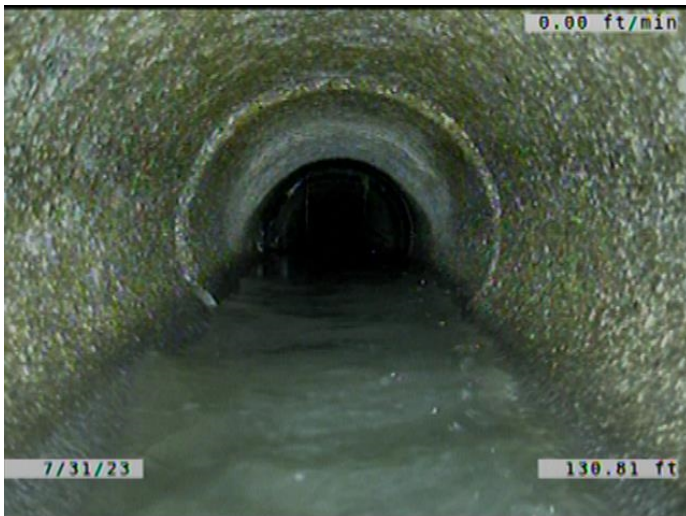
Code: **MWL**  
Description: **Miscellaneous Water Level**

Distance (ft): **130.8**  
Structural Grade: **0**  
O&M Grade: **0**  
Clock Start/From:  
Clock To:  
1st Value:  
2nd Value:  
Value Percent: **35.000**  
Continuous Index:  
Within 8" of Joint: **NO**  
Remarks:

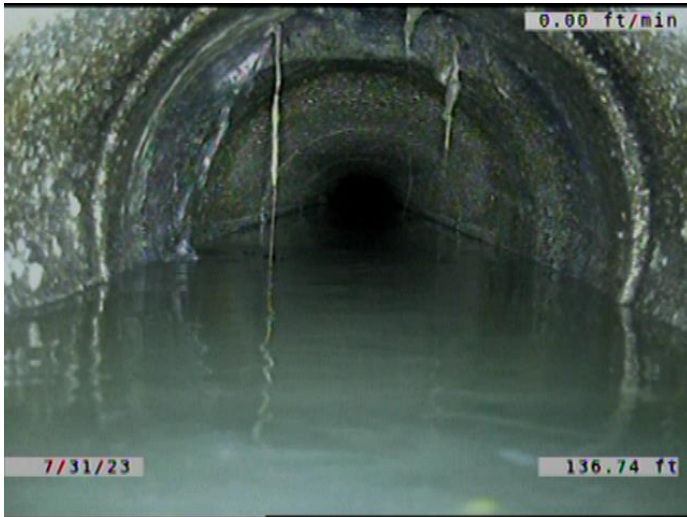
Code: **MWL**  
Description: **Miscellaneous Water Level**

Distance (ft): **136.7**  
Structural Grade: **0**  
O&M Grade: **0**  
Clock Start/From:  
Clock To:  
1st Value:  
2nd Value:  
Value Percent: **45.000**  
Continuous Index:  
Within 8" of Joint: **NO**  
Remarks:

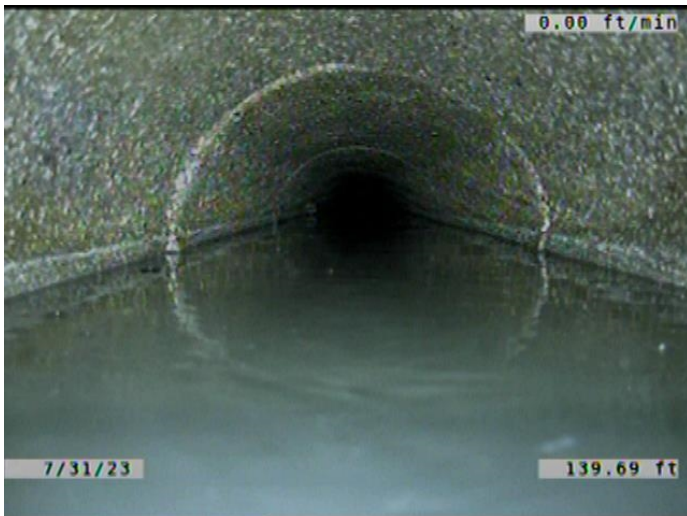
Code: **SMW**  
Description: **Surface Damage Missing Wall**

Distance (ft): **139.7**  
Structural Grade: **5**  
O&M Grade: **0**  
Clock Start/From: **8**  
Clock To: **4**  
1st Value:  
2nd Value:  
Value Percent:  
Continuous Index: **F01**  
Within 8" of Joint: **YES**  
Remarks: **SOIL AND VOID VISIBLE.**

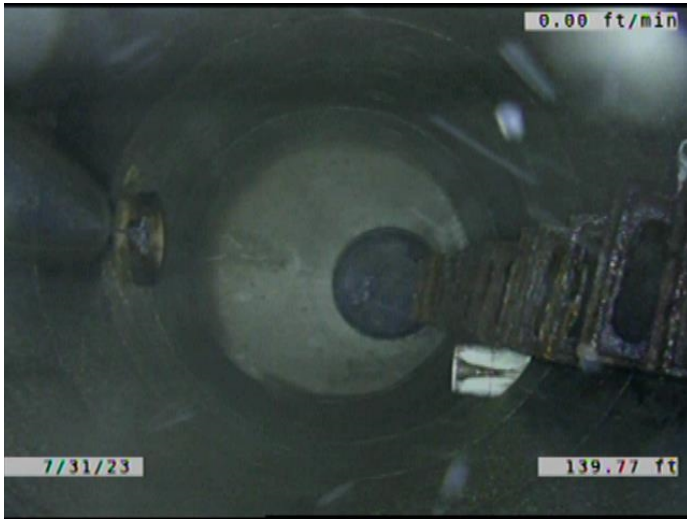
Code:	AMH
Description:	Manhole
Distance (ft):	139.8
Structural Grade:	0
O&M Grade:	0
Clock Start/From:	
Clock To:	
1st Value:	
2nd Value:	
Value Percent:	
Continuous Index:	
Within 8" of Joint:	NO
Remarks:	M-902-027
