Profile/Photo Observation Report

Date:	09/18/2023	Weather:		Coding:	PACP 7.0
Pipe Length (ft):	205.0	Owner:	City of Hobart	Pre Clean:	Heavy Cleaning
P.O.#:	YES502259	Surveyor:	S. Bucklin	PSR:	P-902-034-033
Customer:	City of Hobart	Clean Date:	08/14/2023	Shape:	C

Street:	East 34th Place	Flow Control:	Not Controlled
City:	Hobart, IN	Year Renewed:	
Location:	Easement/Right of Way	Tape/Media #:	
Purpose:	Routine Assessment	Dia/Height:	8"
Use:	Sanitary Sewage Pipe	Material:	VCP
Drain Area:		Lining:	None
Category:	NA		
Comment:			
Location Details:		Direction of Survey:	Downstream
US MH:	M-902-034	DS MH:	M-902-033
		Total Length Surveyed (ft):	199.4

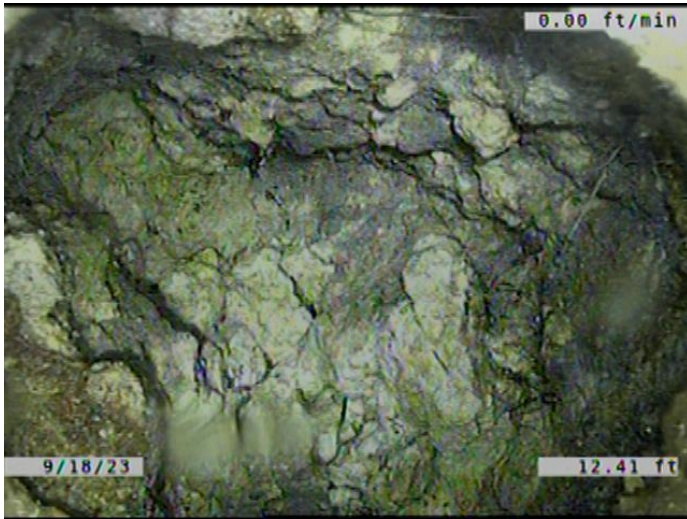
Code: **HVV**
Description: **Hole Void Visible**

Distance (ft): **12.4**
Structural Grade: **5**
O&M Grade: **0**
Clock Start/From: **11**
Clock To: **1**
1st Value:
2nd Value:
Value Percent:
Continuous Index:
Within 8" of Joint: **NO**
Remarks:

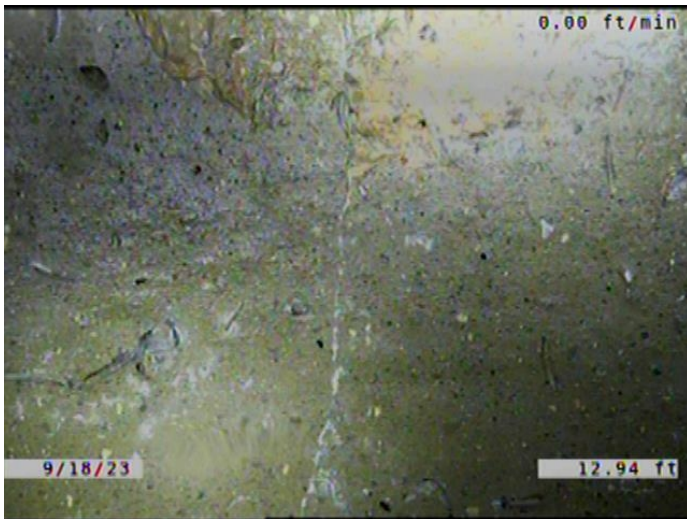
Code: **CM**
Description: **Crack Multiple**

Distance (ft): **12.9**
Structural Grade: **3**
O&M Grade: **0**
Clock Start/From: **11**
Clock To: **1**
1st Value:
2nd Value:
Value Percent:
Continuous Index:
Within 8" of Joint: **YES**
Remarks:

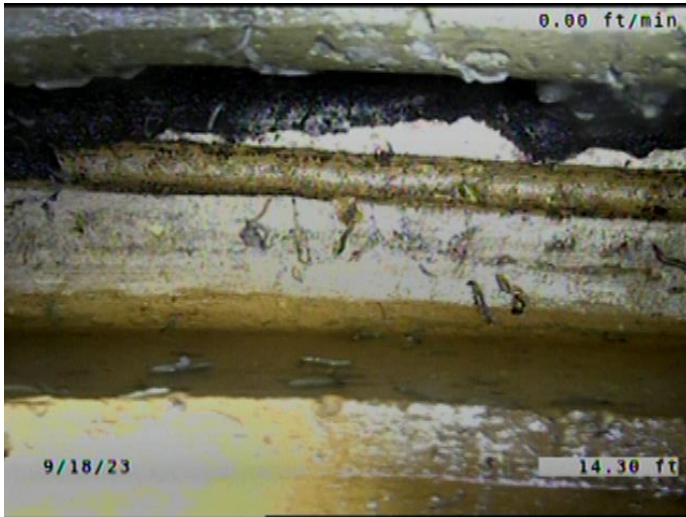
Code: **JAM**
Description: **Joint Angular Medium**

Distance (ft): **14.3**
Structural Grade: **3**
O&M Grade: **0**
Clock Start/From:
Clock To:
1st Value:
2nd Value:
Value Percent:
Continuous Index:
Within 8" of Joint: **NO**
Remarks:

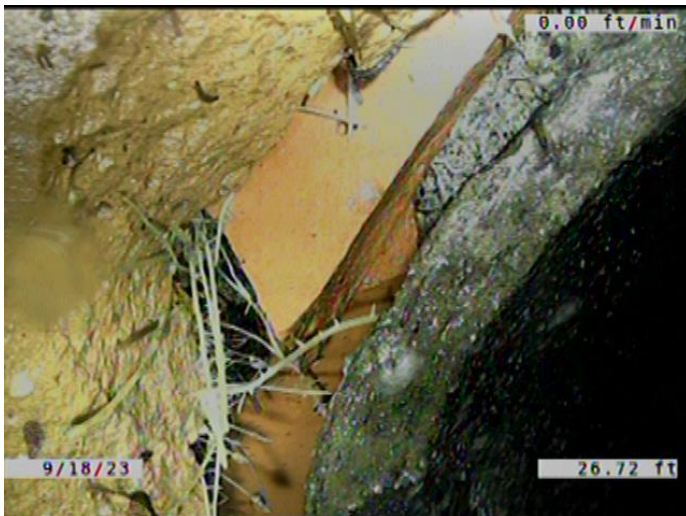
Code: **SSS**
Description: **Surface Damage Surface Spalling**

Distance (ft): **26.3**
Structural Grade: **2**
O&M Grade: **0**
Clock Start/From: **10**
Clock To: **2**
1st Value:
2nd Value:
Value Percent:
Continuous Index:
Within 8" of Joint: **YES**
Remarks:

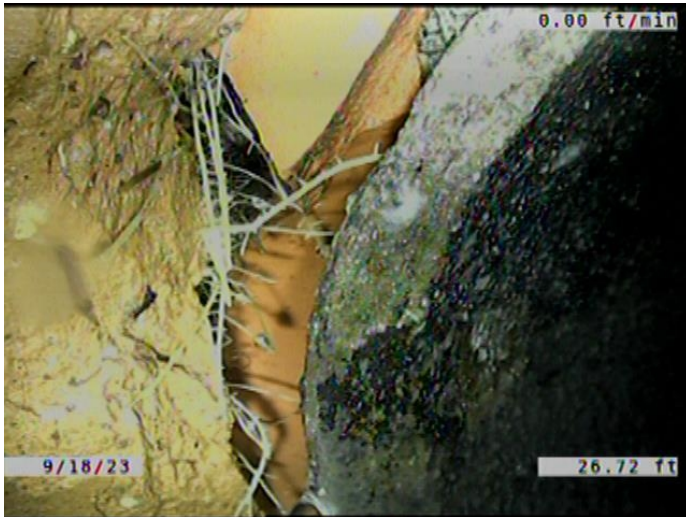
Code: **RFC**
Description: **Roots Fine Connection**

Distance (ft): **26.7**
Structural Grade: **0**
O&M Grade: **1**
Clock Start/From: **11**
Clock To: **12**
1st Value:
2nd Value:
Value Percent:
Continuous Index:
Within 8" of Joint: **NO**
Remarks:

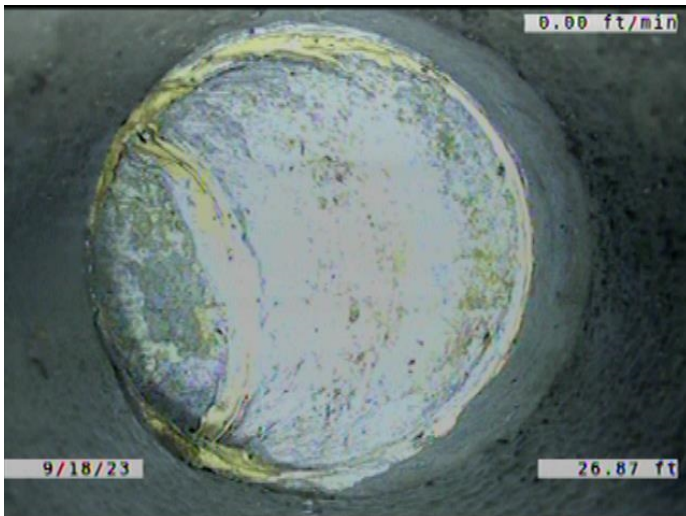
Code: **TBD**
Description: **Tap Break-in/Hammer Defective**

Distance (ft): **26.9**
Structural Grade: **0**
O&M Grade: **3**
Clock Start/From: **12**
Clock To:
1st Value: **6.000**
2nd Value:
Value Percent:
Continuous Index:
Within 8" of Joint: **YES**
Remarks: **LOOKS TO GO TO THE NORTH.**

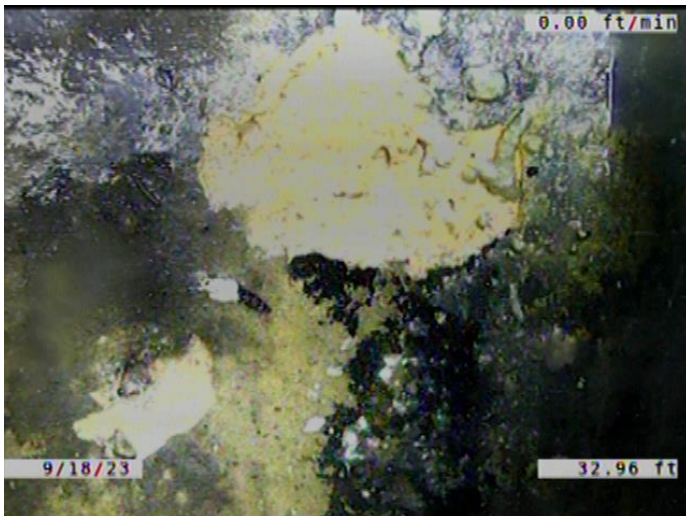
Code: **SSS**
Description: **Surface Damage Surface Spalling**

Distance (ft): **32.9**
Structural Grade: **2**
O&M Grade: **0**
Clock Start/From: **3**
Clock To: **4**
1st Value:
2nd Value:
Value Percent:
Continuous Index:
Within 8" of Joint: **YES**
Remarks:

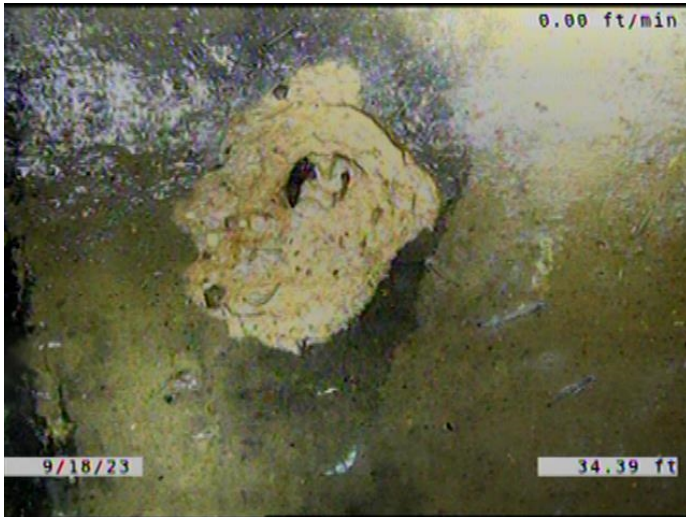
Code: **SSS**
Description: **Surface Damage Surface Spalling**

Distance (ft): **34.4**
Structural Grade: **2**
O&M Grade: **0**
Clock Start/From: **9**
Clock To:
1st Value:
2nd Value:
Value Percent:
Continuous Index:
Within 8" of Joint: **YES**
Remarks:

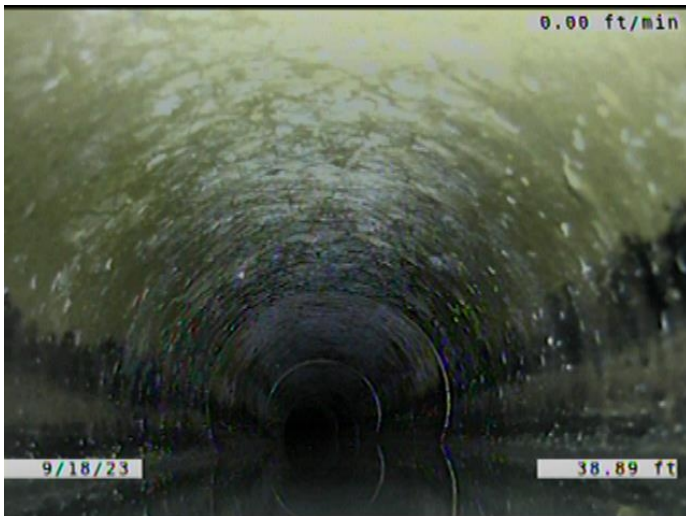
Code: **MWLS**
Description: **Miscellaneous Water Level Sag**

Distance (ft): **38.9**
Structural Grade: **2**
O&M Grade: **0**
Clock Start/From:
Clock To:
1st Value:
2nd Value:
Value Percent: **25.000**
Continuous Index: **S01**
Within 8" of Joint: **NO**
Remarks:

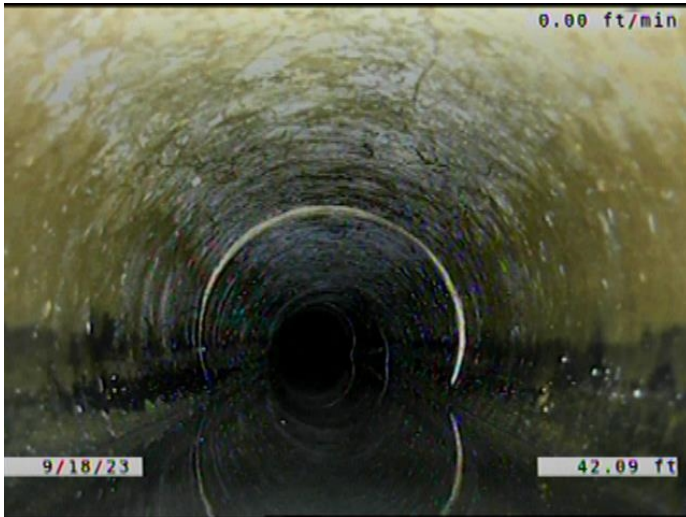
Code: **MWLS**
Description: **Miscellaneous Water Level Sag**

Distance (ft): **42.1**
Structural Grade: **2**
O&M Grade: **0**
Clock Start/From:
Clock To:
1st Value:
2nd Value:
Value Percent: **25.000**
Continuous Index: **F01**
Within 8" of Joint: **NO**
Remarks:

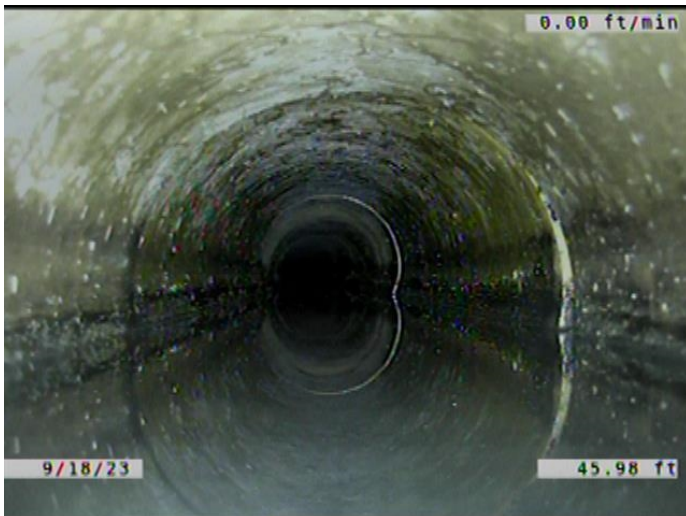
Code: **MWLS**
Description: **Miscellaneous Water Level Sag**

Distance (ft): **46.0**
Structural Grade: **2**
O&M Grade: **0**
Clock Start/From:
Clock To:
1st Value:
2nd Value:
Value Percent: **25.000**
Continuous Index: **S02**
Within 8" of Joint: **NO**
Remarks:

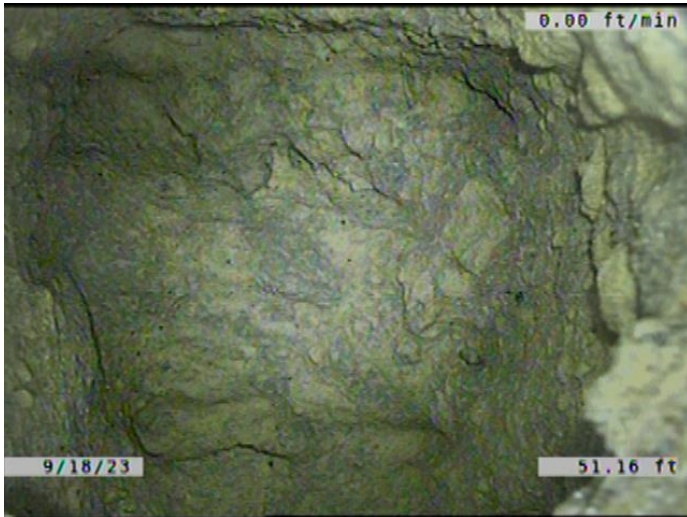
Code: **HVV**
Description: **Hole Void Visible**

Distance (ft): **51.2**
Structural Grade: **5**
O&M Grade: **0**
Clock Start/From: **10**
Clock To: **2**
1st Value:
2nd Value:
Value Percent:
Continuous Index:
Within 8" of Joint: **NO**
Remarks:

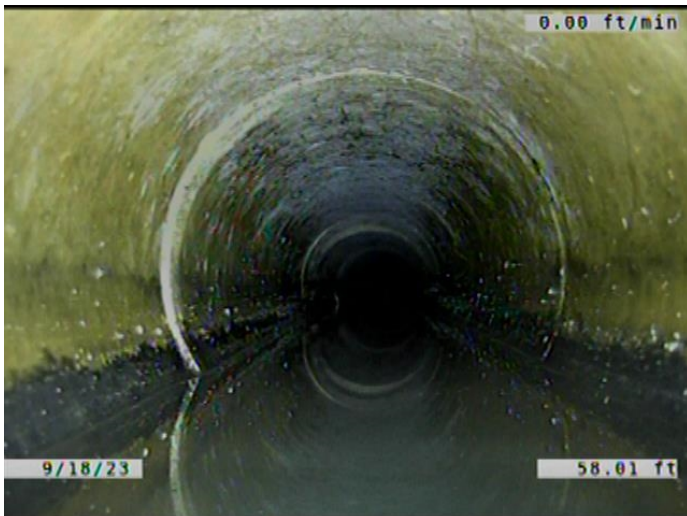
Code: **MWLS**
Description: **Miscellaneous Water Level Sag**

Distance (ft): **58.0**
Structural Grade: **2**
O&M Grade: **0**
Clock Start/From:
Clock To:
1st Value:
2nd Value:
Value Percent: **25.000**
Continuous Index: **F02**
Within 8" of Joint: **NO**
Remarks:

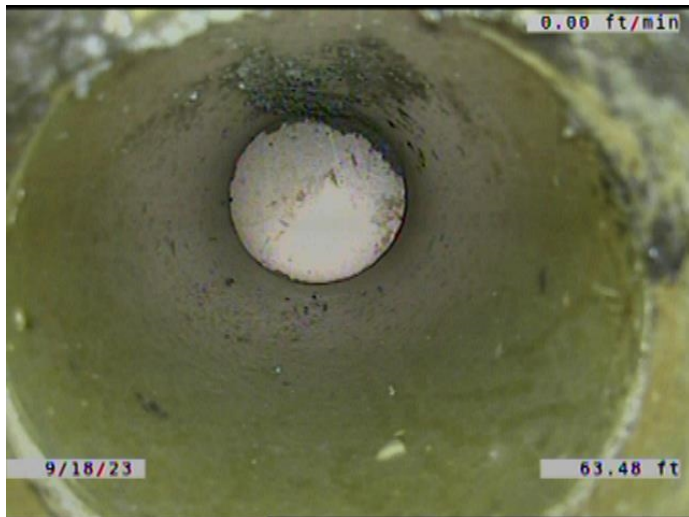
Code: **TFC**
Description: **Tap Factory Capped**

Distance (ft): **63.5**
Structural Grade: **0**
O&M Grade: **0**
Clock Start/From: **12**
Clock To:
1st Value: **6.000**
2nd Value:
Value Percent:
Continuous Index:
Within 8" of Joint: **YES**
Remarks: **ROOTS GROWING IN THE SERVICE TO MAIN JOINT.**

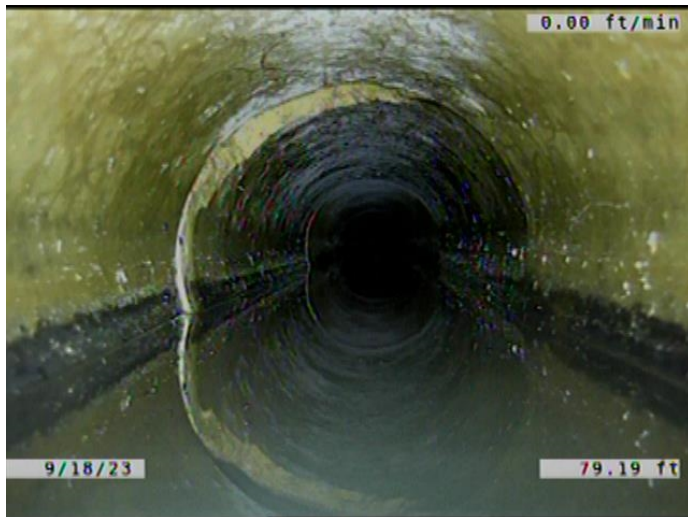
Code: **MWLS**
Description: **Miscellaneous Water Level Sag**

Distance (ft): **79.2**
Structural Grade: **2**
O&M Grade: **0**
Clock Start/From:
Clock To:
1st Value:
2nd Value:
Value Percent: **25.000**
Continuous Index: **S03**
Within 8" of Joint: **NO**
Remarks:

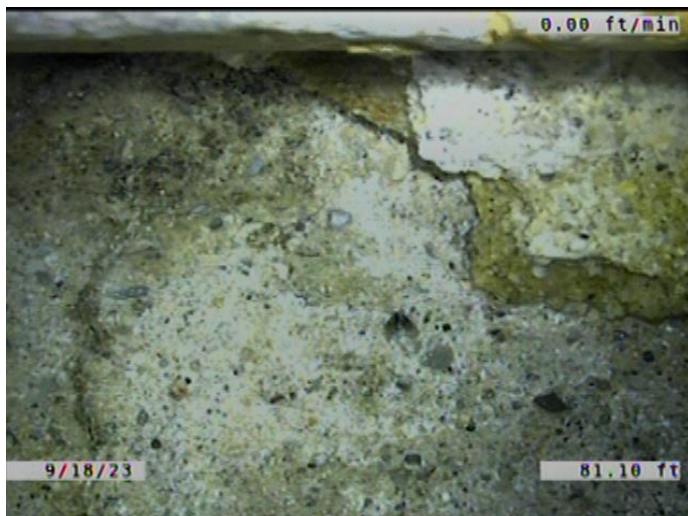
Code: **RPP**
Description: **Point Repair Patch**

Distance (ft): **81.1**
Structural Grade: **0**
O&M Grade: **0**
Clock Start/From: **10**
Clock To: **1**
1st Value:
2nd Value:
Value Percent:
Continuous Index:
Within 8" of Joint: **YES**
Remarks: **REPAIRED WITH CONCRETE WHERE THE PIPE WALL IS MISSING.**

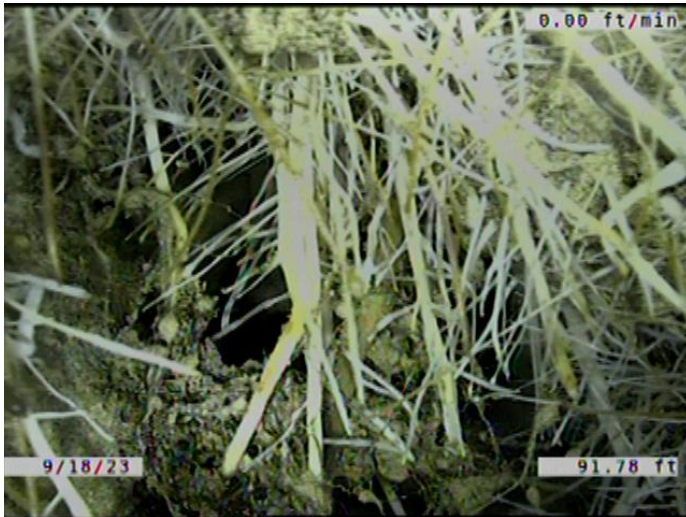
Code: **HVV**
Description: **Hole Void Visible**

Distance (ft): **91.8**
Structural Grade: **5**
O&M Grade: **0**
Clock Start/From: **12**
Clock To: **2**
1st Value:
2nd Value:
Value Percent:
Continuous Index:
Within 8" of Joint: **NO**
Remarks:

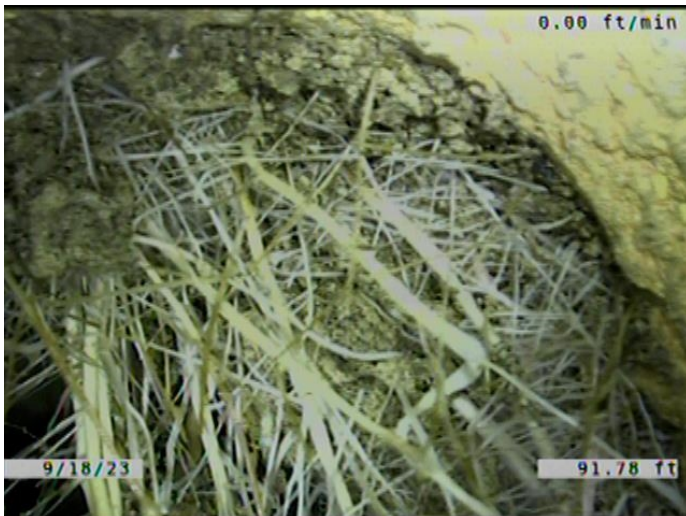
Code: **RFB**
Description: **Roots Fine Barrel**

Distance (ft): **91.8**
Structural Grade: **0**
O&M Grade: **2**
Clock Start/From: **11**
Clock To: **1**
1st Value:
2nd Value:
Value Percent:
Continuous Index:
Within 8" of Joint: **NO**
Remarks: **ROOTS GROWING FROM THE HOLE
IN THE PIPE INTO THE MIAN.**

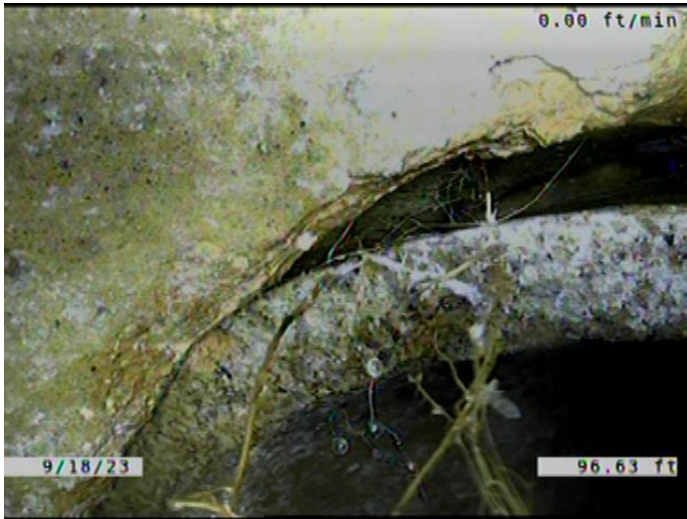
Code: **RFC**
 Description: **Roots Fine Connection**

Distance (ft): **96.6**
 Structural Grade: **0**
 O&M Grade: **1**
 Clock Start/From: **12**
 Clock To: **1**
 1st Value:
 2nd Value:
 Value Percent:
 Continuous Index:
 Within 8" of Joint: **NO**
 Remarks:

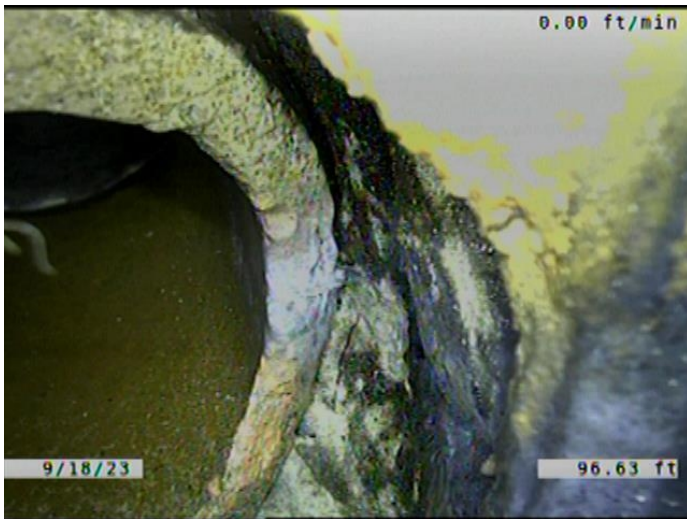
Code: **SSS**
 Description: **Surface Damage Surface Spalling**

Distance (ft): **96.6**
 Structural Grade: **2**
 O&M Grade: **0**
 Clock Start/From: **11**
 Clock To: **3**
 1st Value:
 2nd Value:
 Value Percent:
 Continuous Index:
 Within 8" of Joint: **YES**
 Remarks:

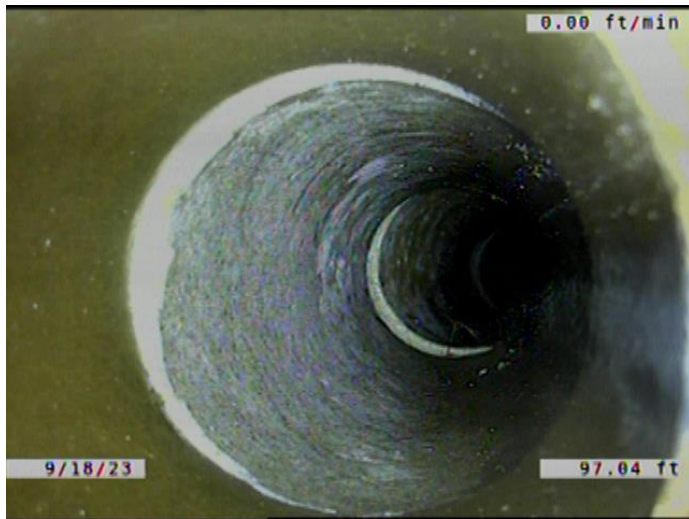
Code:	TBD
Description:	Tap Break-in/Hammer Defective
Distance (ft):	97.0
Structural Grade:	0
O&M Grade:	3
Clock Start/From:	2
Clock To:	
1st Value:	6.000
2nd Value:	
Value Percent:	
Continuous Index:	
Within 8" of Joint:	YES
Remarks:	ROOTS GROWING IN AND AROUND THE SERVICE.

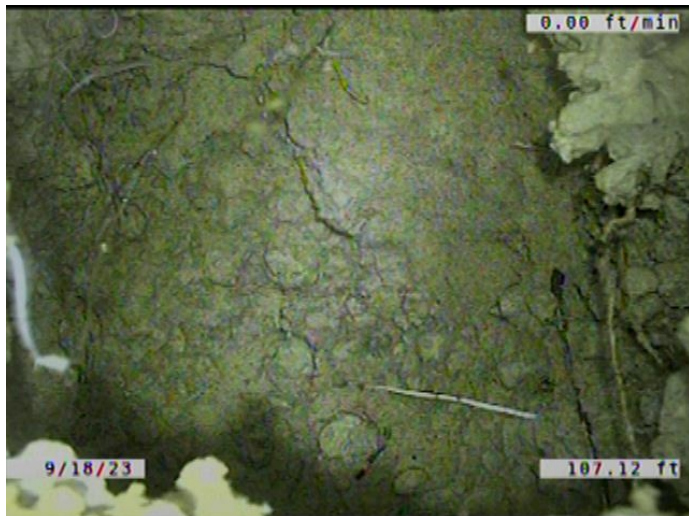
Code:	HVV
Description:	Hole Void Visible
Distance (ft):	107.1
Structural Grade:	5
O&M Grade:	0
Clock Start/From:	11
Clock To:	1
1st Value:	
2nd Value:	
Value Percent:	
Continuous Index:	
Within 8" of Joint:	NO
Remarks:

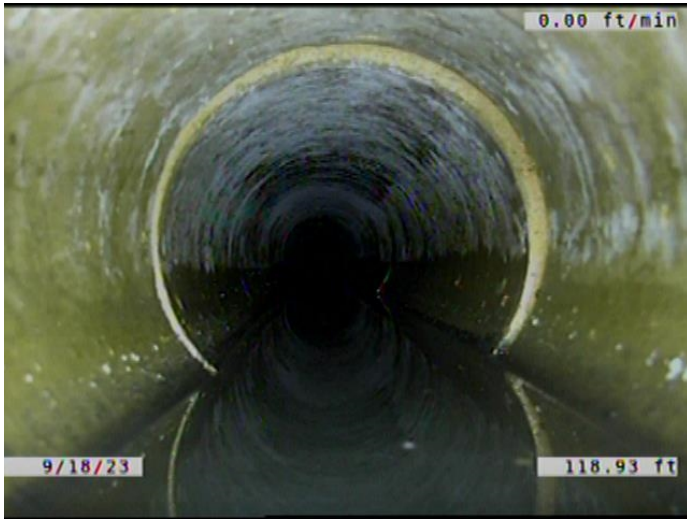
Code: **MWLS**
Description: **Miscellaneous Water Level Sag**

Distance (ft): **118.9**
Structural Grade: **2**
O&M Grade: **0**
Clock Start/From:
Clock To:
1st Value:
2nd Value:
Value Percent: **25.000**
Continuous Index: **F03**
Within 8" of Joint: **NO**
Remarks:

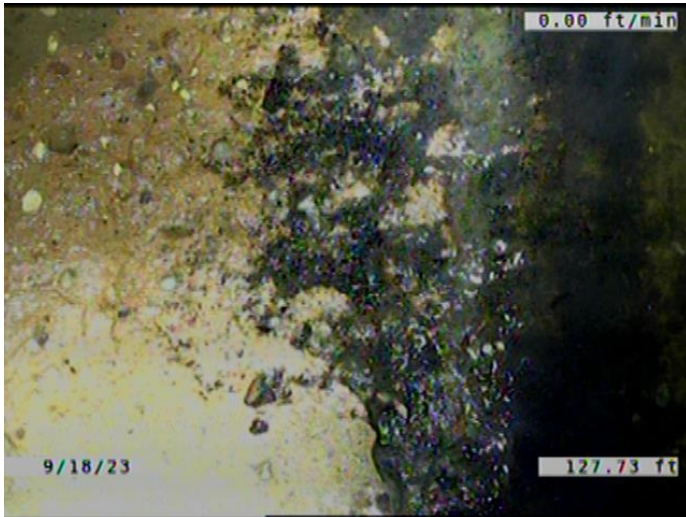
Code: **SSS**
 Description: **Surface Damage Surface Spalling**

Distance (ft): **127.7**
 Structural Grade: **2**
 O&M Grade: **0**
 Clock Start/From: **7**
 Clock To: **9**
 1st Value:
 2nd Value:
 Value Percent:
 Continuous Index:
 Within 8" of Joint: **NO**
 Remarks:

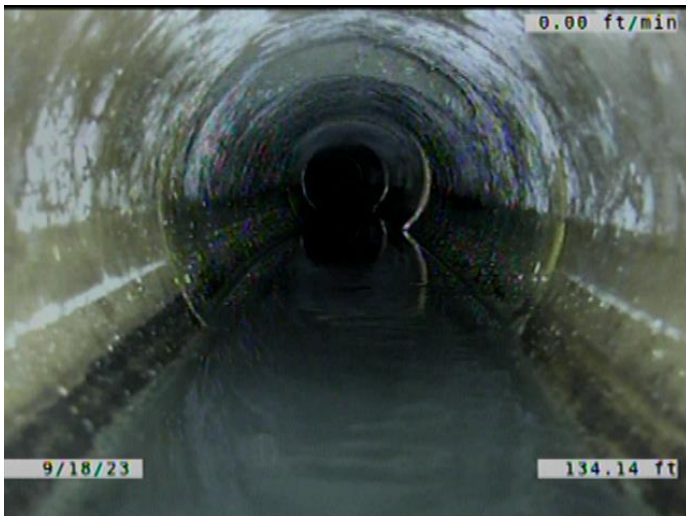
Code: **MWLS**
 Description: **Miscellaneous Water Level Sag**

Distance (ft): **134.1**
 Structural Grade: **2**
 O&M Grade: **0**
 Clock Start/From:
 Clock To:
 1st Value:
 2nd Value:
 Value Percent: **10.000**
 Continuous Index: **S04**
 Within 8" of Joint: **NO**
 Remarks:

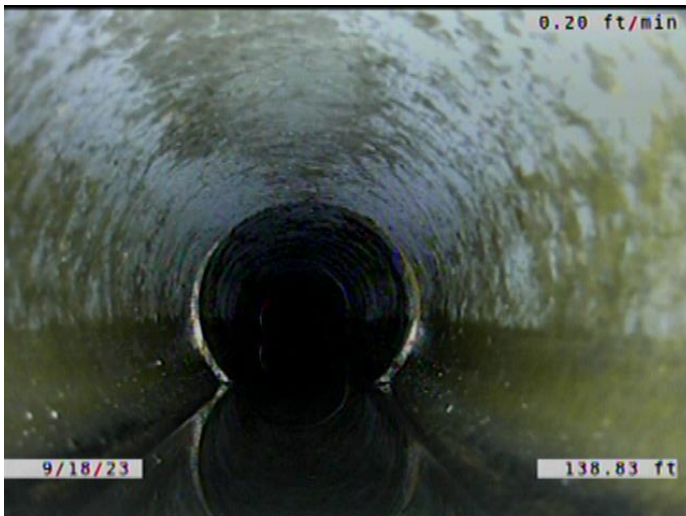
Code: **MWLS**
Description: **Miscellaneous Water Level Sag**

Distance (ft): **138.8**
Structural Grade: **2**
O&M Grade: **0**
Clock Start/From:
Clock To:
1st Value:
2nd Value:
Value Percent: **10.000**
Continuous Index: **F04**
Within 8" of Joint: **NO**
Remarks:

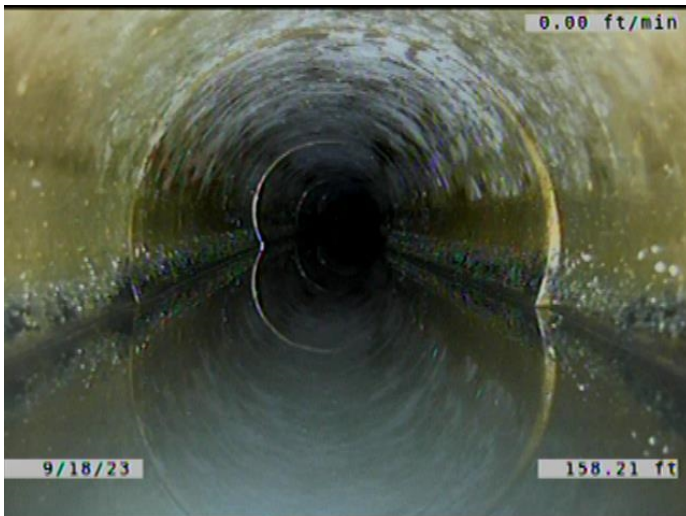
Code: **MWLS**
 Description: **Miscellaneous Water Level Sag**

Distance (ft): **158.2**
 Structural Grade: **2**
 O&M Grade: **0**
 Clock Start/From:
 Clock To:
 1st Value:
 2nd Value:
 Value Percent: **20.000**
 Continuous Index: **S05**
 Within 8" of Joint: **NO**
 Remarks:

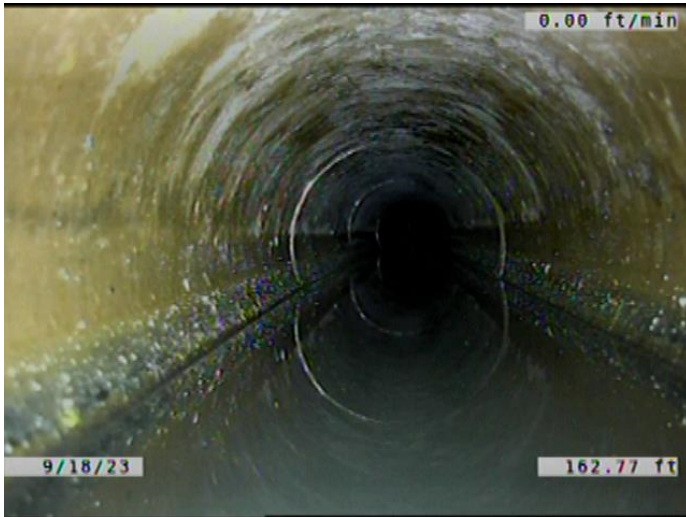
Code: **LR**
Description: **Line Right**

Distance (ft): **162.8**
Structural Grade: **0**
O&M Grade: **1**
Clock Start/From:
Clock To:
1st Value:
2nd Value:
Value Percent: **5.000**
Continuous Index:
Within 8" of Joint: **NO**
Remarks:

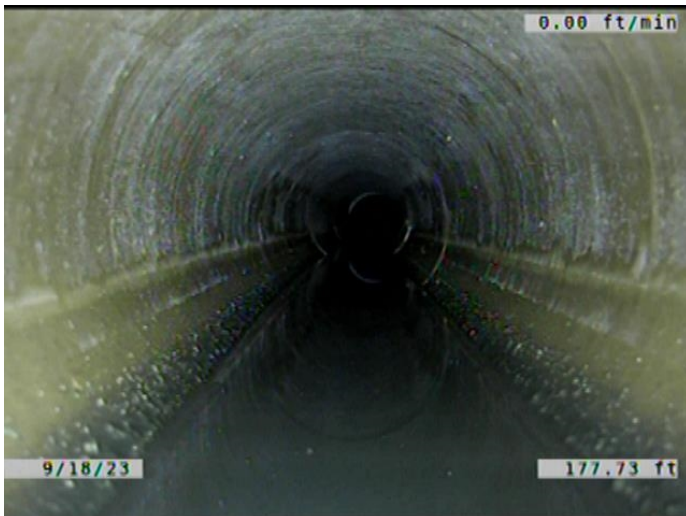
Code: **MWLS**
Description: **Miscellaneous Water Level Sag**

Distance (ft): **177.7**
Structural Grade: **2**
O&M Grade: **0**
Clock Start/From:
Clock To:
1st Value:
2nd Value:
Value Percent: **20.000**
Continuous Index: **F05**
Within 8" of Joint: **NO**
Remarks:
