Profile/Photo Observation Report

Date:	03/23/2018	Weather:		Coding:	PACP 6.0
Pipe Length (ft):	256.9	Owner:	NA	Pre Clean:	Not Known
P.O.#:		Surveyor:	Jen Costello	PSR:	P-902-037-035
Customer:		Clean Date:	01/01/1900	Shape:	C

Street:	RANDOLPH PL	Flow Control:	Not Controlled
City:	Hobart, IN	Year Renewed:	
Location:	Other	Tape/Media #:	
Purpose:	Not Known	Dia/Height:	10"
Use:	Sanitary	Material:	VCP
Drain Area:	NA	Lining:	
Category:	NA		
Comment:

Location Details:		Direction of Survey:	Downstream
US MH:	M-902-037	DS MH:	M-902-035
		Total Length Surveyed (ft):	6.1

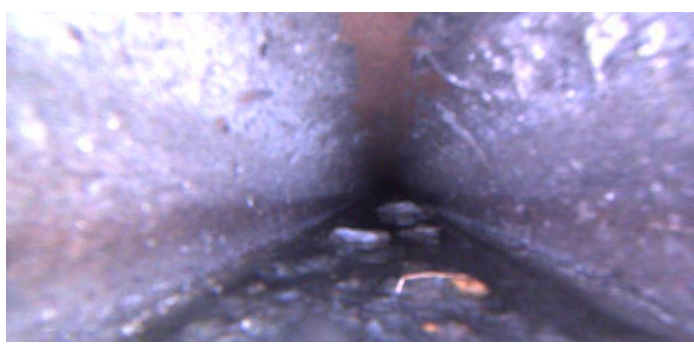
Code: **AMH**
Description: **Manhole**

Distance (ft): **.0**
Structural Grade: **0**
O&M Grade: **0**
Clock Start/From:
Clock To:
1st Value:
2nd Value:
Value Percent:
Continuous Index:
Within 8" of Joint: **NO**
Remarks: **M-902-037**

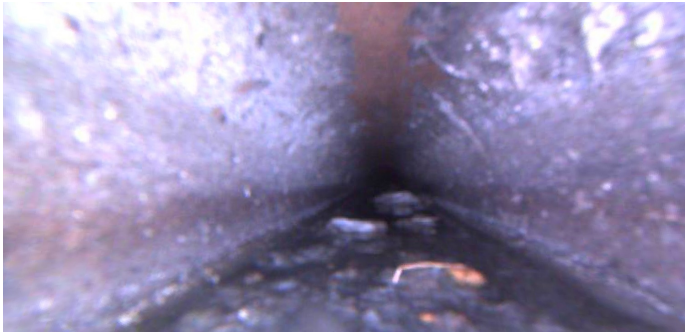
Code:	MWL
Description:	Water Level

Distance (ft):	.0
Structural Grade:	0
O&M Grade:	0
Clock Start/From:	
Clock To:	
1st Value:	
2nd Value:	
Value Percent:	30.000
Continuous Index:	
Within 8" of Joint:	NO
Remarks:

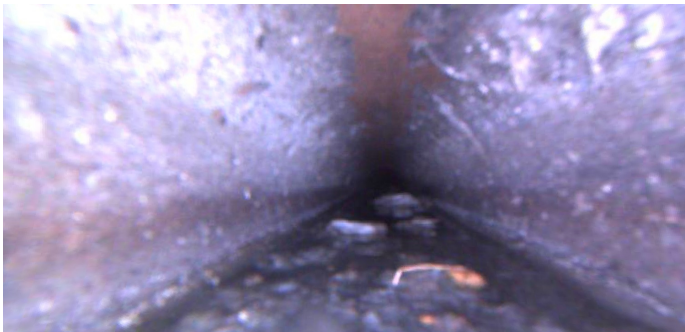
Code:	DAGS
Description:	Deposits Attached Grease

Distance (ft):	.0
Structural Grade:	0
O&M Grade:	2
Clock Start/From:	8
Clock To:	4
1st Value:	
2nd Value:	
Value Percent:	5.000
Continuous Index:	
Within 8" of Joint:	NO
Remarks:

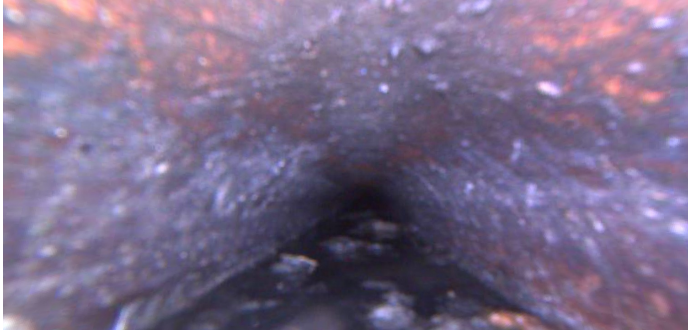
Code:	MSA
Description:	Abandoned Survey
Distance (ft):	6.1
Structural Grade:	0
O&M Grade:	0
Clock Start/From:	
Clock To:	
1st Value:	
2nd Value:	
Value Percent:	
Continuous Index:	
Within 8" of Joint:	NO
Remarks:	DEBRIS UNDER WATER
