## Profile/Photo Observation Report

Street:	<b>randolph pl</b>	Flow Control:	<b>Not Controlled</b>
City:	<b>Hobart, IN</b>	Year Renewed:	
Location:	<b>Other</b>	Tape/Media #:	
Purpose:	<b>Not Known</b>	Dia/Height:	<b>10"</b>
Use:	<b>Sanitary</b>	Material:	<b>VCP</b>
Drain Area:	<b>NA</b>	Lining:	
Category:	<b>NA</b>		
Comment:

Location Details:		Direction of Survey:	<b>Downstream</b>
US MH:	<b>M-902-037</b>	DS MH:	<b>M-902-035</b>
		Total Length Surveyed (ft):	<b>6.1</b>

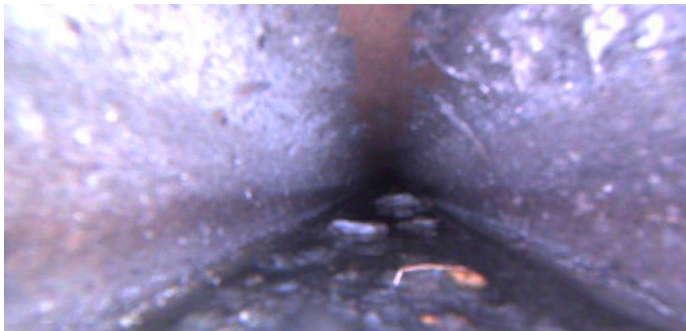
Code: **AMH**  
Description: **Manhole**

Distance (ft): **.0**  
Structural Grade: **0**  
O&M Grade: **0**  
Clock Start/From:  
Clock To:  
1st Value:  
2nd Value:  
Value Percent:  
Continuous Index:  
Within 8" of Joint: **NO**  
Remarks: **M-902-037**

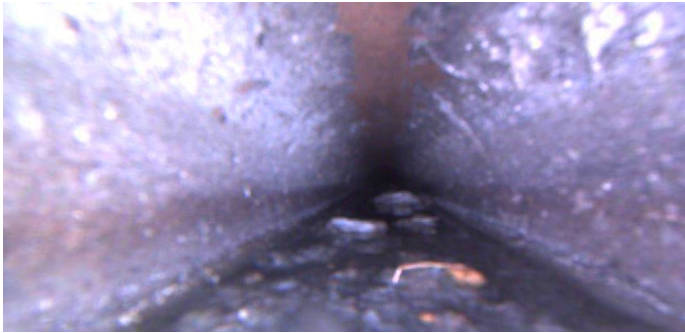
Code:	<b>MWL</b>
Description:	<b>Water Level</b>

Distance (ft):	<b>.0</b>
Structural Grade:	<b>0</b>
O&M Grade:	<b>0</b>
Clock Start/From:	
Clock To:	
1st Value:	
2nd Value:	
Value Percent:	<b>30.000</b>
Continuous Index:	
Within 8" of Joint:	<b>NO</b>
Remarks:

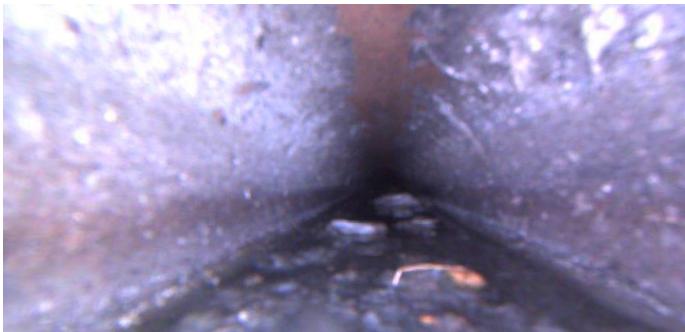
Code:	<b>DAGS</b>
Description:	<b>Deposits Attached Grease</b>

Distance (ft):	<b>.0</b>
Structural Grade:	<b>0</b>
O&M Grade:	<b>2</b>
Clock Start/From:	<b>8</b>
Clock To:	<b>4</b>
1st Value:	
2nd Value:	
Value Percent:	<b>5.000</b>
Continuous Index:	
Within 8" of Joint:	<b>NO</b>
Remarks:

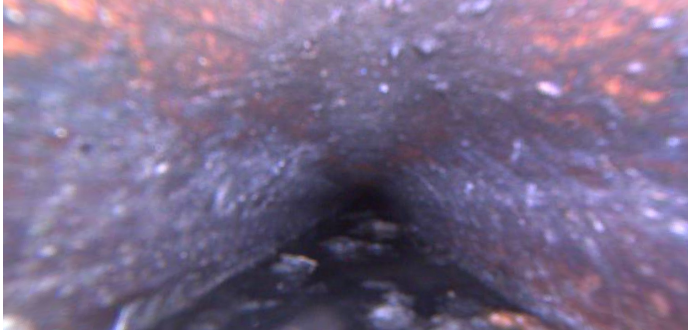
Code:	<b>MSA</b>
Description:	<b>Abandoned Survey</b>
Distance (ft):	<b>6.1</b>
Structural Grade:	<b>0</b>
O&M Grade:	<b>0</b>
Clock Start/From:	
Clock To:	
1st Value:	
2nd Value:	
Value Percent:	
Continuous Index:	
Within 8" of Joint:	<b>NO</b>
Remarks:	<b>DEBRIS UNDER WATER</b>
