Profile/Photo Observation Report

Date:	03/23/2018	Weather:		Coding:	PACP 6.0
Pipe Length (ft):	120.1	Owner:	NA	Pre Clean:	Not Known
P.O.#:		Surveyor:	Jen Costello	PSR:	P-902-038-037
Customer:		Clean Date:	01/01/1900	Shape:	C

Street:	RANDOLPH PL	Flow Control:	Not Controlled
City:	Hobart, IN	Year Renewed:	
Location:	Other	Tape/Media #:	
Purpose:	Not Known	Dia/Height:	10"
Use:	Sanitary	Material:	PVC
Drain Area:	NA	Lining:	
Category:	NA		
Comment:

Location Details:		Direction of Survey:	Upstream
US MH:	M-902-038	DS MH:	M-902-037
		Total Length Surveyed (ft):	90.9

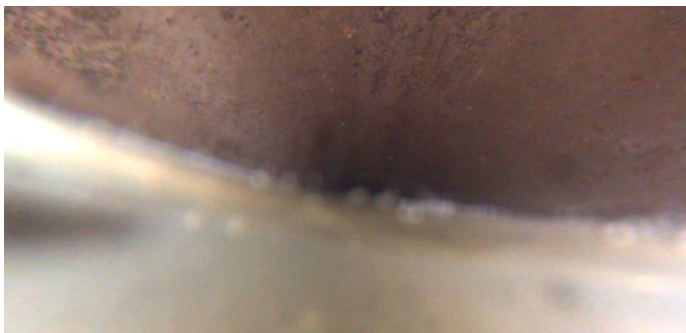
Code: **AMH**
Description: **Manhole**

Distance (ft): **.0**
Structural Grade: **0**
O&M Grade: **0**
Clock Start/From:
Clock To:
1st Value:
2nd Value:
Value Percent:
Continuous Index:
Within 8" of Joint: **NO**
Remarks: **M-902-037**

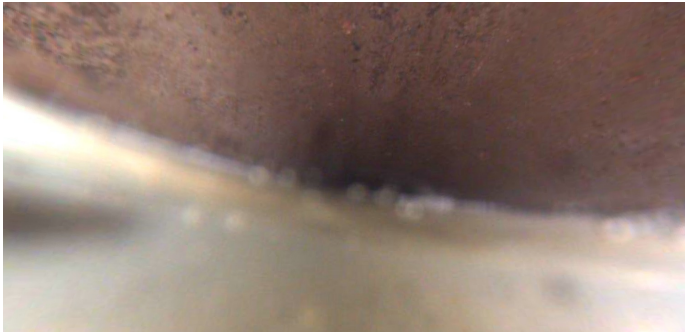
Code:	MWL
Description:	Water Level

Distance (ft):	.0
Structural Grade:	0
O&M Grade:	0
Clock Start/From:	
Clock To:	
1st Value:	
2nd Value:	
Value Percent:	40.000
Continuous Index:	
Within 8" of Joint:	NO
Remarks:

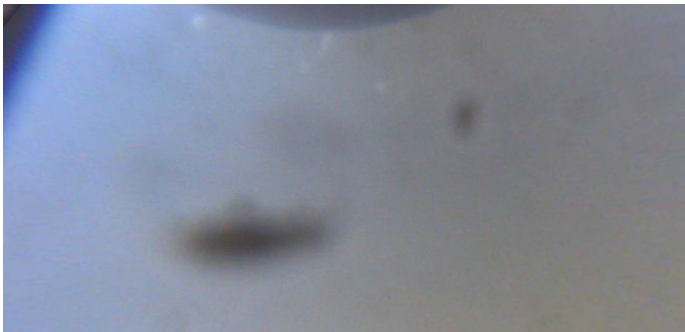
Code:	MWL
Description:	Water Level

Distance (ft):	11.8
Structural Grade:	0
O&M Grade:	0
Clock Start/From:	
Clock To:	
1st Value:	
2nd Value:	
Value Percent:	100.000
Continuous Index:	
Within 8" of Joint:	NO
Remarks:

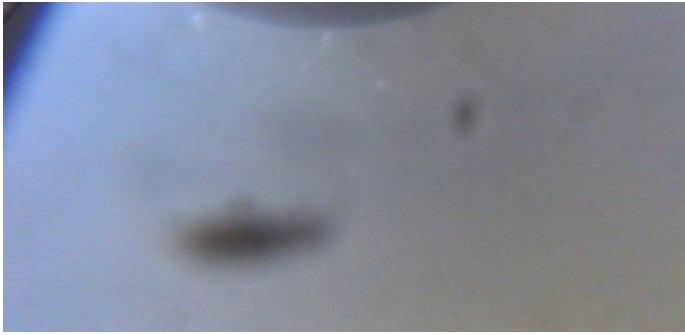
Code: **MCU**
Description: **Camera Underwater**

Distance (ft): **11.8**
Structural Grade: **0**
O&M Grade: **4**
Clock Start/From:
Clock To:
1st Value:
2nd Value:
Value Percent:
Continuous Index: **S01**
Within 8" of Joint: **NO**
Remarks:

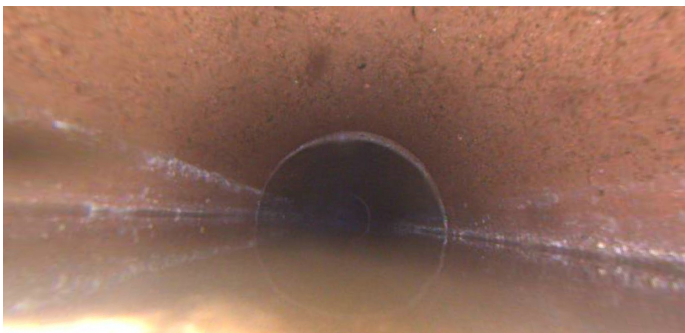
Code: **MCU**
Description: **Camera Underwater**

Distance (ft): **26.2**
Structural Grade: **0**
O&M Grade: **4**
Clock Start/From:
Clock To:
1st Value:
2nd Value:
Value Percent:
Continuous Index: **F01**
Within 8" of Joint: **NO**
Remarks:

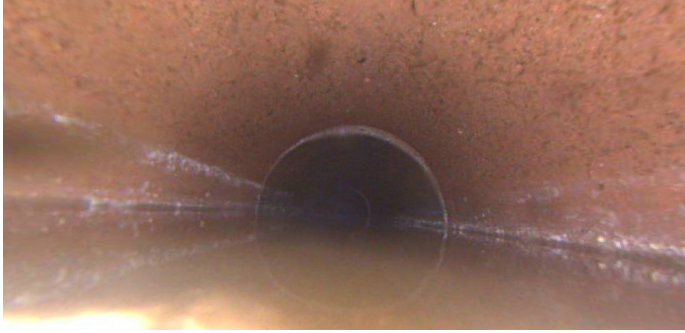
Code: **MWL**
Description: **Water Level**

Distance (ft): **26.2**
Structural Grade: **0**
O&M Grade: **0**
Clock Start/From:
Clock To:
1st Value:
2nd Value:
Value Percent: **40.000**
Continuous Index:
Within 8" of Joint: **NO**
Remarks:

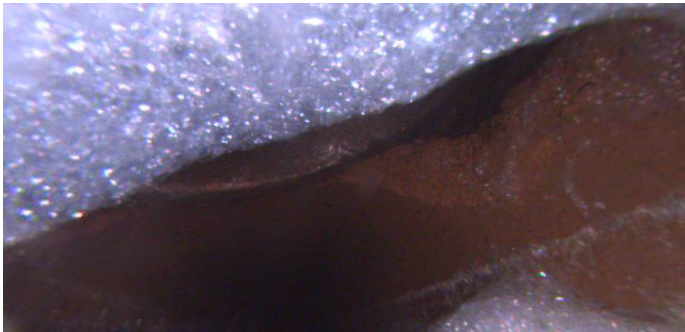
Code: **TBI**
Description: **Tap Break-in Intruding**

Distance (ft): **35.8**
Structural Grade: **0**
O&M Grade: **2**
Clock Start/From: **12**
Clock To:
1st Value: **4.000**
2nd Value: **1.000**
Value Percent:
Continuous Index:
Within 8" of Joint:
Remarks: **suds**

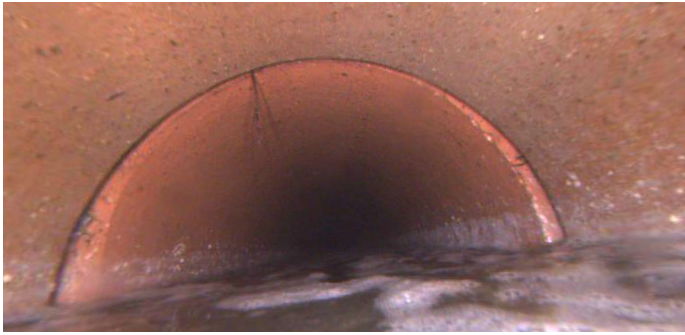
Code: **RFJ**
Description: **Roots Fine Joint**

Distance (ft): **49.4**
Structural Grade: **0**
O&M Grade: **1**
Clock Start/From: **12**
Clock To:
1st Value:
2nd Value:
Value Percent:
Continuous Index:
Within 8" of Joint: **YES**
Remarks:

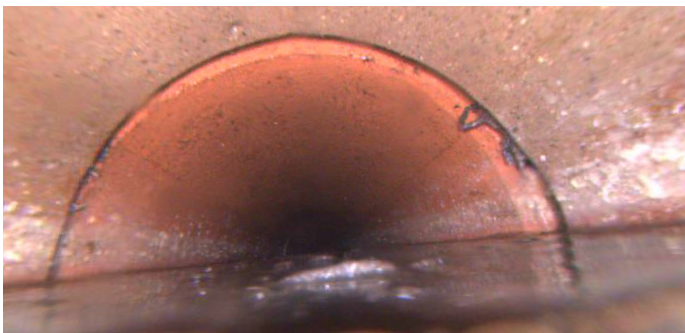
Code: **RFJ**
Description: **Roots Fine Joint**

Distance (ft): **65.0**
Structural Grade: **0**
O&M Grade: **1**
Clock Start/From: **10**
Clock To:
1st Value:
2nd Value:
Value Percent:
Continuous Index:
Within 8" of Joint: **YES**
Remarks:

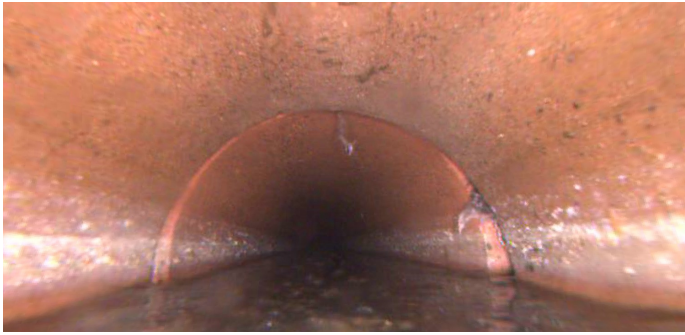
Code: **RFJ**
Description: **Roots Fine Joint**

Distance (ft): **74.5**
Structural Grade: **0**
O&M Grade: **1**
Clock Start/From: **10**
Clock To: **12**
1st Value:
2nd Value:
Value Percent:
Continuous Index: **S02**
Within 8" of Joint: **YES**
Remarks:

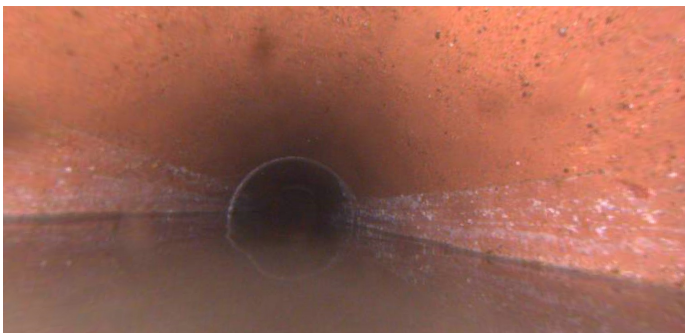
Code: **RFJ**
Description: **Roots Fine Joint**

Distance (ft): **90.9**
Structural Grade: **0**
O&M Grade: **1**
Clock Start/From: **10**
Clock To: **12**
1st Value:
2nd Value:
Value Percent:
Continuous Index: **F02**
Within 8" of Joint: **YES**
Remarks:

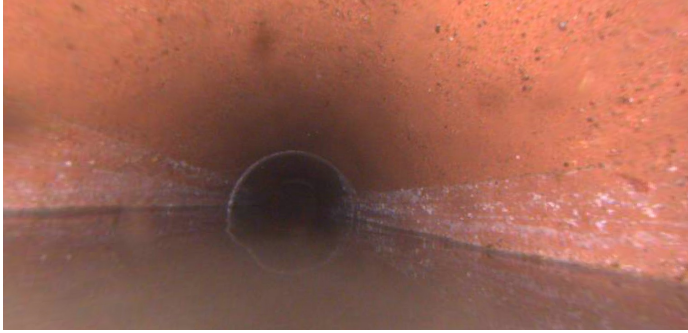
Code:	MSA
Description:	Abandoned Survey
Distance (ft):	90.9
Structural Grade:	0
O&M Grade:	0
Clock Start/From:	
Clock To:	
1st Value:	
2nd Value:	
Value Percent:	
Continuous Index:	
Within 8" of Joint:	NO
Remarks:	debris under water
