## Profile/Photo Observation Report

Date:	<b>03/23/2018</b>	Weather:		Coding:	<b>PACP 6.0</b>
Pipe Length (ft):	<b>120.1</b>	Owner:	<b>NA</b>	Pre Clean:	<b>Not Known</b>
P.O.#:		Surveyor:	<b>Jen Costello</b>	PSR:	<b>P-902-038-037</b>
Customer:		Clean Date:	<b>01/01/1900</b>	Shape:	<b>C</b>

Street:	<b>randolph pl</b>	Flow Control:	<b>Not Controlled</b>
City:	<b>Hobart, IN</b>	Year Renewed:	
Location:	<b>Other</b>	Tape/Media #:	
Purpose:	<b>Not Known</b>	Dia/Height:	<b>10"</b>
Use:	<b>Sanitary</b>	Material:	<b>PVC</b>
Drain Area:	<b>NA</b>	Lining:	
Category:	<b>NA</b>		
Comment:

Location Details:		Direction of Survey:	<b>Upstream</b>
US MH:	<b>M-902-038</b>	DS MH:	<b>M-902-037</b>
		Total Length Surveyed (ft):	<b>90.9</b>

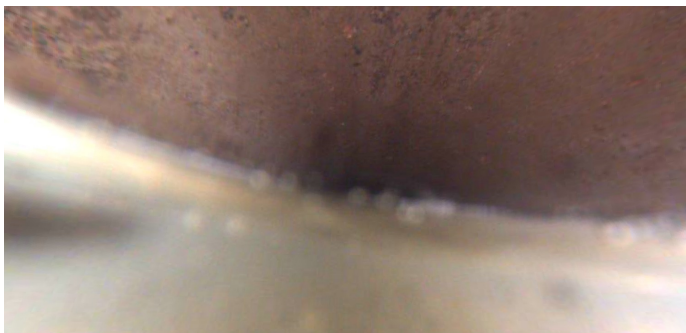
Code: **AMH**  
Description: **Manhole**

Distance (ft): **.0**  
Structural Grade: **0**  
O&M Grade: **0**  
Clock Start/From:  
Clock To:  
1st Value:  
2nd Value:  
Value Percent:  
Continuous Index:  
Within 8" of Joint: **NO**  
Remarks: **M-902-037**

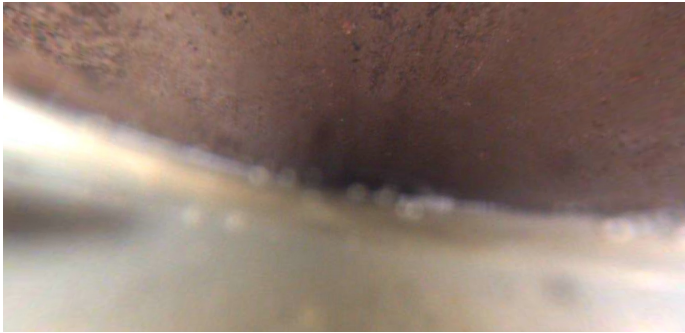
Code:	<b>MWL</b>
Description:	<b>Water Level</b>

Distance (ft):	<b>.0</b>
Structural Grade:	<b>0</b>
O&M Grade:	<b>0</b>
Clock Start/From:	
Clock To:	
1st Value:	
2nd Value:	
Value Percent:	<b>40.000</b>
Continuous Index:	
Within 8" of Joint:	<b>NO</b>
Remarks:

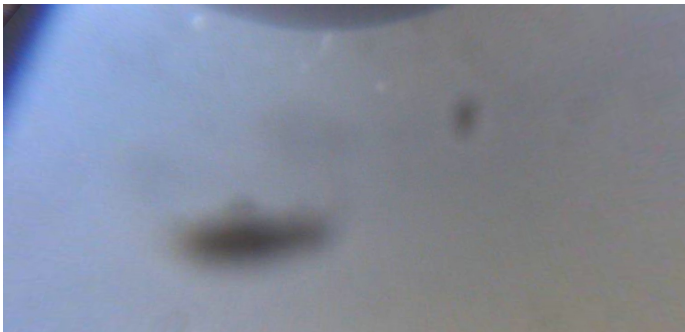
Code:	<b>MWL</b>
Description:	<b>Water Level</b>

Distance (ft):	<b>11.8</b>
Structural Grade:	<b>0</b>
O&M Grade:	<b>0</b>
Clock Start/From:	
Clock To:	
1st Value:	
2nd Value:	
Value Percent:	<b>100.000</b>
Continuous Index:	
Within 8" of Joint:	<b>NO</b>
Remarks:

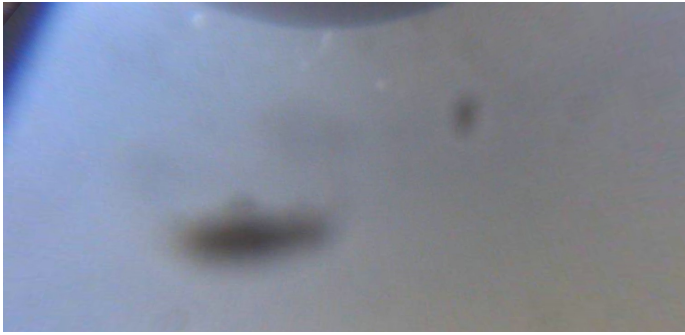
Code: **MCU**  
Description: **Camera Underwater**

Distance (ft): **11.8**  
Structural Grade: **0**  
O&M Grade: **4**  
Clock Start/From:  
Clock To:  
1st Value:  
2nd Value:  
Value Percent:  
Continuous Index: **S01**  
Within 8" of Joint: **NO**  
Remarks:

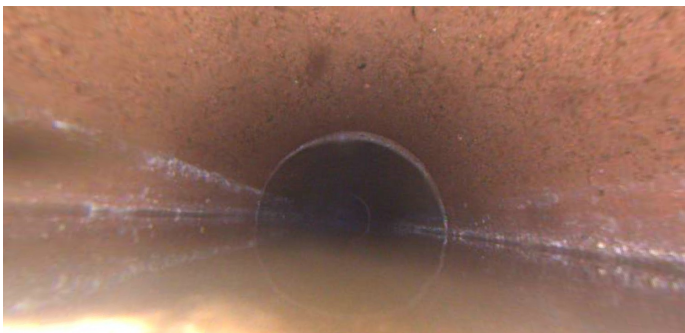
Code: **MCU**  
Description: **Camera Underwater**

Distance (ft): **26.2**  
Structural Grade: **0**  
O&M Grade: **4**  
Clock Start/From:  
Clock To:  
1st Value:  
2nd Value:  
Value Percent:  
Continuous Index: **F01**  
Within 8" of Joint: **NO**  
Remarks:

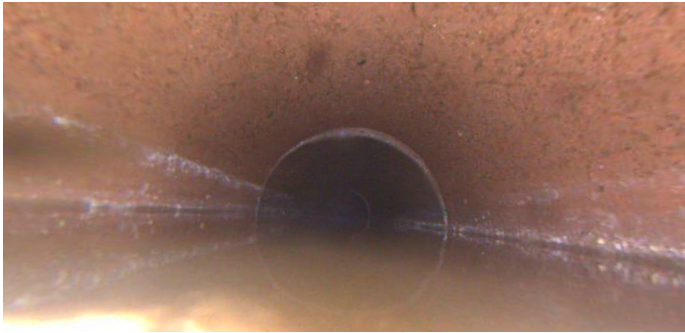
Code: **MWL**  
Description: **Water Level**

Distance (ft): **26.2**  
Structural Grade: **0**  
O&M Grade: **0**  
Clock Start/From:  
Clock To:  
1st Value:  
2nd Value:  
Value Percent: **40.000**  
Continuous Index:  
Within 8" of Joint: **NO**  
Remarks:

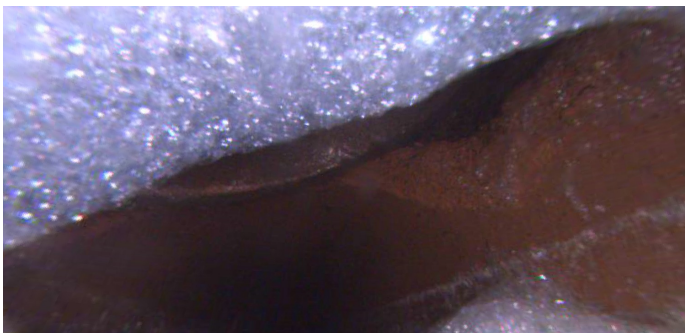
Code: **TBI**  
Description: **Tap Break-in Intruding**

Distance (ft): **35.8**  
Structural Grade: **0**  
O&M Grade: **2**  
Clock Start/From: **12**  
Clock To:  
1st Value: **4.000**  
2nd Value: **1.000**  
Value Percent:  
Continuous Index:  
Within 8" of Joint:  
Remarks: **suds**

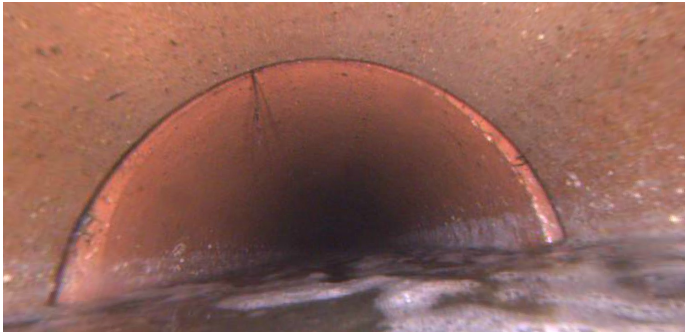
Code: **RFJ**  
Description: **Roots Fine Joint**

Distance (ft): **49.4**  
Structural Grade: **0**  
O&M Grade: **1**  
Clock Start/From: **12**  
Clock To:  
1st Value:  
2nd Value:  
Value Percent:  
Continuous Index:  
Within 8" of Joint: **YES**  
Remarks:

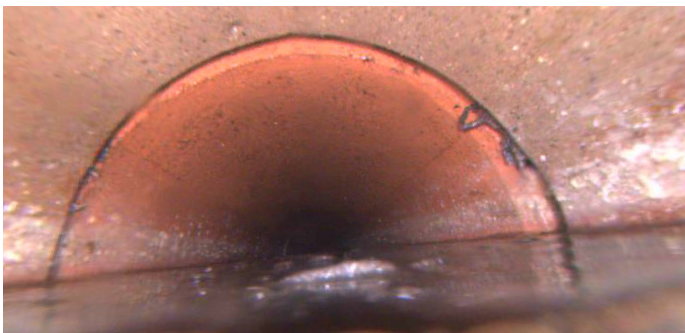
Code: **RFJ**  
Description: **Roots Fine Joint**

Distance (ft): **65.0**  
Structural Grade: **0**  
O&M Grade: **1**  
Clock Start/From: **10**  
Clock To:  
1st Value:  
2nd Value:  
Value Percent:  
Continuous Index:  
Within 8" of Joint: **YES**  
Remarks:

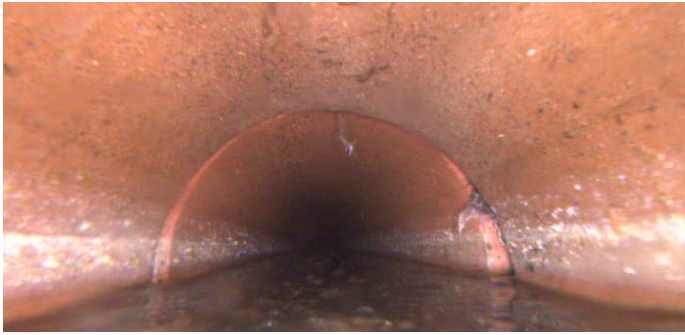
Code: **RFJ**  
Description: **Roots Fine Joint**

Distance (ft): **74.5**  
Structural Grade: **0**  
O&M Grade: **1**  
Clock Start/From: **10**  
Clock To: **12**  
1st Value:  
2nd Value:  
Value Percent:  
Continuous Index: **S02**  
Within 8" of Joint: **YES**  
Remarks:

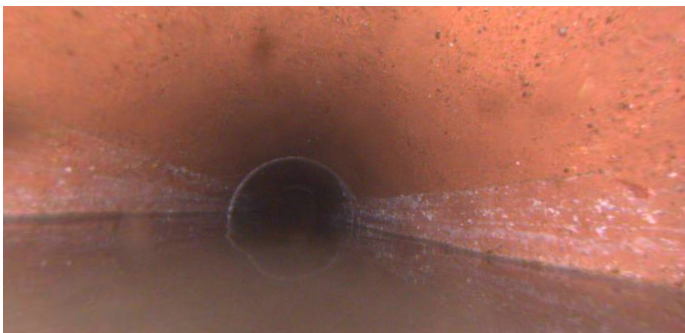
Code: **RFJ**  
Description: **Roots Fine Joint**

Distance (ft): **90.9**  
Structural Grade: **0**  
O&M Grade: **1**  
Clock Start/From: **10**  
Clock To: **12**  
1st Value:  
2nd Value:  
Value Percent:  
Continuous Index: **F02**  
Within 8" of Joint: **YES**  
Remarks:

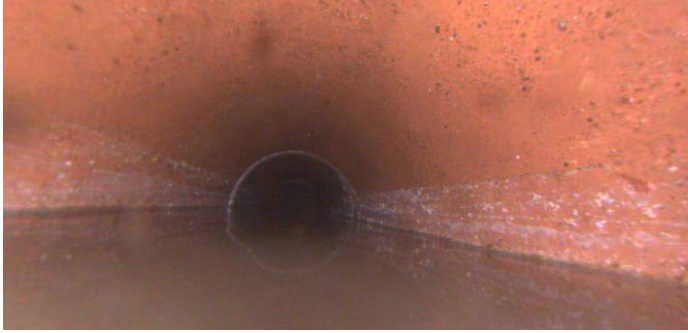
Code:	<b>MSA</b>
Description:	<b>Abandoned Survey</b>
Distance (ft):	<b>90.9</b>
Structural Grade:	<b>0</b>
O&M Grade:	<b>0</b>
Clock Start/From:	
Clock To:	
1st Value:	
2nd Value:	
Value Percent:	
Continuous Index:	
Within 8" of Joint:	<b>NO</b>
Remarks:	<b>debris under water</b>
