Profile/Photo Observation Report

Date:	04/10/2018	Weather:		Coding:	PACP 6.0
Pipe Length (ft):	281.5	Owner:	City of Hobart	Pre Clean:	No Pre-Cleaning
P.O.#:	2004	Surveyor:	SAN	PSR:	P-902-039-032
Customer:	Red Zone	Clean Date:		Shape:	C

Street:	3775 34th Ave	Flow Control:	Not Controlled
City:	Hobart In	Year Renewed:	
Location:	Light Highway	Tape/Media #:	Deliverable 1
Purpose:	Routine Assessment	Dia/Height:	18"
Use:	Sanitary	Material:	RCP
Drain Area:	unknown	Lining:	
Category:	NA		
Comment:	403-1/Incomplete due to debris. PSR incorrect on video overlay.		
Location Details:	Backyards	Direction of Survey:	Downstream
US MH:	M-902-039	DS MH:	M-902-032
		Total Length Surveyed (ft):	.1

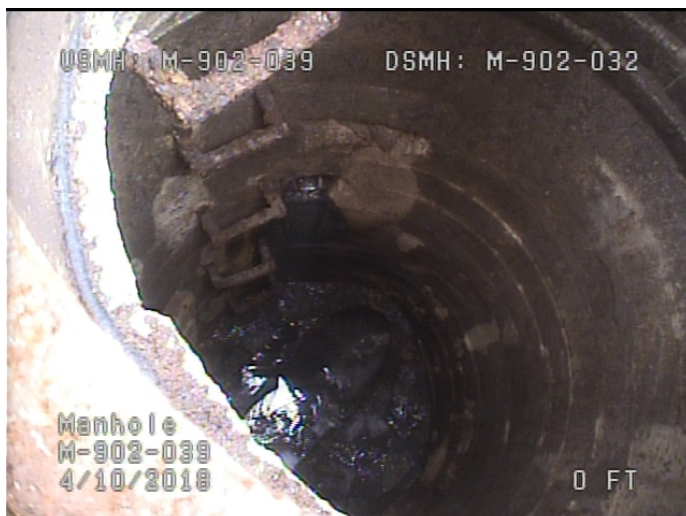
Code:	AMH
Description:	Manhole
Distance (ft):	.0
Structural Grade:	0
O&M Grade:	0
Clock Start/From:	
Clock To:	
1st Value:	
2nd Value:	
Value Percent:	
Continuous Index:	
Within 8" of Joint:	NO
Remarks:	M-902-039

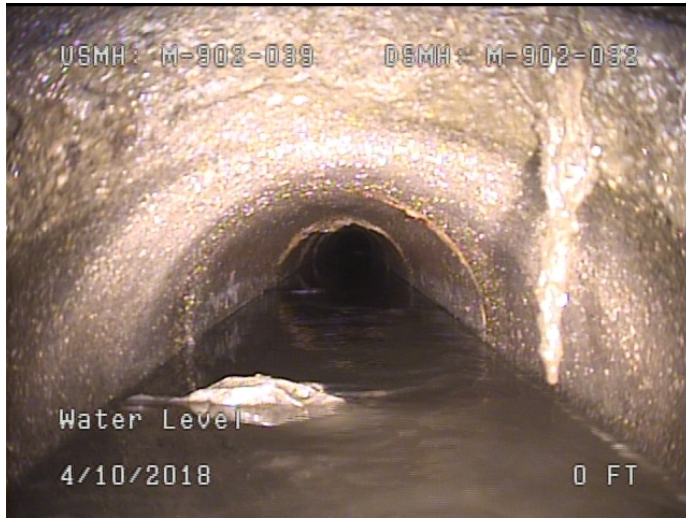
Code: **MWL**
 Description: **Water Level**

Distance (ft): **.0**
 Structural Grade: **0**
 O&M Grade: **0**
 Clock Start/From:
 Clock To:
 1st Value:
 2nd Value:
 Value Percent: **10.000**
 Continuous Index:
 Within 8" of Joint: **NO**
 Remarks:

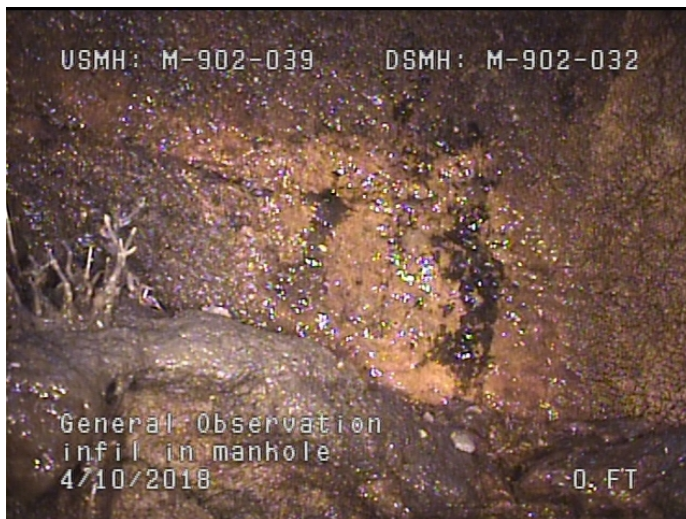
Code: **MGO**
 Description: **General Observation**

Distance (ft): **.0**
 Structural Grade: **0**
 O&M Grade: **0**
 Clock Start/From:
 Clock To:
 1st Value:
 2nd Value:
 Value Percent:
 Continuous Index:
 Within 8" of Joint: **NO**
 Remarks: **infil in manhole**

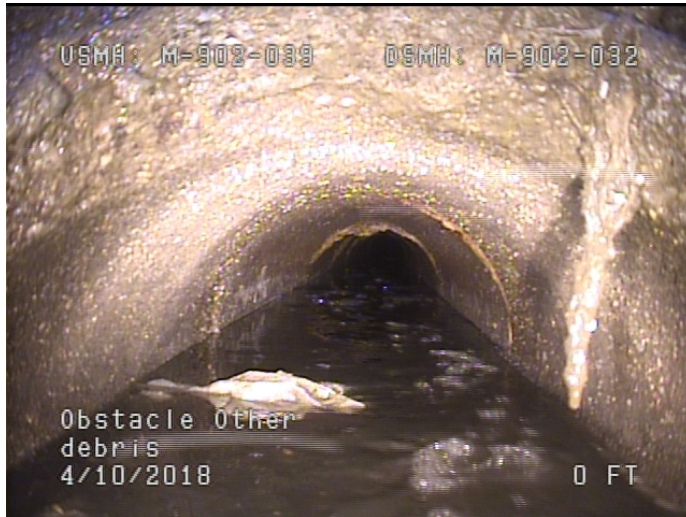
Code:	OBZ
Description:	Obstacle Other
Distance (ft):	.0
Structural Grade:	0
O&M Grade:	5
Clock Start/From:	4
Clock To:	8
1st Value:	
2nd Value:	
Value Percent:	35.000
Continuous Index:	
Within 8" of Joint:	NO
Remarks:	debris

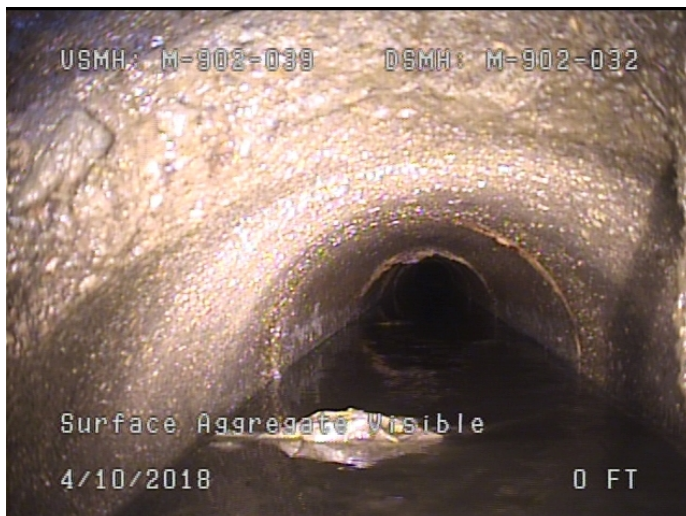
Code:	SAV
Description:	Surface Aggregate Visible
Distance (ft):	.0
Structural Grade:	3
O&M Grade:	0
Clock Start/From:	8
Clock To:	4
1st Value:	
2nd Value:	
Value Percent:	
Continuous Index:	
Within 8" of Joint:	NO
Remarks:

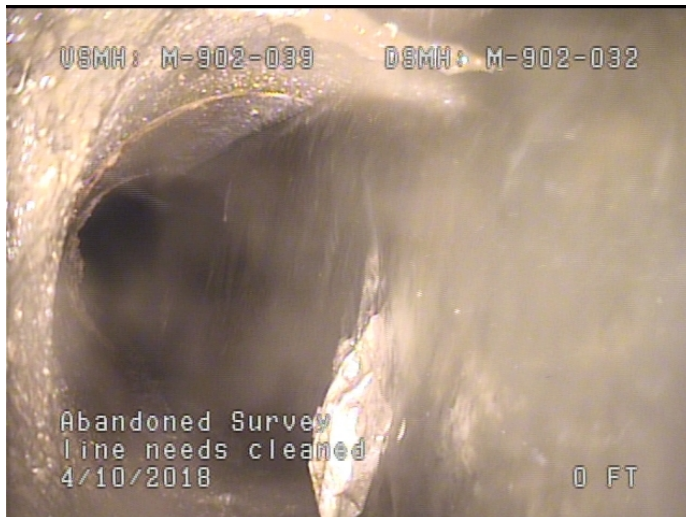
Code:	MSA
Description:	Abandoned Survey
Distance (ft):	.0
Structural Grade:	0
O&M Grade:	0
Clock Start/From:	
Clock To:	
1st Value:	
2nd Value:	
Value Percent:	
Continuous Index:	
Within 8" of Joint:	NO
Remarks:	line needs cleaned
